## Existing Conditions and Recommendations

### Civil and Site

Historic Hall of Waters  
 Assessment and Feasibility Study

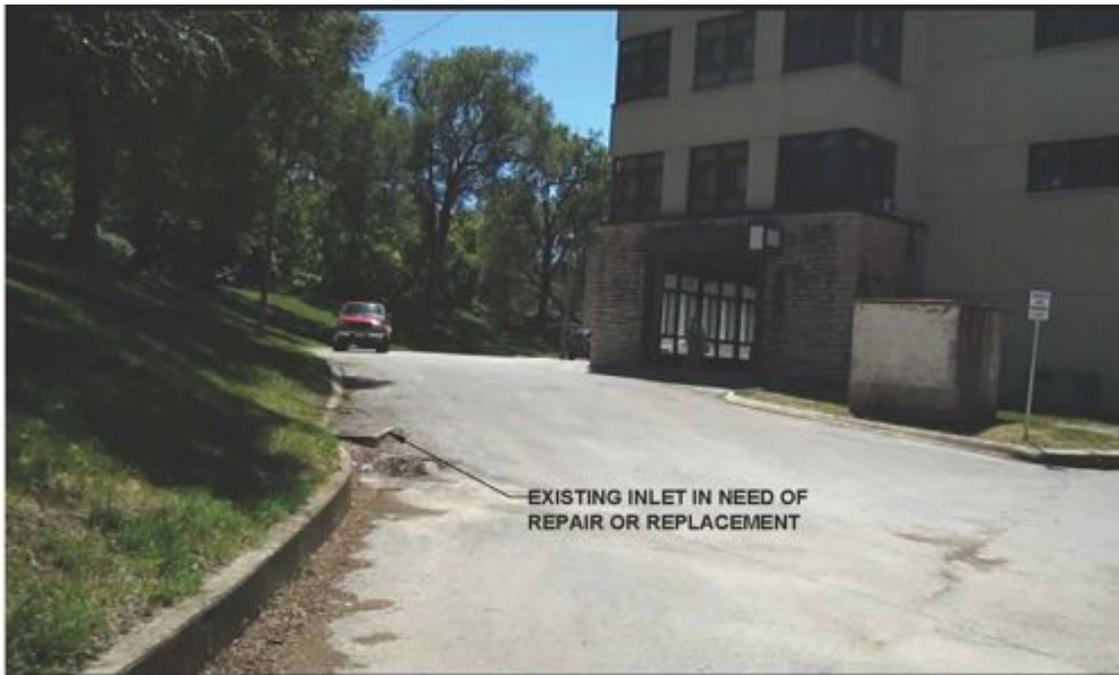
During rain events, the City Staff have witnessed storm water exiting the inlets several inches high. Storm water also enters the building through exterior doors located along the east side of the Hall of Waters.

4600 College Blvd. Suite 100 Overland Park, KS. 66211 913-451-1818 Fax. 913-451-7599	<b>FLOOD AT GARAGE</b>	<b>EXHIBIT</b>
	Hall of Waters Site Analysis 201 E Broadway Street, Excelsior Springs, MO	<b>6</b>
		SEPT, 2012

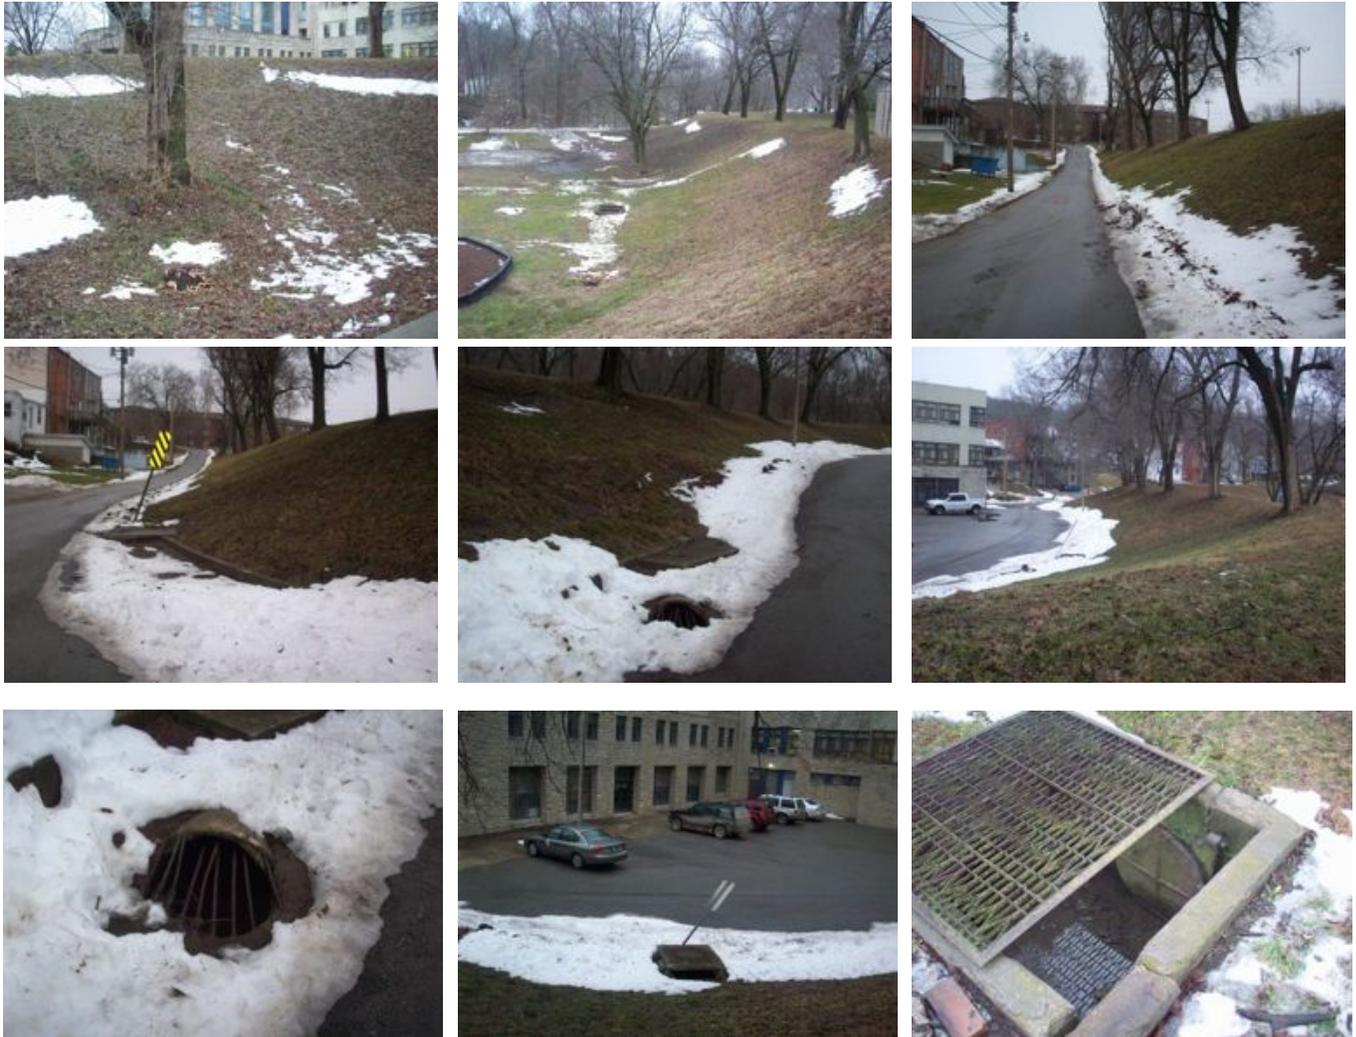
Fig. 36 – Photographs of flood berm and various inlets around the building. (SKDG 2012)

The Hall of Waters had a berm constructed along East Fork Fishing River to protect the property during flooding, see Exhibit 6. This berm was constructed in 1955. The condition of the berm is unknown. As shown in the pictures several trees were planted on and around the berm. The effect of the trees on the berm should be analyzed by a geotechnical engineer. Several existing inlets are in need of repair and or replacement.

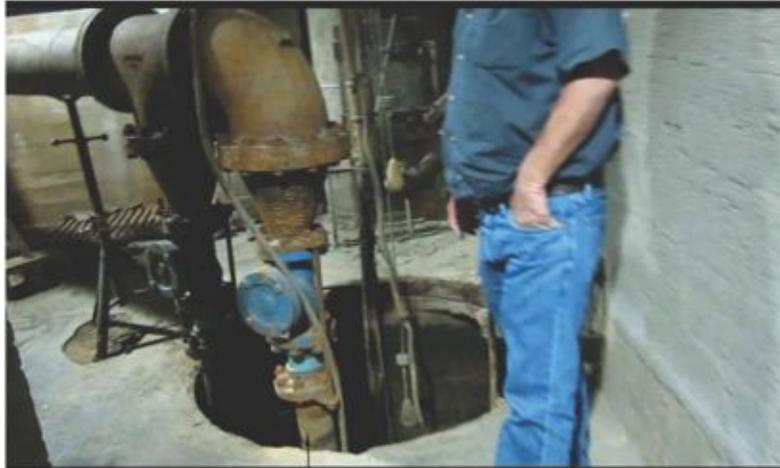
EXISTING SUMP PUMPS IN BASEMENT

The Hall of Waters Basement has several sump pumps, see [Exhibit 7](#), that were installed to control flooding into the building. These exit the building through a 10" DIP (Ductile Iron Pipe) to a storm grate inlet in Siloam Park south easterly from the building, see [Exhibit 8](#). This 10" DIP sump pump drain pipe has a flap gate located within the inlet.

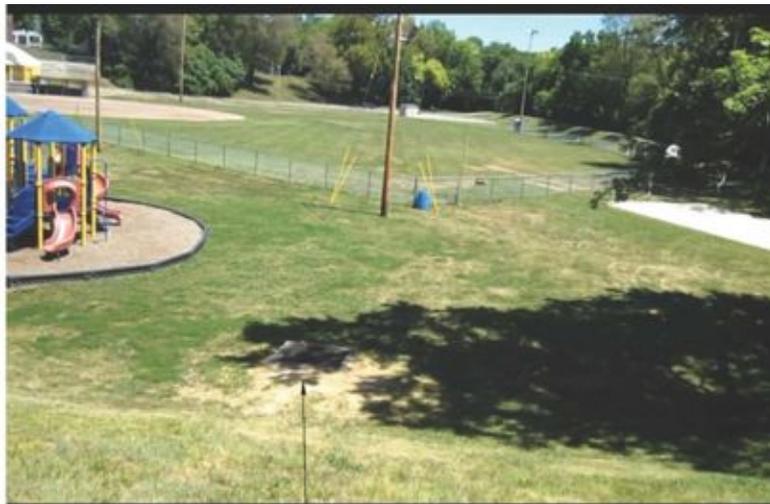
EXISTING INLET WITH 10" DIP FLAP GATE

As discussed with the City, this flap gate gets compromised and clogged during flood events which keeps the gate open and has allowed flood waters, debris as well as fish to enter the pipe from the East Fork Fishing River directly into the Hall of Waters basement.

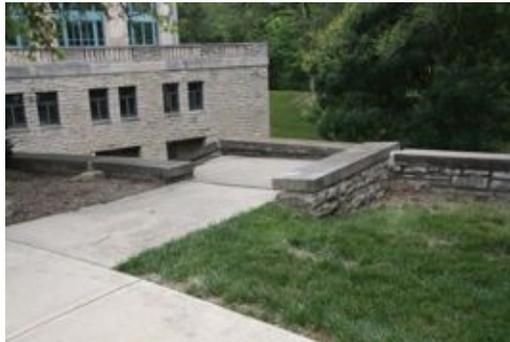
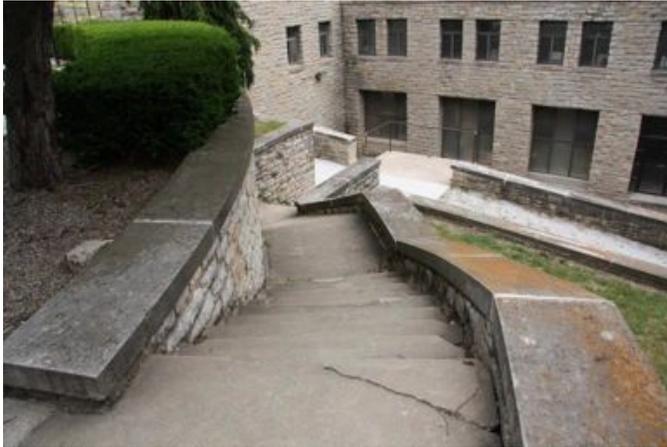
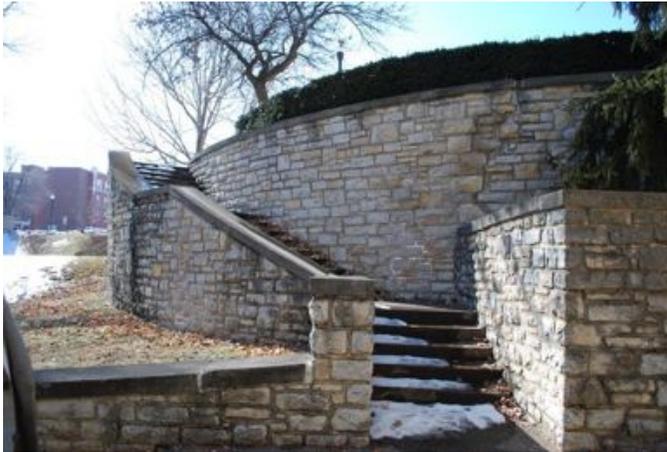
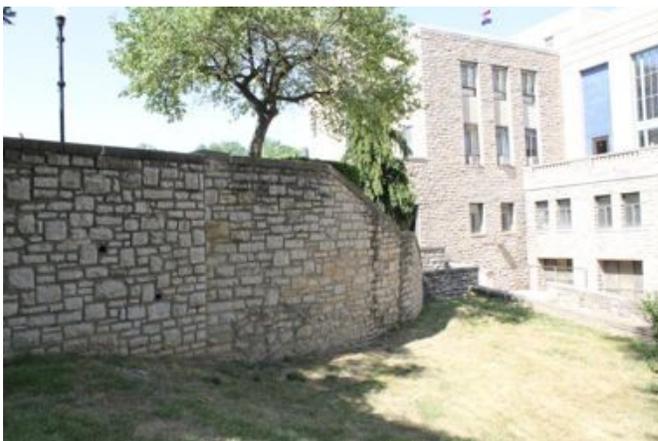
The curved site wall (Figures 38 - 42) located to the south of the west entrance is experiencing settlement with rotation outward (Figure 42). In addition, multiple attempts to repair the surface of the wall have been attempted over time. The retaining wall section that is rotating outward is closest to the main entrance. This outward rotation is more than a 1" displacement. In addition to the stone wall, the concrete stairs are deteriorated and exhibit spalling and cracking. They have also settled and are no longer plumb. The joint between the wall and the stair is wide open, allowing water to infiltration below the concrete stair, which will eventually undermine the stair.

If repairing the crack in the southwest stair and retaining wall is not an option, further investigation and borings are needed with analysis by a geotechnical engineer. City plans on what improvements and storm system were constructed in this general drive area should be reviewed and understood. Repairs may include a new retaining wall (sub surface) as well as extensive dedicated under drainage/dewatering system in order to save the stone wall. Pinning the existing stone wall back to the new retaining wall in order to stabilize it could be studied. It may take a retaining wall dedicated to stabilize and return the existing stone wall back to where it needs to be and then construct another retaining wall back away from the improved stone wall (a few feet) that would transfer the existing sub grade loads and totally protect the existing stone wall in the future.

It would be desirable to completely remove and replace the concrete stair in its entirety, as it is too deteriorated to patch. A new stair should be constructed to closely replicate the existing stair. Also, a new period-appropriate railing should be installed.

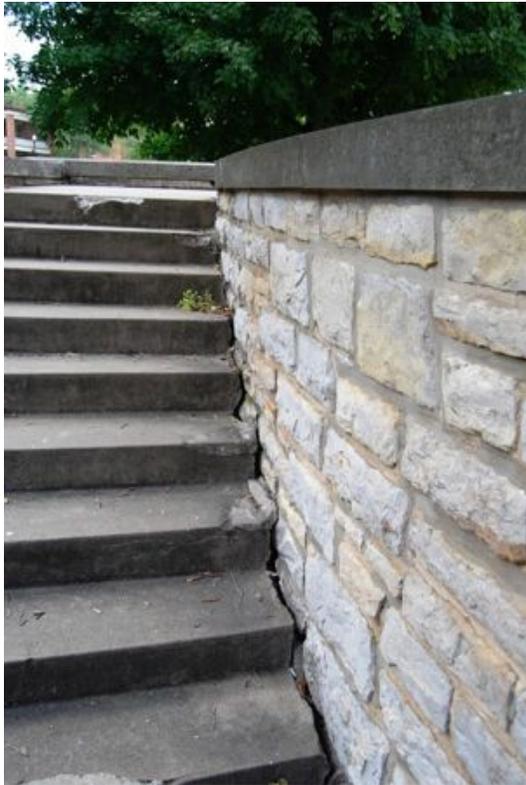
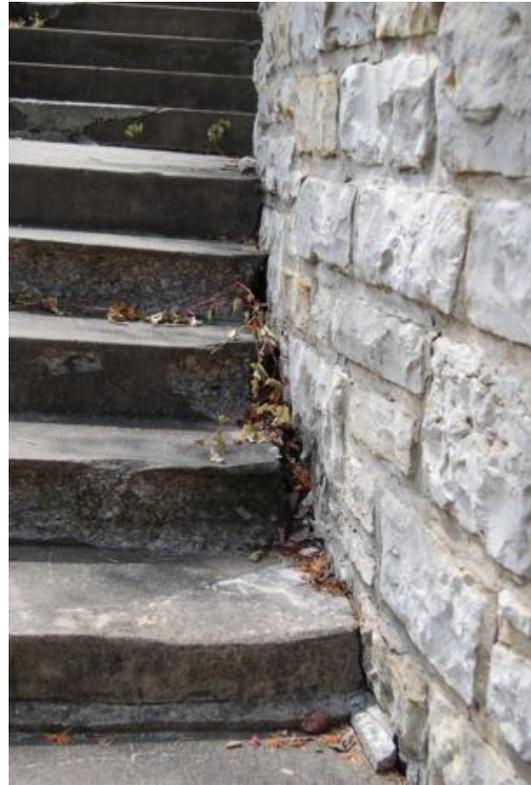
In addition to the crack which appears in the curved stone wall, there is a stress/settlement in the south driveway. This crack in the concrete runs generally parallel to the existing stone wall drop-off area above. It appears that subsurface pressure and movement behind the wall is occurring. This may be due to the sub grade above the stone wall that is not being controlled. This would lead it to move in the path of least resistance.

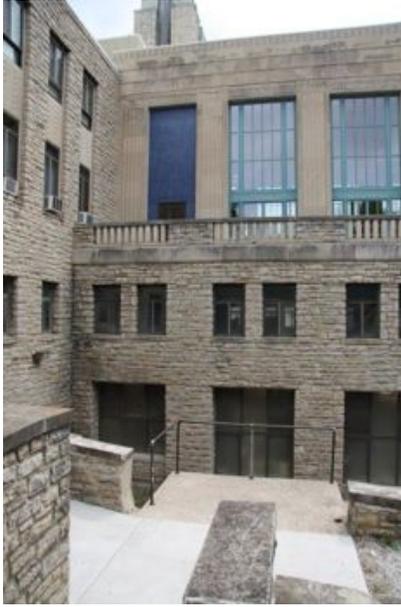
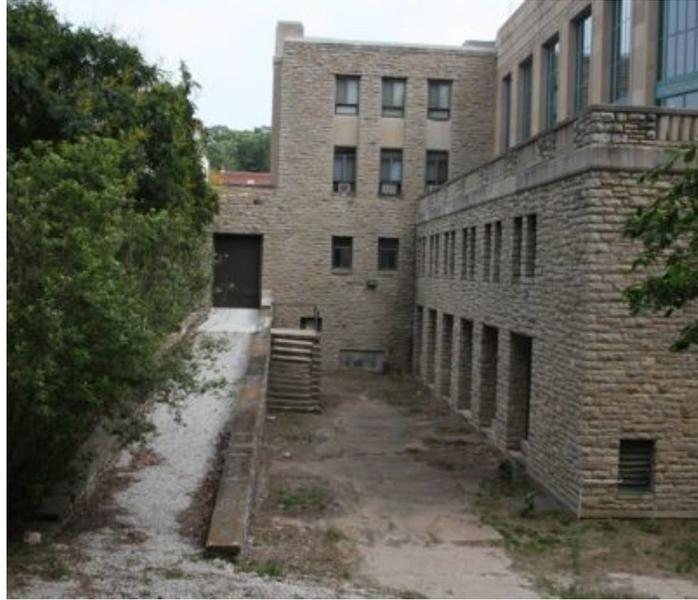
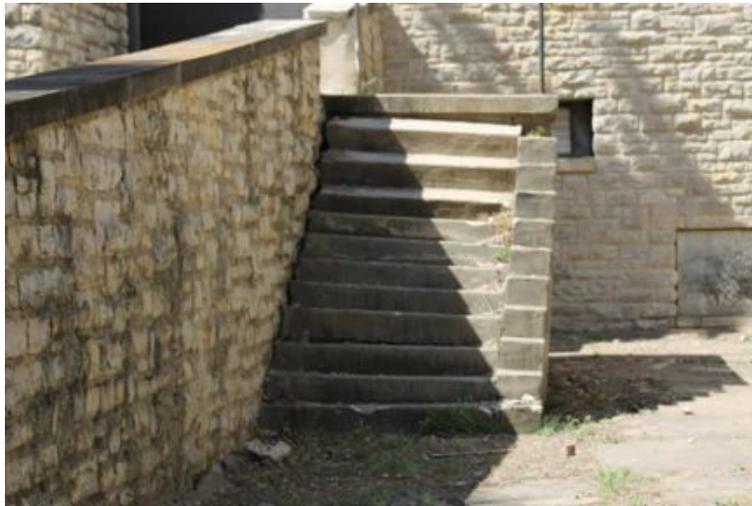
At the base of the curved stair are the south ramp and stairs (Figures 45-47). The ramp is concrete at the top landing and the remainder is gravel. The ramp walls appear to be stable; however, the concrete stairs, along with the outer wall for the extended landing, are in a state of failure. This wall is rotating outward causing the entire concrete stair and landing to slope downward away from the wall. The outer wall is more than 5 inches out of plumb. In addition, the wall and the stair combination have settled and are no longer plumb. The settlement appears to be in excess of 3 to 4 inches. In addition the concrete stair and landing is also experiencing excessive surface cracking from freeze thaw damage or possible corrosion. The concrete surface has multiple areas of scaling and de-bonding. The stair is no longer safe for use and should be closed until sufficient structural repairs and installation of new code-compliant guard and hand rails can be made.

Fig. 47 Ramp Wall, Landing and South Stair with Settlement (SKDG 2012)

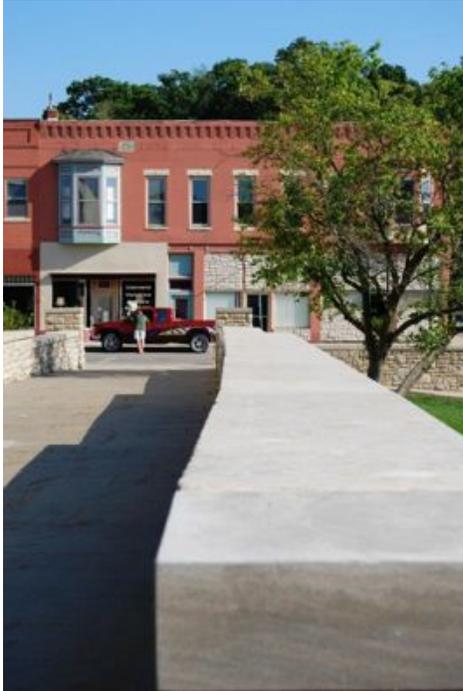
Fig. 48 North Ramp Bowed Wall (SKDG 2012)

The north ramp is original to the construction of the Hall of Waters and is therefore a significant historic feature. The ramp extends from Broadway Street approximately 110 feet and lands at the intersection of the North and West Terraces. The ramp slopes gradually, though it has not been evaluated to verify it meets current ADA slope requirements, which is 1:12 grade, or 1" of rise per 12" of travel distance. The ramp is in fair condition. The side walls are constructed of pitched stone and are topped with capstones. The stone walls are very long and do not contain any expansion joints. The walls both tend to slope outwards slightly towards the tops of the wall, especially near the middle of the length of the wall. The walls also bow slightly. The walkway surface is concrete that is in fair to poor condition. The thickness of the concrete slab is unknown at this time. The upper North and West Terraces were found, during a previous

study, to have had multiple layers of concrete poured on top. These additional concrete toppers led engineers to determine that the structural system of the terraces were approximately 50% over capacity. At the top of the ramp, as it intersects the North and West Terraces, the concrete was approximately 16" thick total. It is unknown what the original top elevation of the concrete was, but it was likely at least 4"-5" below its present height. This additional concrete weight on the foundation, coupled with the fact that there is no expansion joint along the ramp edges, has likely led to the bowing and sloping walls. Further investigation is warranted in order to determine the best solution for future ramp repairs, which may include removing some of the topping concrete down to its original height, in order to reduce weight.

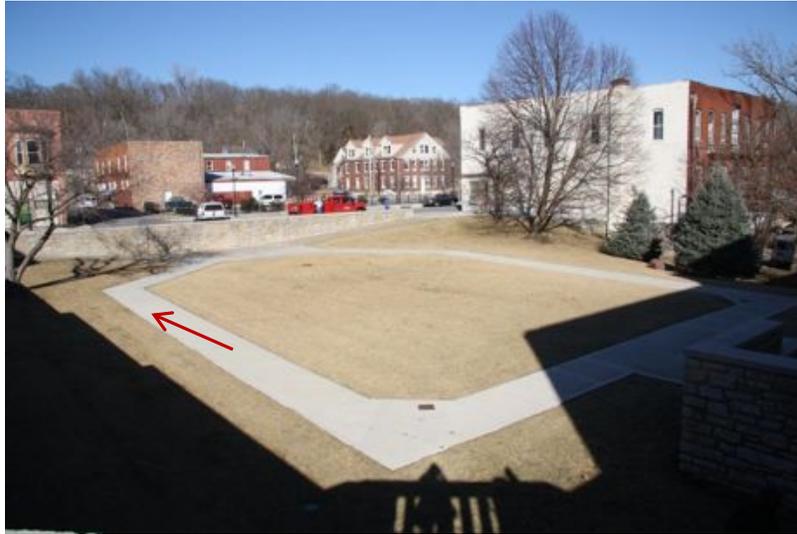
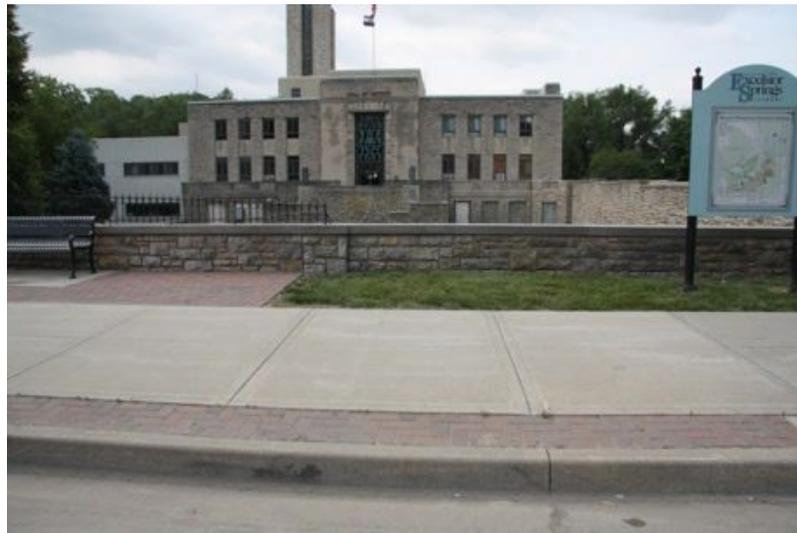
The North Courtyard is slightly sunken below the adjacent Broadway Street. The Courtyard serves as the main park space in front of the Hall of Waters Building and the space is considered to be among the most important historic site features. A series of spring houses associated with Siloam and Sulpho Saline Springs once stood on this site. The original Siloam Spring pump is still located in a subterranean basement below the North Courtyard. The stone walls adjacent to the North Courtyard include the stone wall adjacent to Broadway Street, the North Ramp and the North Terrace and North Terrace Stairs. These walls are in fair condition. The capstone at the west end of the Broadway Stone Retaining Wall is missing a large section

that requires replacement. The remainder of the wall is in fair condition, requiring only typical maintenance. The western portion of the North Terrace stone wall was repaired and repointed in 2009 as part of an emergency wall repair project. The east portion of the wall still requires complete restoration and a thorough inspection and scope of work should be prepared for this work.

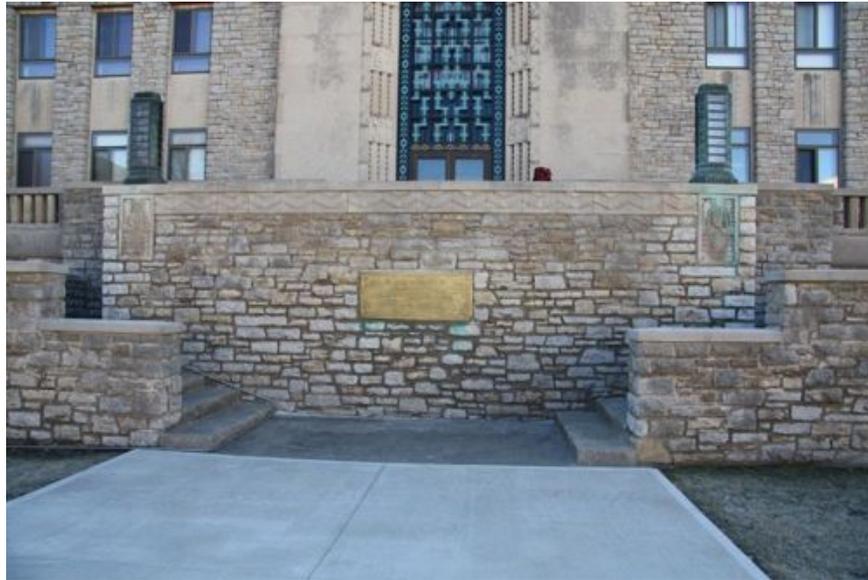
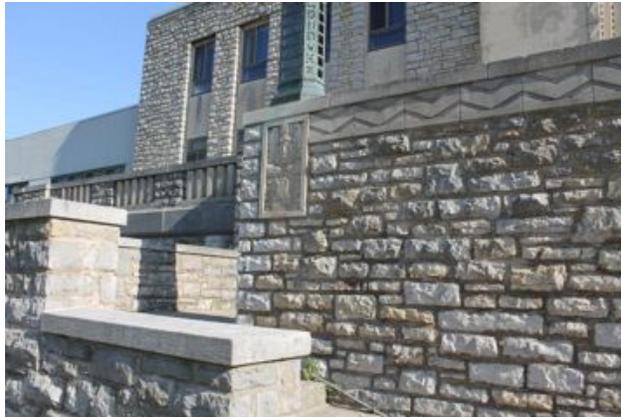
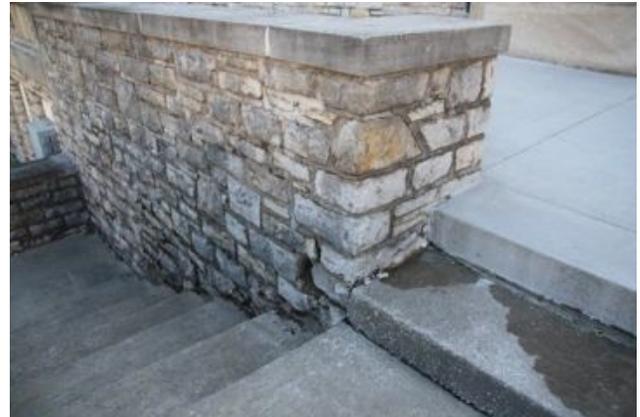
The North Entrance Stair is accessed from the North Courtyard and leads to the North Terrace. This grand stair is original to the construction of the Hall of Waters and is considered to be one of its most significant exterior features. The walls surrounding the symmetrical stair are in fair condition, requiring 100% repointing, some stone repairs and some patching. The walls have copper staining below the decorative post-mounted entrance lights. The walls also have staining which needs to be cleaned. The capstones require repointing and sealant installation.

The concrete stairs are deteriorating and the aggregate is becoming exposed. Plants are growing in the cracks between the stairs and the walls. These plants need to be removed and a new sealant joint installed in order to prevent water and dirt from accumulating in the joints and causing freeze thaw damage to the stairs and the stone walls. The stairs need new handrails, as well.

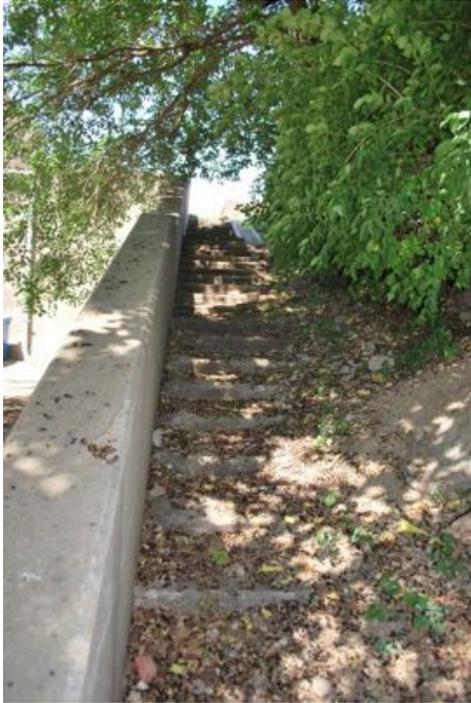
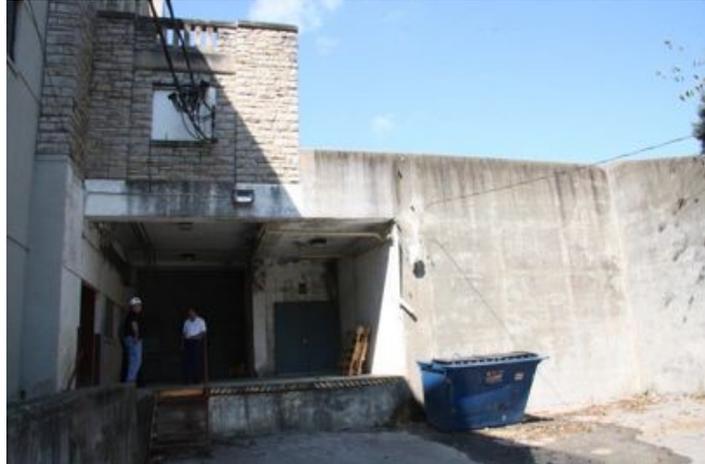
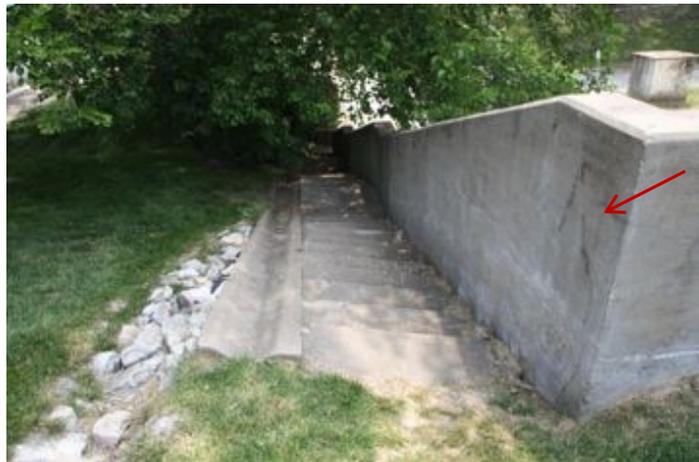
Along the east edge of the North Courtyard, an original concrete stair leads to the lower parking lot. The stair and east side of the Courtyard are retained by a tall concrete wall. The wall is in overall fair condition. There are some minor cracks that should be repaired as soon as possible to prevent further freeze thaw damage. The concrete stair is in very poor condition. The stair is cracked and has settled. Therefore, the stair is out of plumb and is dangerous. This is exaggerated by the fact that the stair has no handrail. This stair should be closed to public use until it can be reconstructed and a new handrail is installed.

Fig. 58 East Courtyard Stair and Retaining Wall. Note the vertical crack in the wall near the corner. (SKDG 2012)
