Building Foundation and Structure

Overview

Interior Structural Conditions

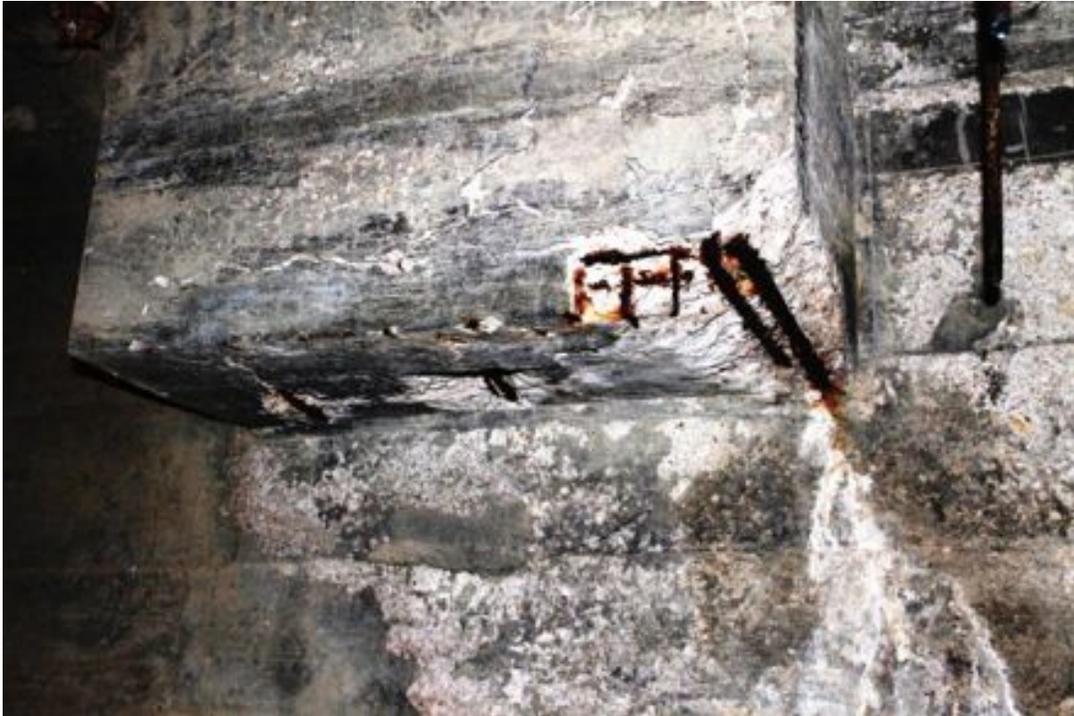
Fig. S1 Pool wall haunch damage. (SEA 2012)

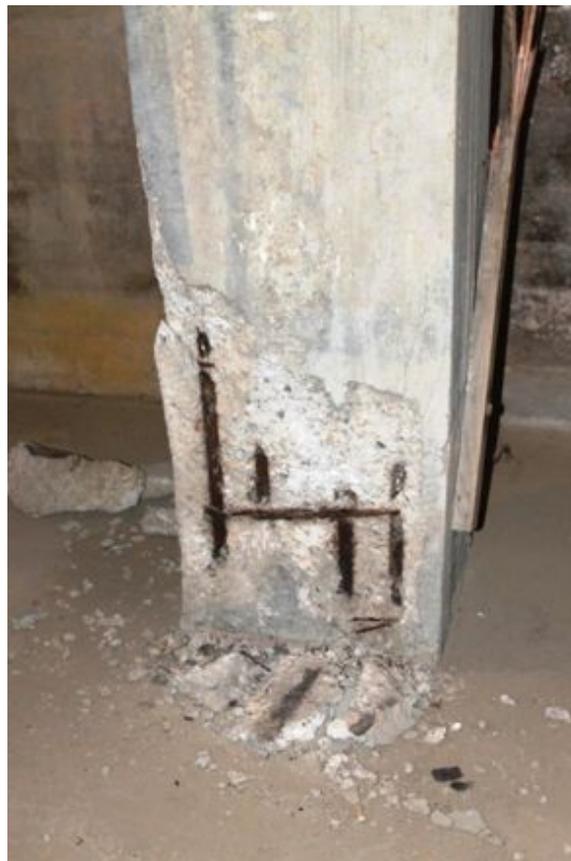
A number of interior columns, beams, and soffits have corroded causing the concrete to delaminate. Most of the columns around the pool structure exhibit spalls from corrosion in the bottom few feet of the column (Figure S2), most likely the result of leaking chlorinated water from the swimming pool coupled with the high humidity in the space. Some of the distressed interior columns had been roped off to protect against the possibility of fall hazards from the unsound concrete. The ability of the columns, beams, and slabs to safely carry the existing loading is impacted, so these structural deficiencies should be repaired soon.

Fig. S2 Corrosion damaged column. (SEA 2012)

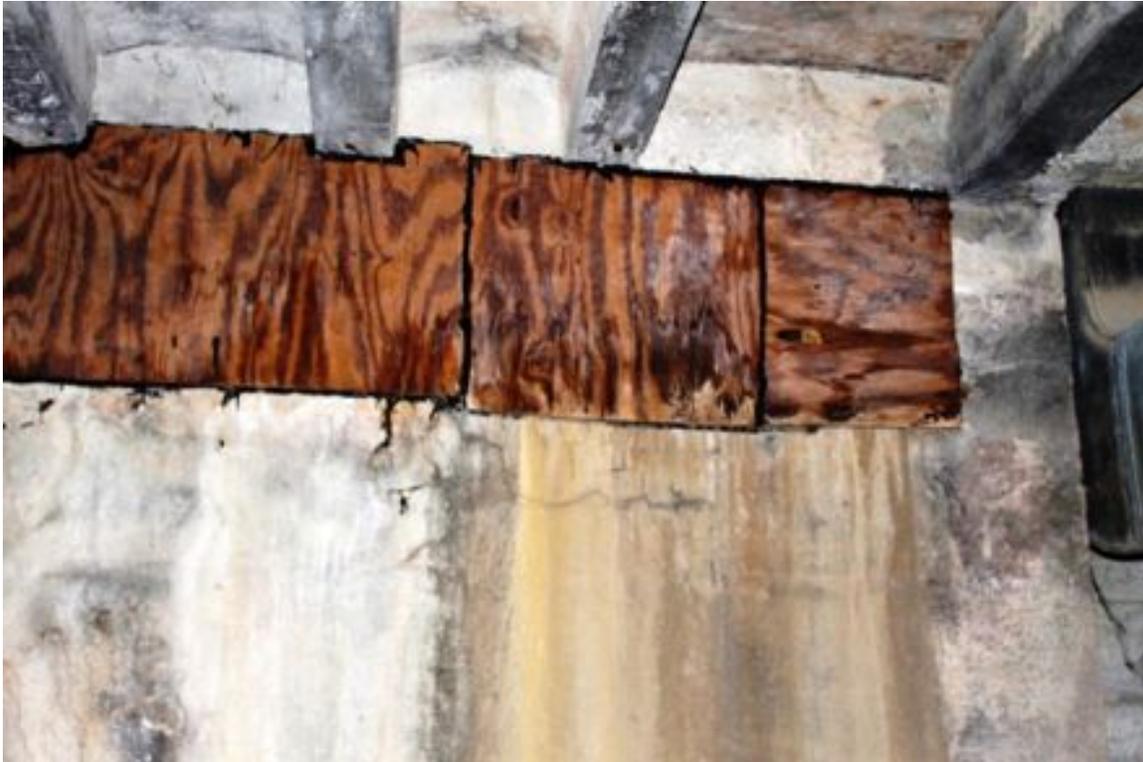
In some areas there is evidence of previous vertical wall penetrations (Figure S3), most notably along the west basement foundation wall. Around the penetrations, there are cracks, efflorescence, and evidence of leaks. These should also be addressed during the building restoration project.

Fig. S3 West foundation wall opening repair. (SEA 2012)

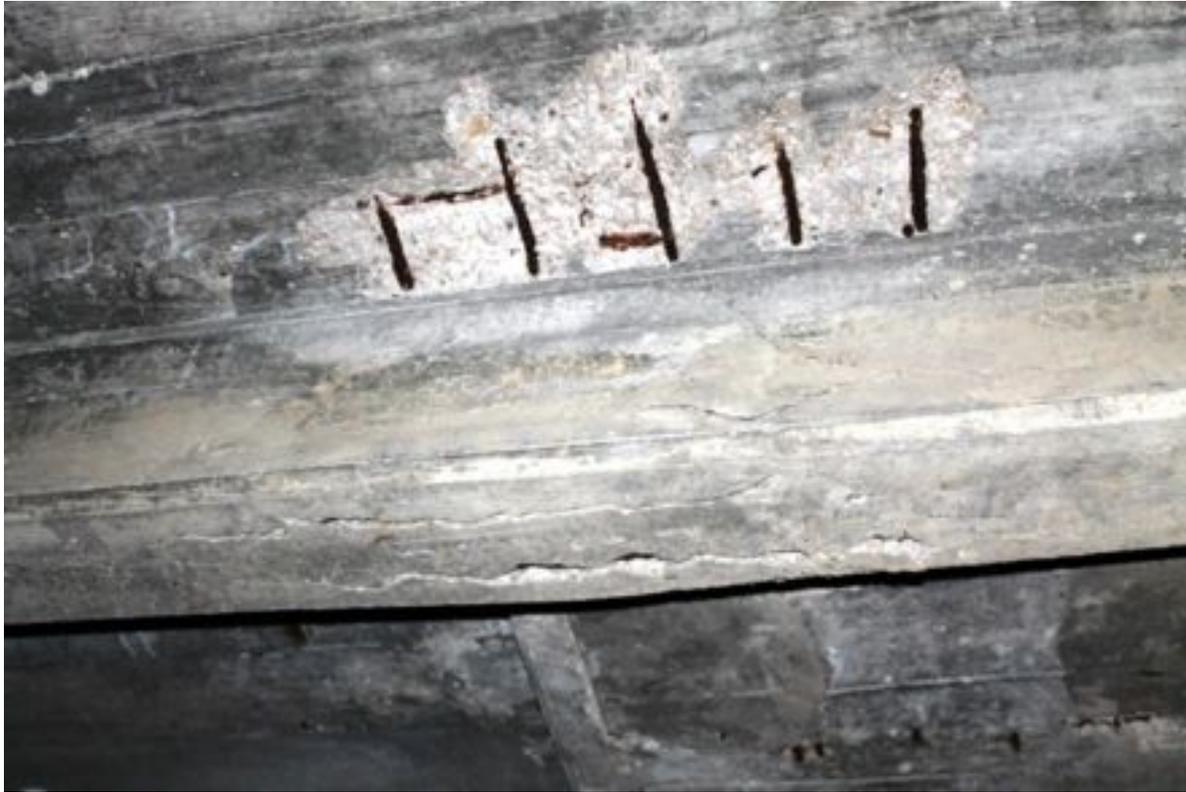
Most of the supported slab distress through the rest of the floor is due to delaminated joists (small beams) (Figure S4) and pans (slab sections between joists) (Figure S5) which are in need of conventional partial (e.g. some of the pans/slabs) or full-depth repairs. Where some full-depth pan/slab repairs are needed, finish floor materials spaces may need to be removed and replaced.

Fig. S4 Delaminated concrete joist. (SEA 2012)

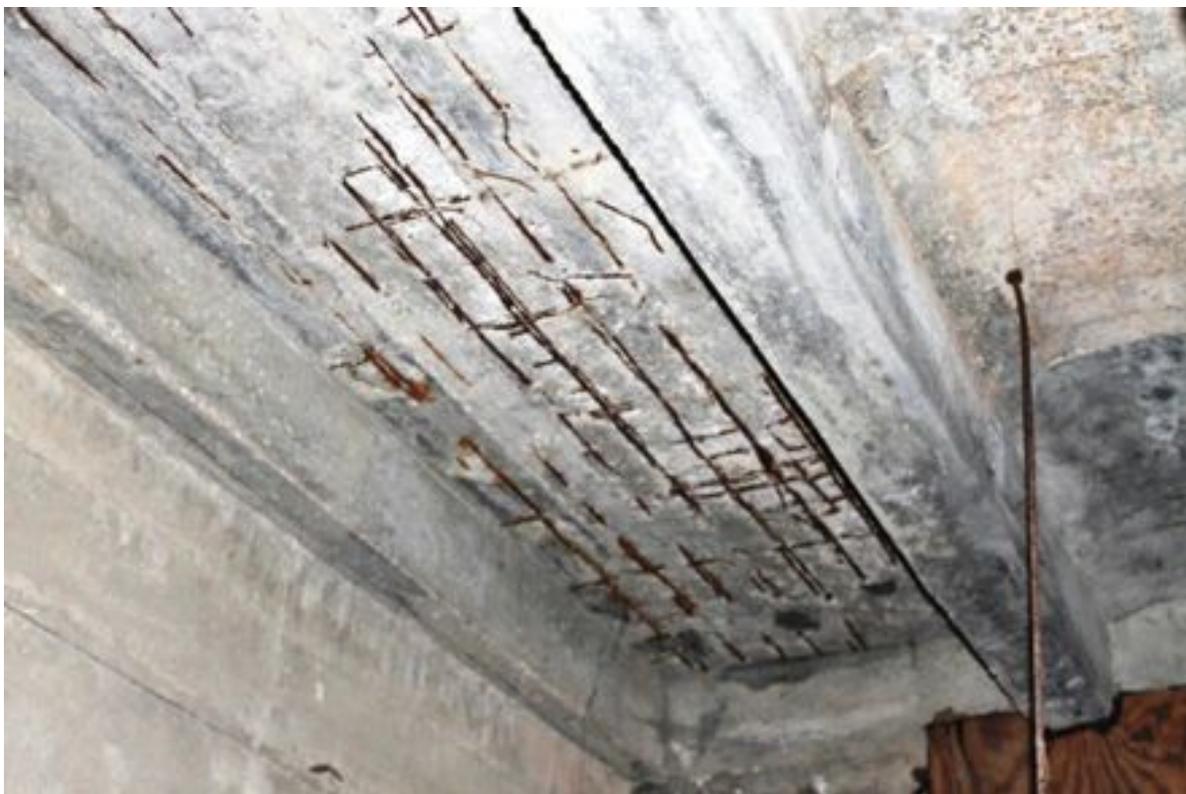
Fig. S5 Distressed pan soffit. (SEA 2012)

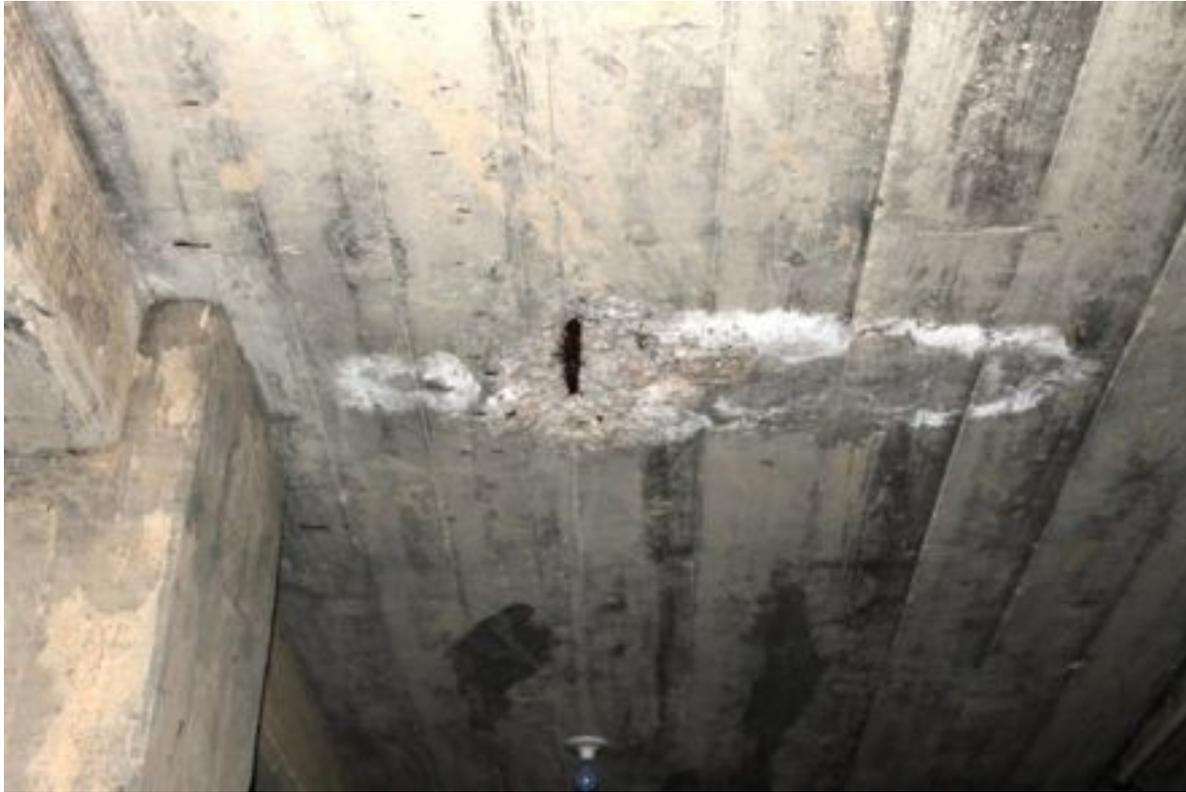
Fig. S6 Leaking Ground Floor Mezzanine slab crack. (SEA 2012)

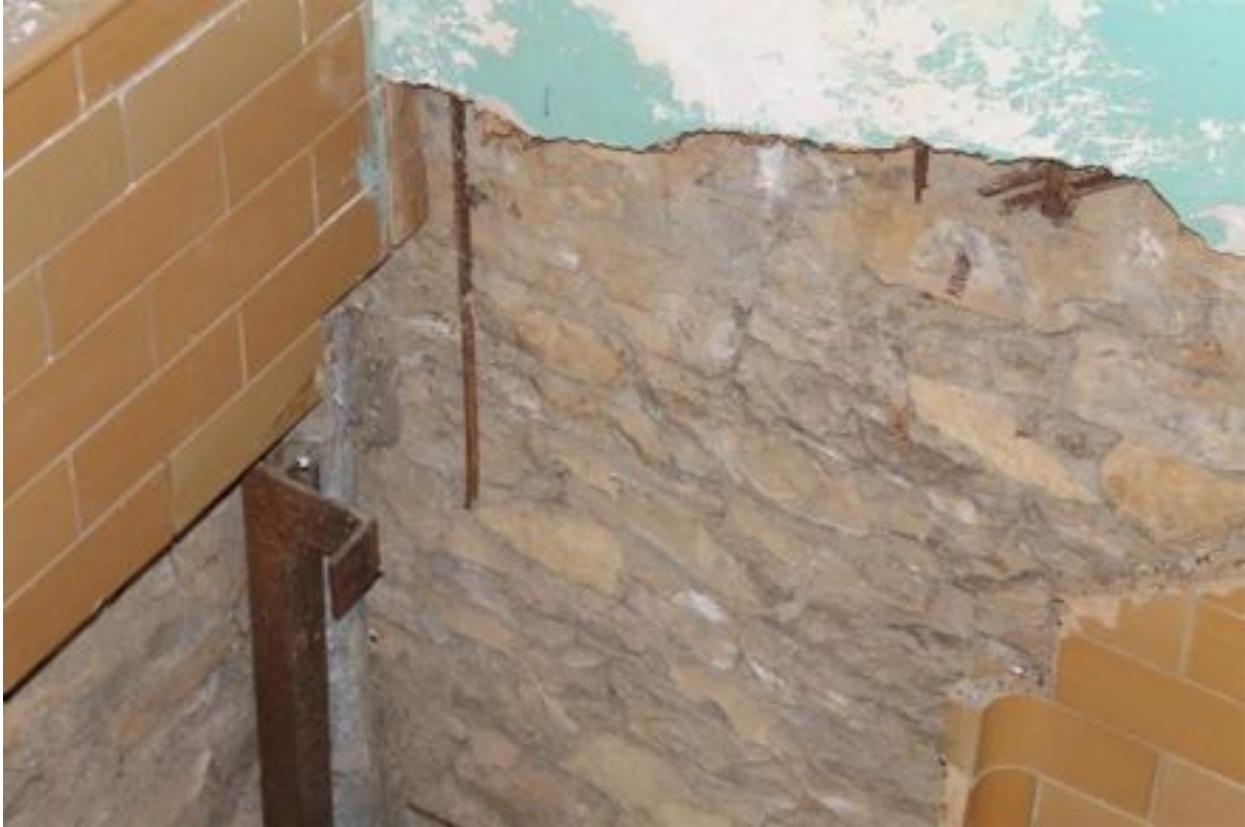
The Ground Floor level is at Elevation 76' – 0", and is an elevated structural concrete slab. The southern portion of the building is occupied by the pool structure. Ingress and egress are provided from the interior pool space to the exterior via doors along the east, south, and west walls. The original interior southeast and southwest stairs from the Ground Floor to the Ground Floor Mezzanine in the Pool Room have been demolished, and the remaining hole is a potential fall hazard from the mezzanine level above.

Fig. S7 Condition of one of the demolished corner stair in the Pool Room. (SEA 2012)

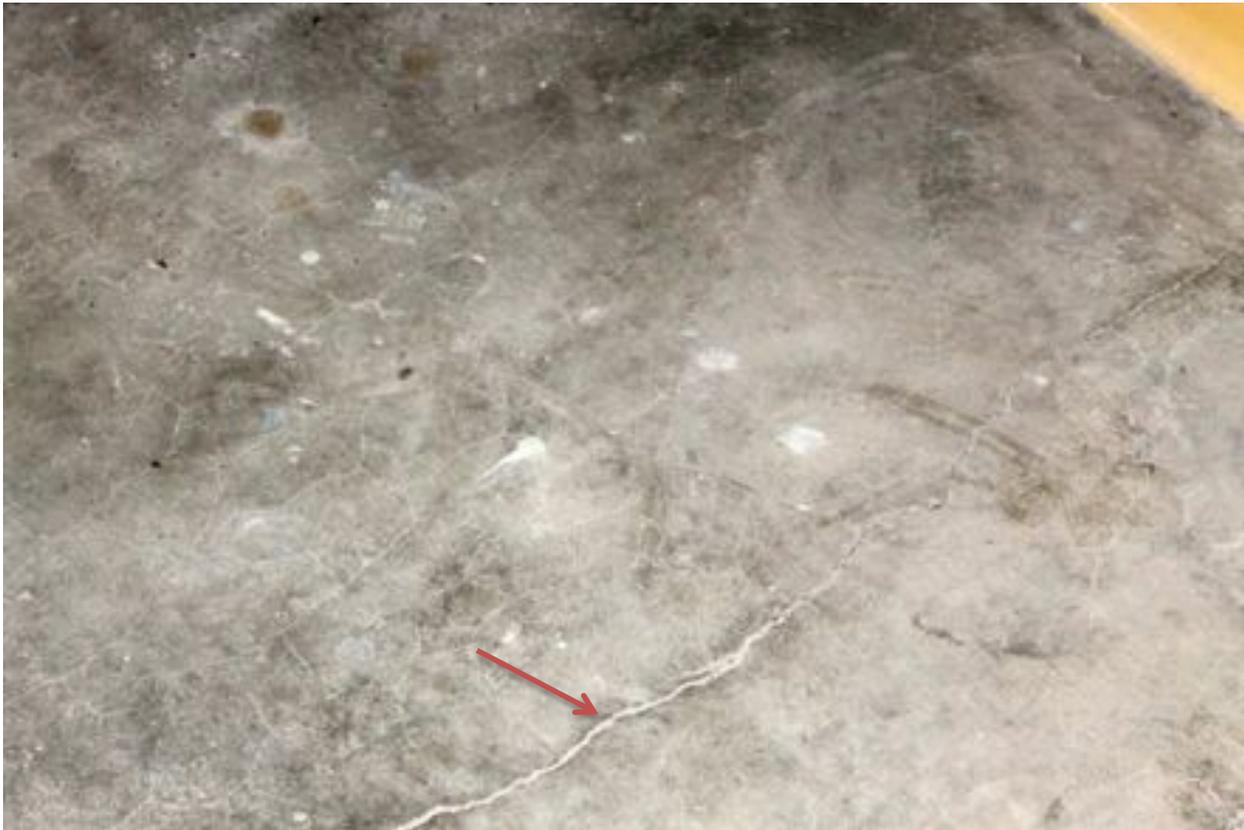
The Ground Floor Mezzanine level is documented at Elevation 88' – 0", making it approximately 12' – 0" above the Ground Floor, which allows for a balcony around the pool. In general this floor is in relatively good condition. In the floor slab, there are a large number of cracks (Figure S8), most of which appeared to be full-depth in nature. Most of the floor slab cracks occur at column lines, and were probably caused by shrinkage following the original construction. The full-depth slab cracks can be repaired with an epoxy crack injection, while the shallower cracks can be routed and sealed with a urethane joint sealant. These repair techniques can be used throughout the building. In addition to the floor cracks, there are some beams and columns in need of repair.

Fig. S8 Typical Ground Floor Mezzanine slab crack (red arrow). (SEA 2012)

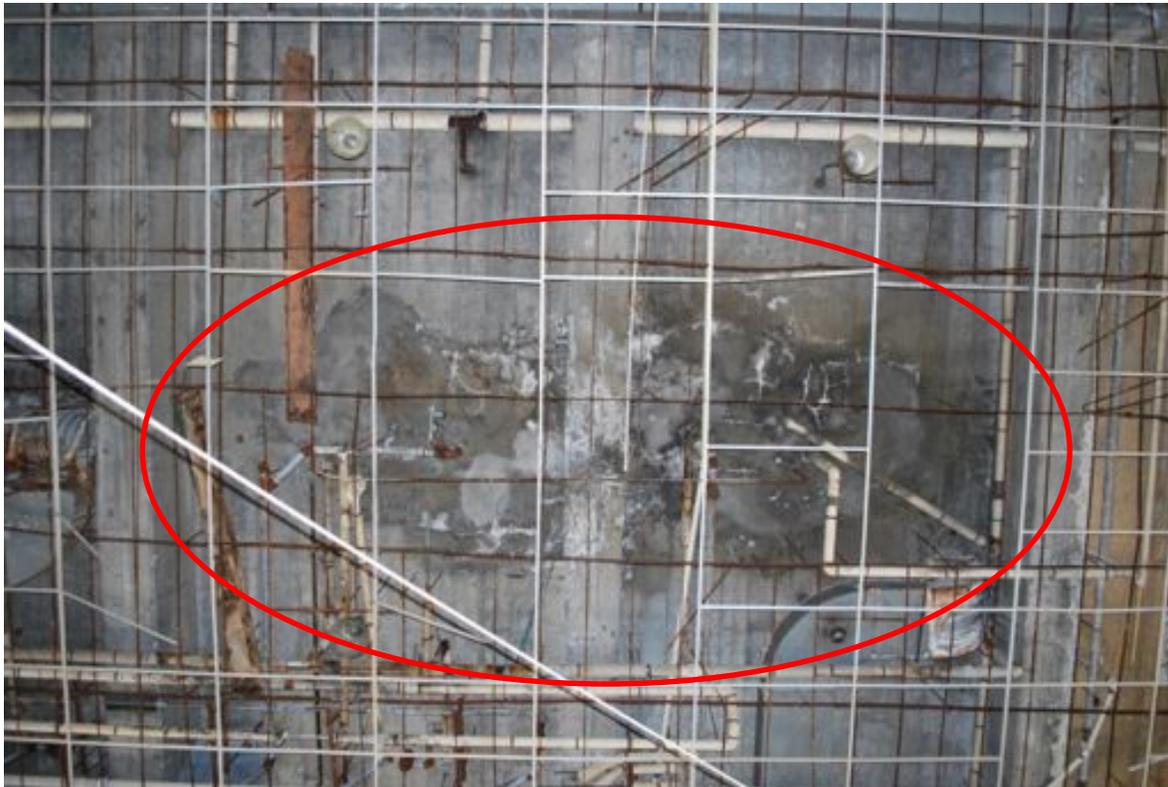
A Critical Repair condition exists, as noted in the Ground Floor Overview section, in the slab and beams under the historical mineral Water Bar in the Hall of Springs. The structural framing for this area consists of a one-way, beam-and-slab type construction. The slabs are approximately 4 ½" to 5" thick, according to the record documents. There are three bays in particular that exhibit moderate to severe corrosion delamination. Although an estimate has been made on the degree of delamination, further investigation is needed to determine the extent of the damage. .

Fig. S10 View of concrete slab and beams below First Floor Water Bar in the Hall of Springs. (SRJA 2012)

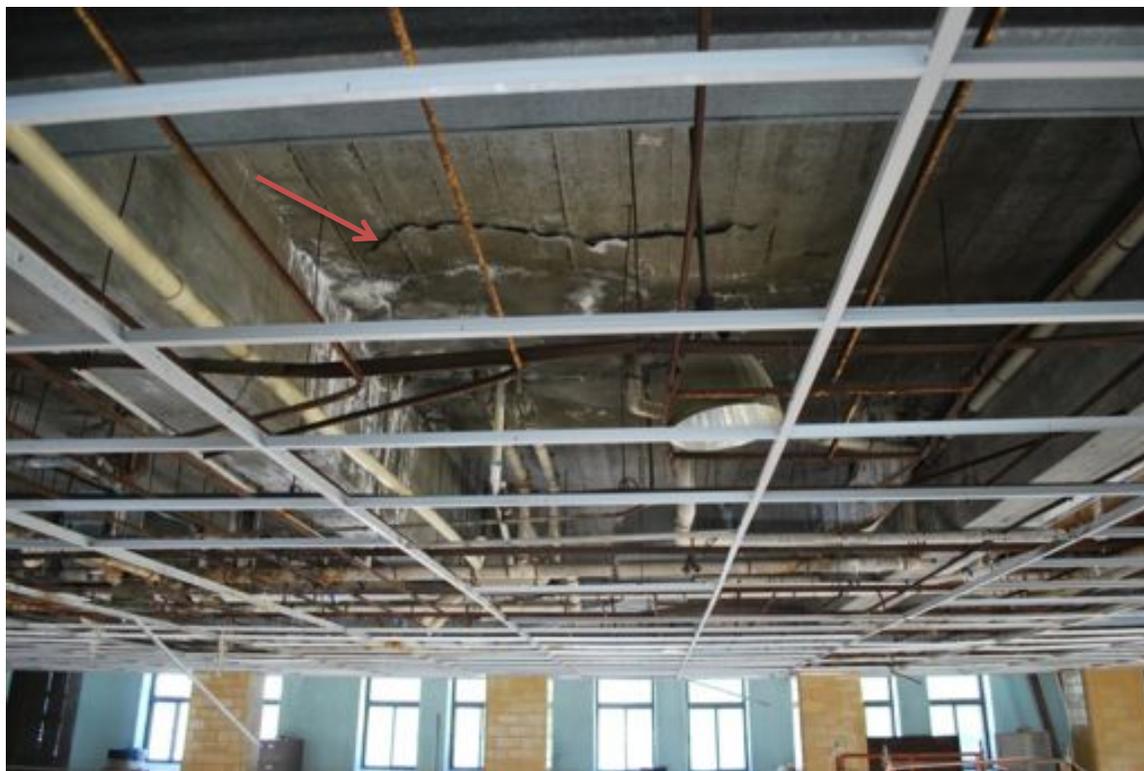
Most of the slab delamination (Figure S11 and S12) appear to require full-depth repairs, while the adjacent, distressed beams (Figure S13) will only require partial-depth repairs. During the repairs, it may be necessary to partially dismantle sections of the historical mineral Water Bar and remove the abandoned piping drains and other sources of leaks, which have contributed to the corrosion process and slab degradation. These issues are critical, life-safety concerns, and their repair should be prioritized.

Fig. S11 View of First Floor concrete slab delamination from the balcony at the Ground Mezzanine Floor level. (SRJA 2012)

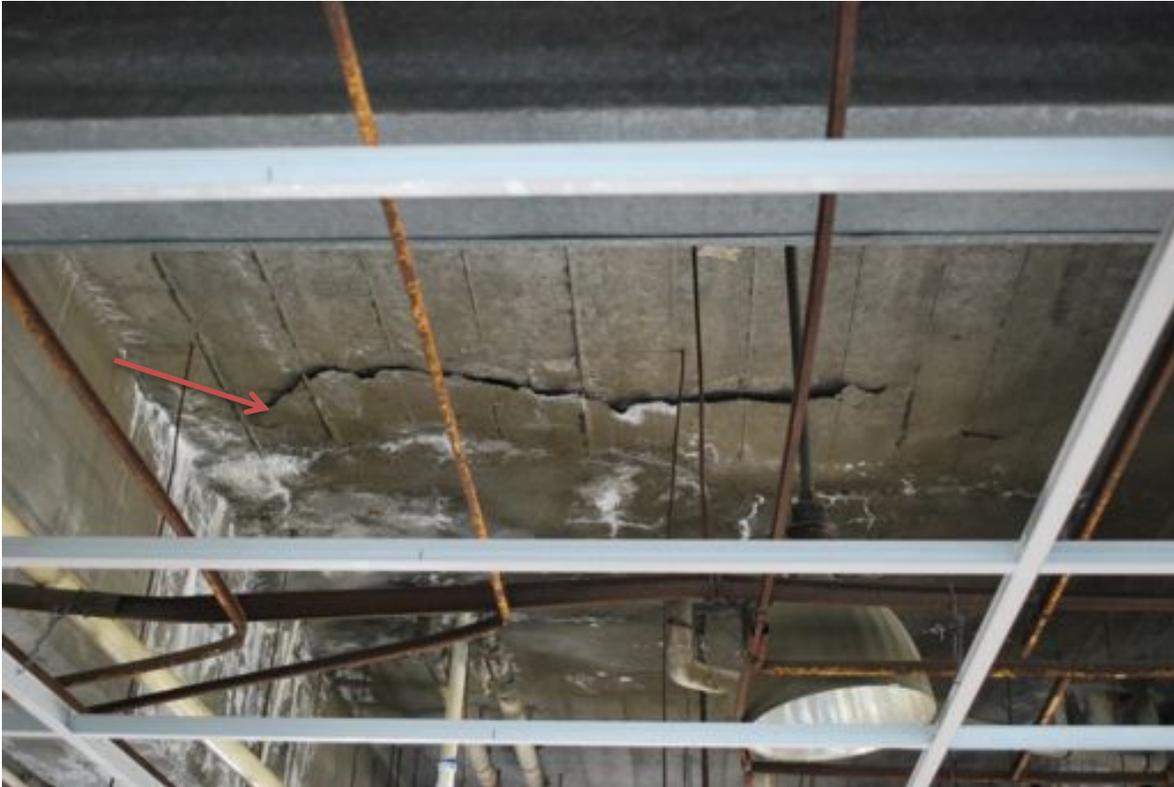
Fig. S12 Detail view of concrete delamination on the First Floor slab. (SRJA 2012)

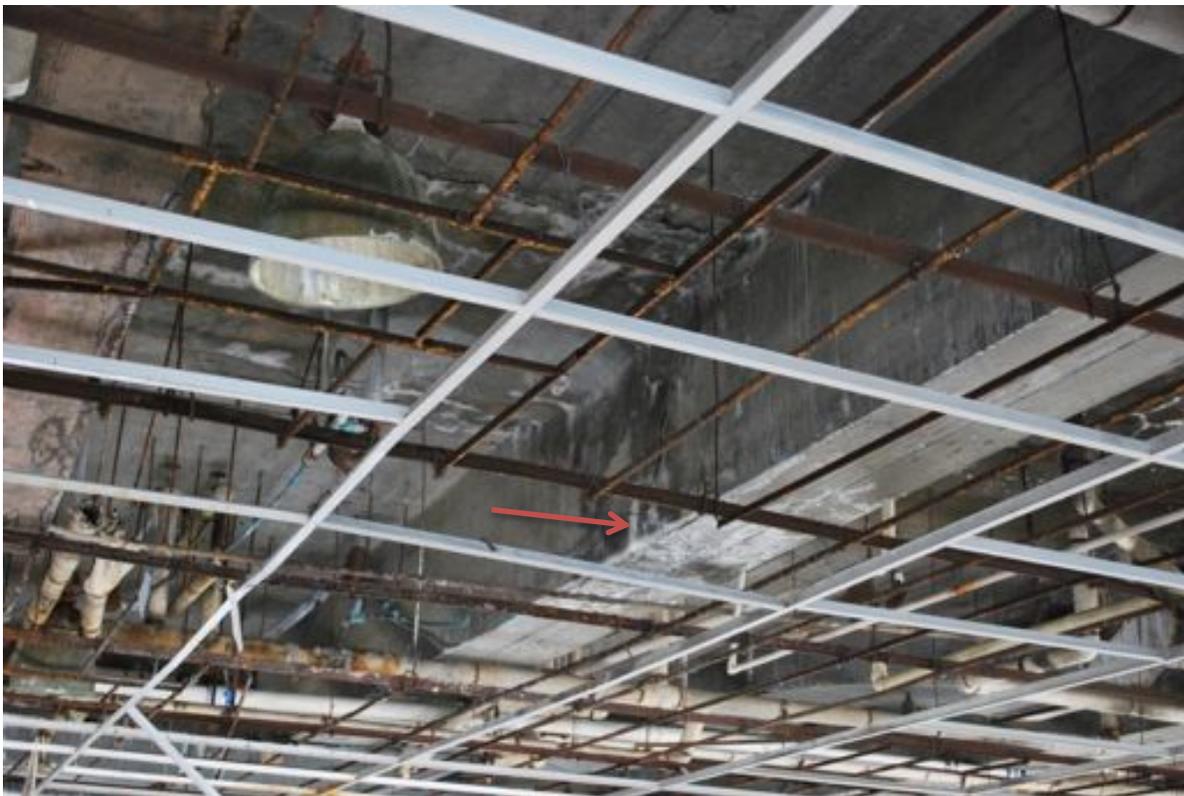
Fig. S13 Distressed concrete beam from the First Floor structure. Note the mineral water leak stains and cracks in concrete (red arrow). (SRJA 2012)

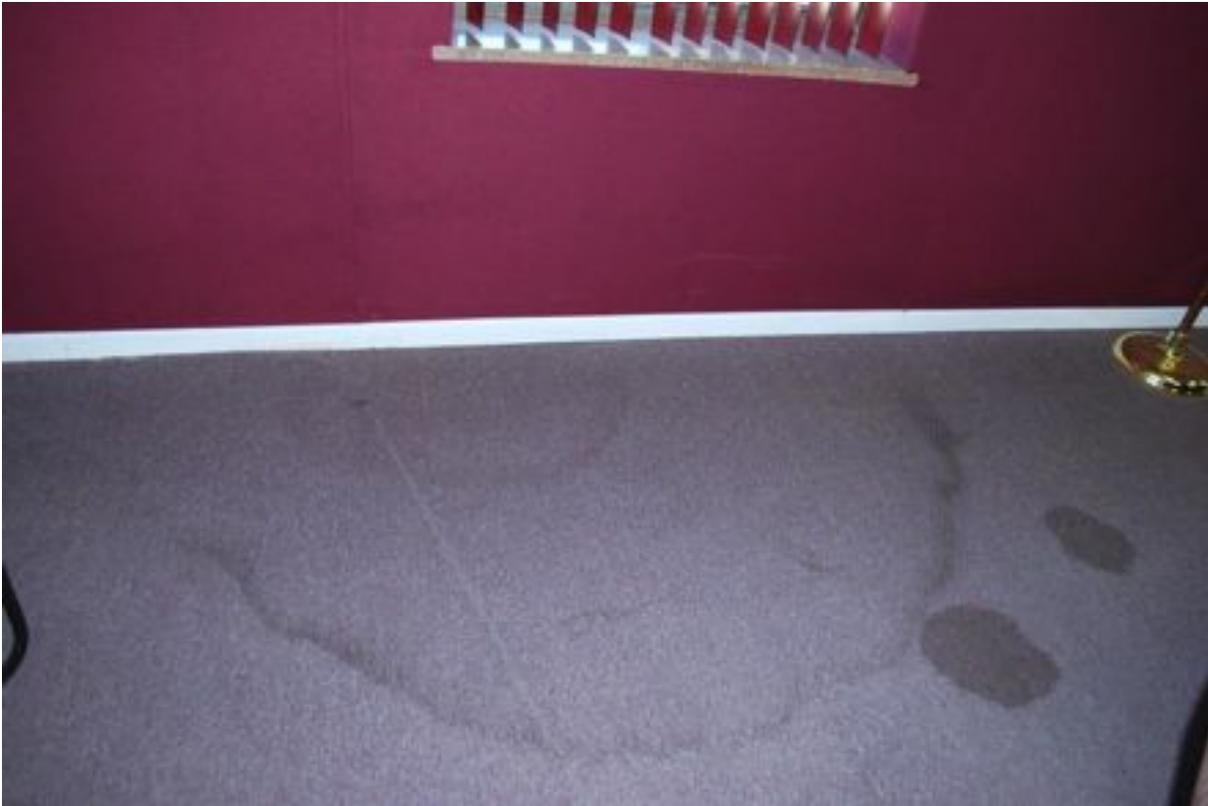
Fig. S14 Leaks in Council Chambers. (SRJA 2012)

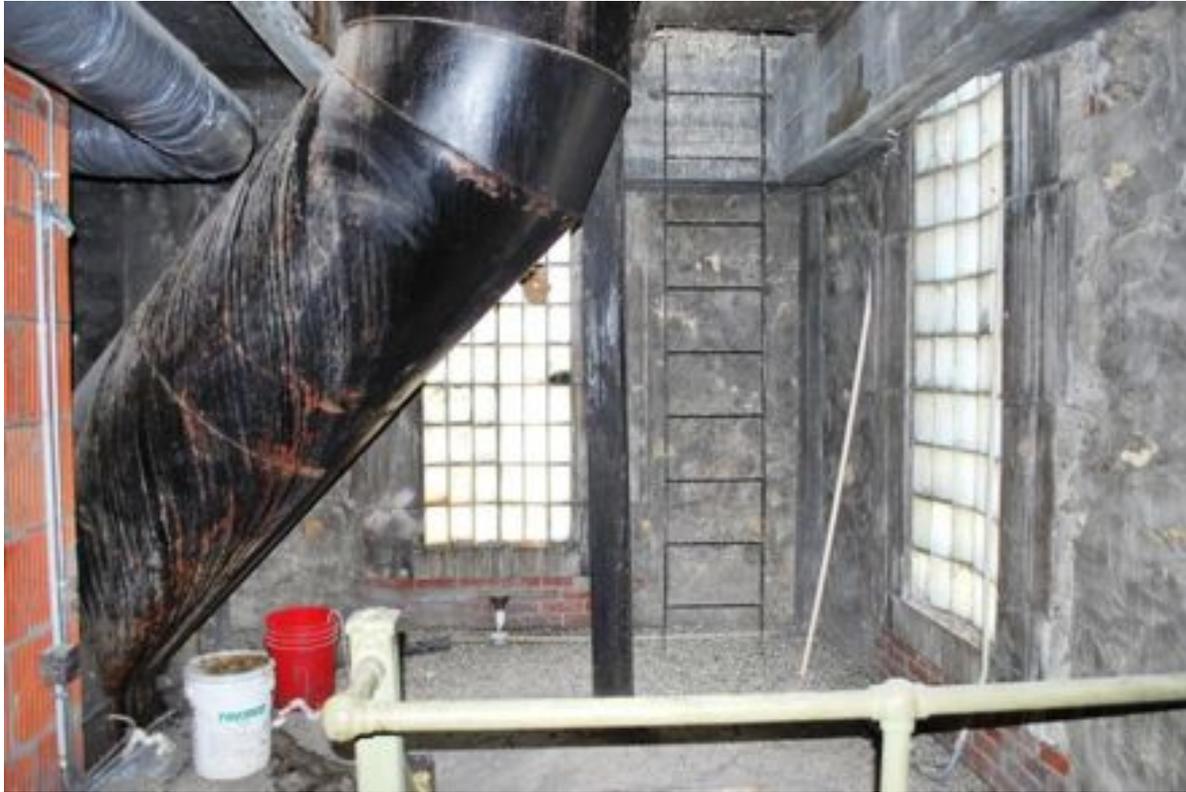
The Tower façade (refer to Exterior Assessment section) has been damaged over time by hail, vandalism, wind, and general degradation. These issues have created holes that allow pigeons to enter into the tower, and deposit their droppings throughout the interior. Pigeon droppings are odorous, as well as very caustic, as they contain high percentages of nitrogen which when combined with moisture can aggressively attack concrete and structural steel. At the time of assessment, the amount of pigeon droppings made safe access beyond the Penthouse Floor problematic and thus the Tower's interior concrete structure was only reviewed in a cursory manner.

Fig. S16 Penthouse floor access to the Tower. (SEA 2012)

It is recommended that a future structural assessment and possibly forensics testing be done of the Tower's structural materials. Additionally, the existing steel flue pipe should be investigated for possible leaks and degradation if it is to remain, as it could cause the concrete and mortar contamination from the carbonation process.
