## Exterior Conditions Assessment

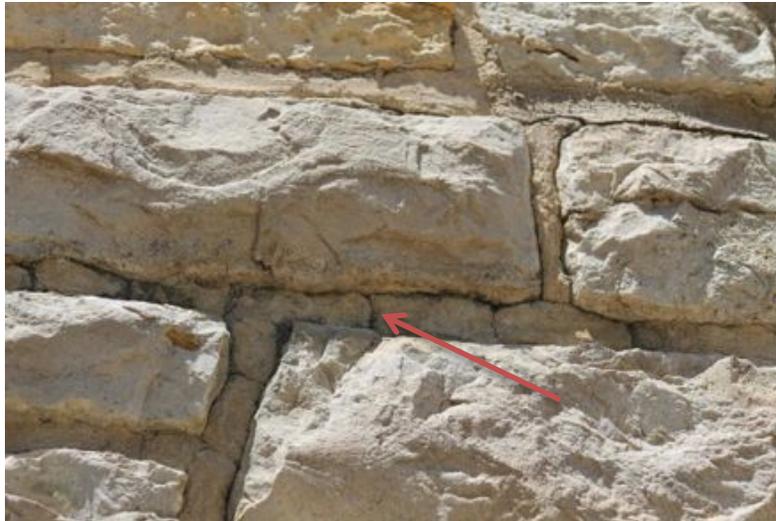
Observations made on-site revealed large portions of the limestone mortar joints have failed. The mortar has either separated from the stone or has cracked in the center portions. Additional mortar has flaked off which indicates a shallow surface-applied pointing repair during a previous project (Figure 64).

Fig. 64 North Elevation Deteriorated Mortar Joints. (SEA 2012)

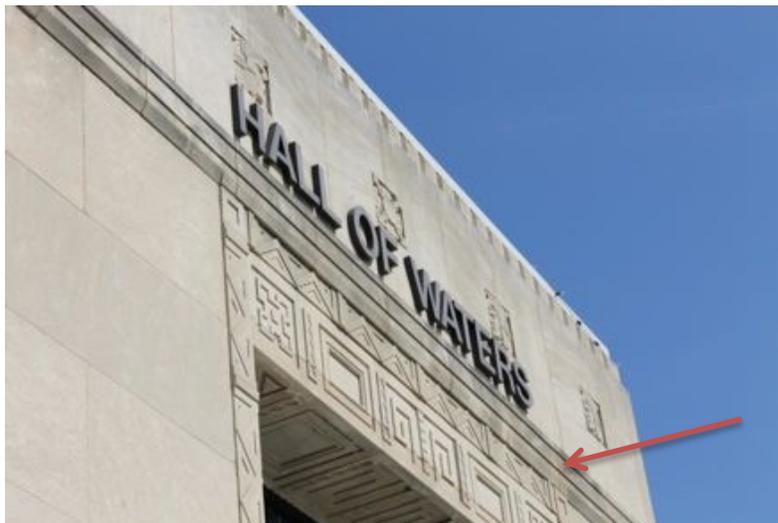
The North Elevation is experiencing the same types of organic and inorganic staining (Figure 65) as found on the East, West, and South Elevations. As this weathering process continues, dust particles and metal deposits are accumulating on the outer surface.

Fig. 65 North Elevation Biological Staining. (SEA 2012)

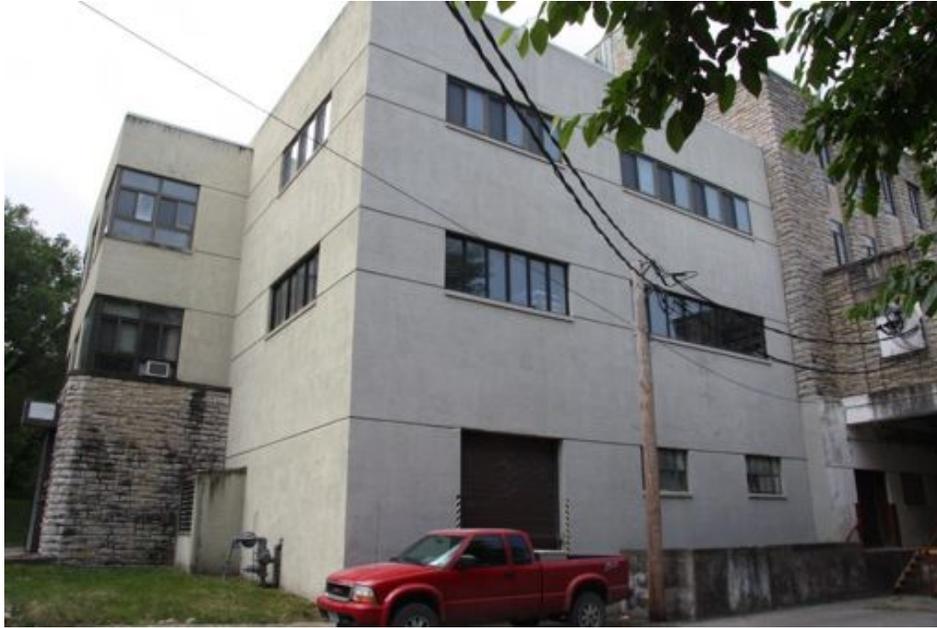
The cast-in-place concrete façade which encompasses the east end of the north façade has minor deterioration issues. Most of the issues found on this concrete façade are due to corrosion occurring in the reinforcing steel embedded in the concrete. From our observations most of this is occurring due to inadequate cover of concrete over the existing reinforcing steel.

Some of the corrosion of the reinforcing bars at these locations may also be attributed to carbonation contamination due to environmental conditions.

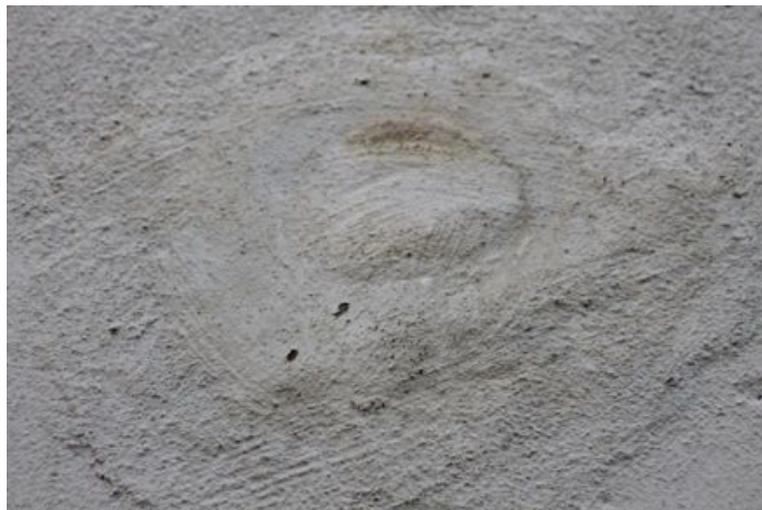
In addition to the delamination and corrosion issues of the concrete façade the existing coating that has been applied to the concrete is beginning to de-bond and fall off the face of the building. As the coating ages it becomes brittle due to exposure to the environment and UV rays. When the coating becomes too brittle to move with the expanding and contracting substrate it loses the ability to adhere (Figure 67).

Fig. 67 North Elevation East End. Coating is de-bonding from concrete surface. (SEA 2012)

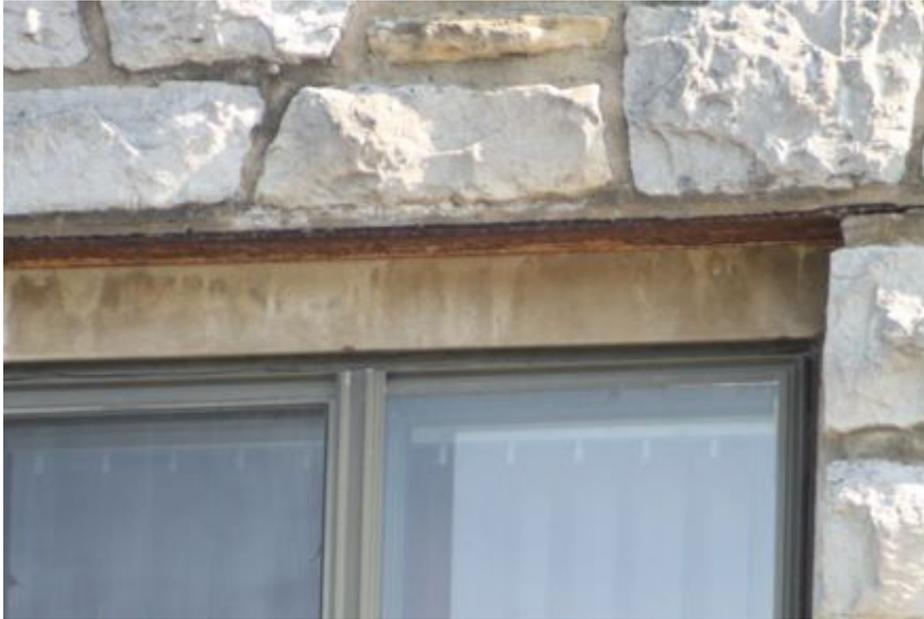
As with the other elevations of the structure, the windows and door way openings have various stages of steel lintel corrosion issues. All of the lintels in the stone and the stone portions of the building have exposed steel plates. These plates are welded to C channels that are embedded in the stone or cast stone along with the backup material. Corrosion has caused these plates to warp in some locations creating cracks and damage to the stone and mortar joints. In addition at some of these locations the inner embedded C channels may be experiencing corrosion which is allowing the plates to move outward and also displacing some of the stone (Figures 68 & 69).

Fig. 68 North Elevation, East of Entrance Second Floor Window. Corrosion of steel lintel. (SEA 2012)

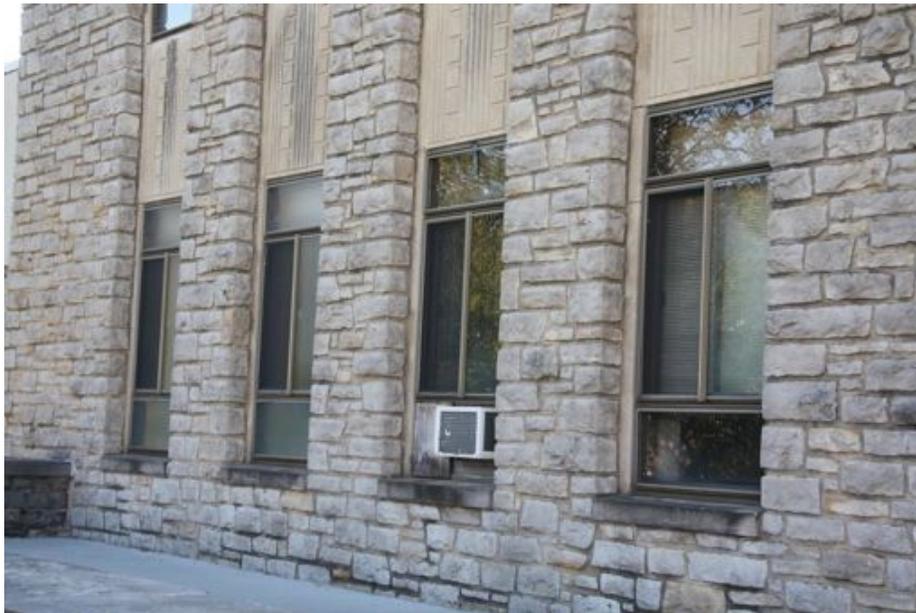
Fig. 69 North Elevation First Floor window configuration. Embedded steel lintels are not exposed. (SRJA 2012)

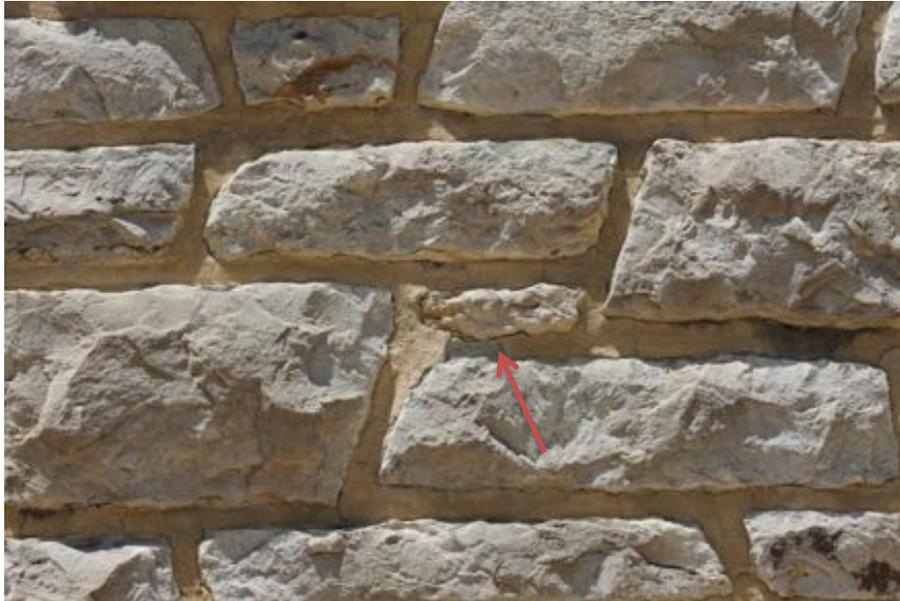
Observations made on-site showed large portions of the limestone mortar joints have failed. The mortar has either separated from the stone or has cracked in the center portions. Additional mortar has flaked off which indicates a shallow surface mortar applied repair done during a previous project (Figure 72).

Fig. 72 West Elevation Lower Level. Mortar joint has thin mortar overlay. (SEA 2012)

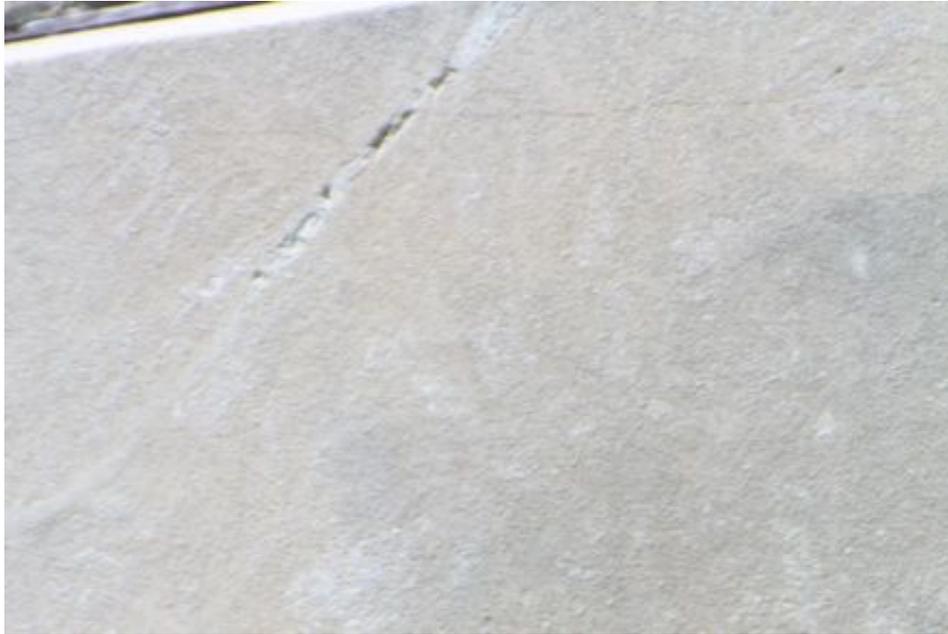
Additionally, some cracking has occurred to the south of the main entrance on the face of the cast stone. This crack is found in the upper corner of the entrance area above the water table. Since the crack does not go beyond the water table and only encompasses a few stones, settlement issues and foundation movement are not considered to be the cause. Most likely the brick back up at the parapet has experienced brick growth and caused the cracks to form on the face of the cast stone (Figure 73).

Fig. 73 West Elevation Crack at Cast Stone Entryway Southwest Corner. (SEA 2012)

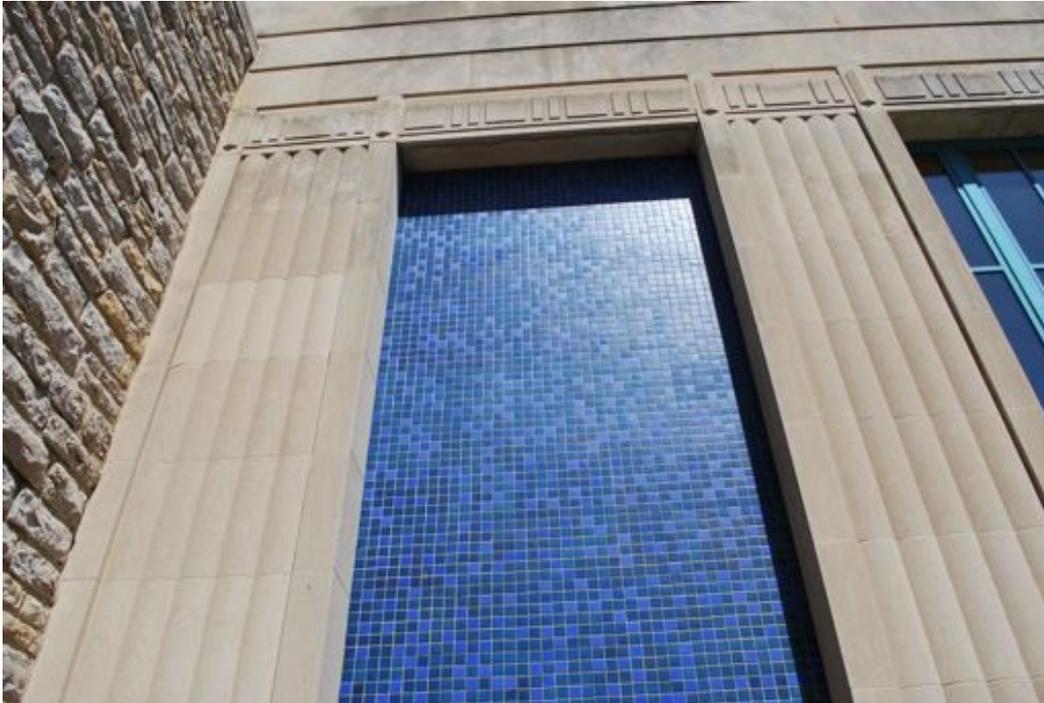
The West Elevation of the Hall of Springs has glazed 2"x2" tile installed above and around the doorway into the Hall (Figure 74). This is the same blue tile found on the East Elevation of the Hall of Springs. The tile is slightly recessed into the building. The glazed tile is experiencing some deterioration from exposure to weather and the grout joints have a slight skim coating of material in the joints over the original grout. This material is de-bonding and coming off the existing mortar joints in multiple locations.

Fig. 74 West Elevation detail view of blue exterior tiles. (SRJA 2012)

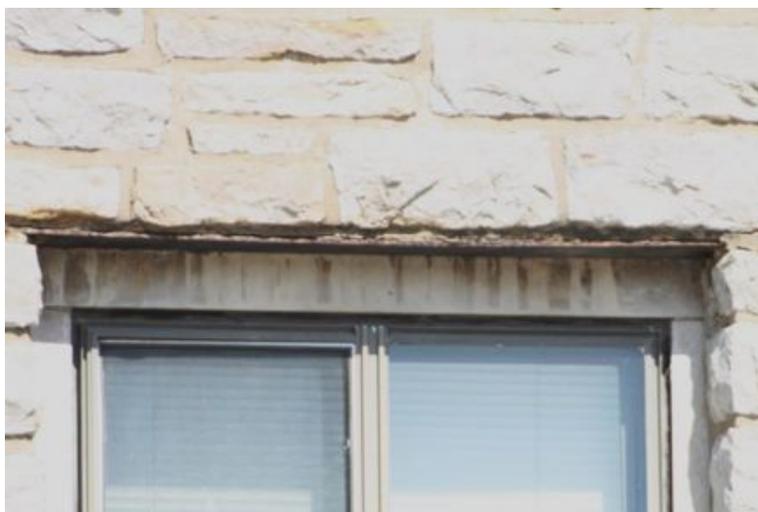
As with the other elevations of the structure, the windows and door openings have various stages of steel lintel corrosion issues. All of the lintels in the rubble stone façade and the cast stone façade have exposed steel plates. These plates are welded to C channels that are embedded in the stone or cast stone along with the backup material. Corrosion has caused these plates to warp in some locations creating cracks and damage to the stone and mortar joints. In addition at some of these locations the inner embedded C channels may be experiencing corrosion which is allowing the plates to move outward and also displacing some of the stone units (Figure 75).

Fig. 75 West Elevation Corrosion on Window Lintel Next to Entryway. (SEA 2012)

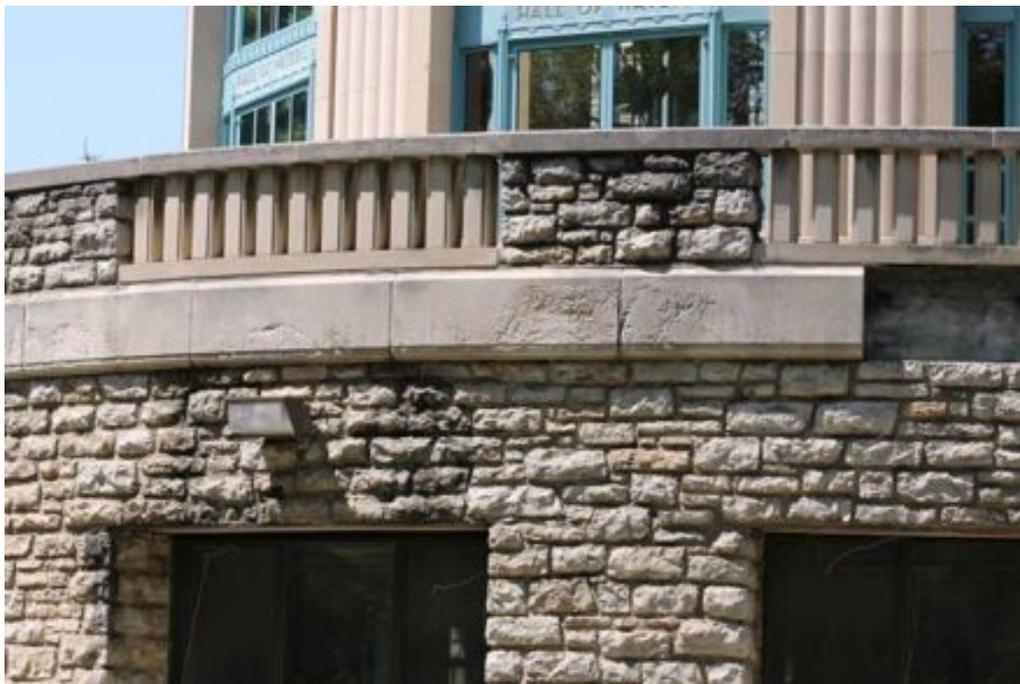
The South Elevation of the structure has additional concerns with the cast stone. Along the curved section of the façade some of the intermediate water table stones are severely deteriorating and one stone is completely missing (Figure 80). These cast stone pieces appear to be experiencing severe freeze thaw damage. Freeze/thaw damage is disintegration of the concrete paste holding the individual pieces of aggregate (crushed rock) together, resulting in concrete reverting back to its aggregate components. When water-saturated concrete freezes, the concrete is subjected to internal stress due to the expanding water. Normally, concrete that is subjected to freezing weather and moisture is air entrained. Air-entrained concrete is produced by adding into the concrete mix an admixture that creates millions of microscopic air bubbles that are distributed in the concrete. When the air bubbles are properly sized and distributed, they provide space for the freezing water to expand into, thereby minimizing stress build up. The degree of air entrainment is determined when the cast stone is produced and cannot be altered after the concrete hardens.

Fig. 80 South Elevation of South Wing detail showing stone deterioration. (SEA 2012)

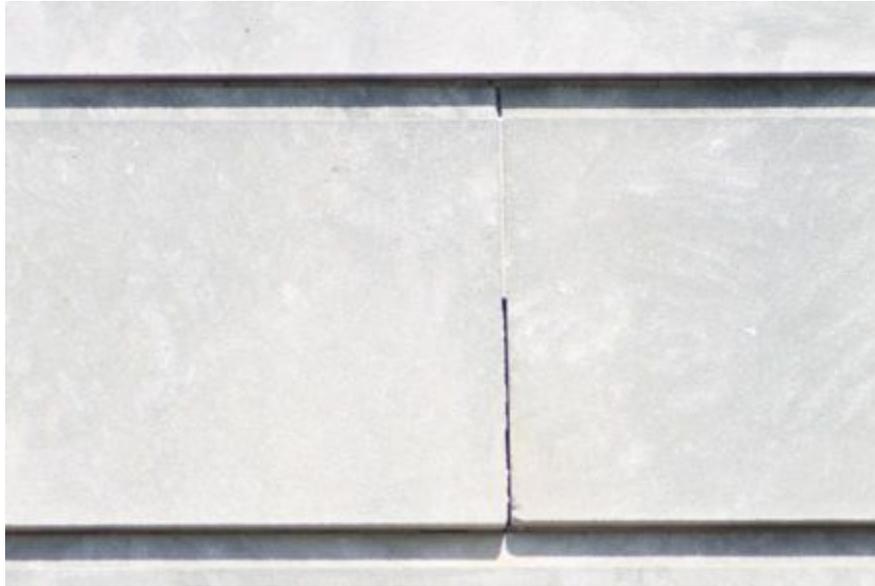
The minor issues with the cast stone are mortar joints failures and severe organic staining. Mortar joints are experiencing the same high percentage of failure as noted in the rubble stone façade (Figure 81).

Fig. 81 South Elevation Deteriorated Mortar Joints. (SEA 2012)

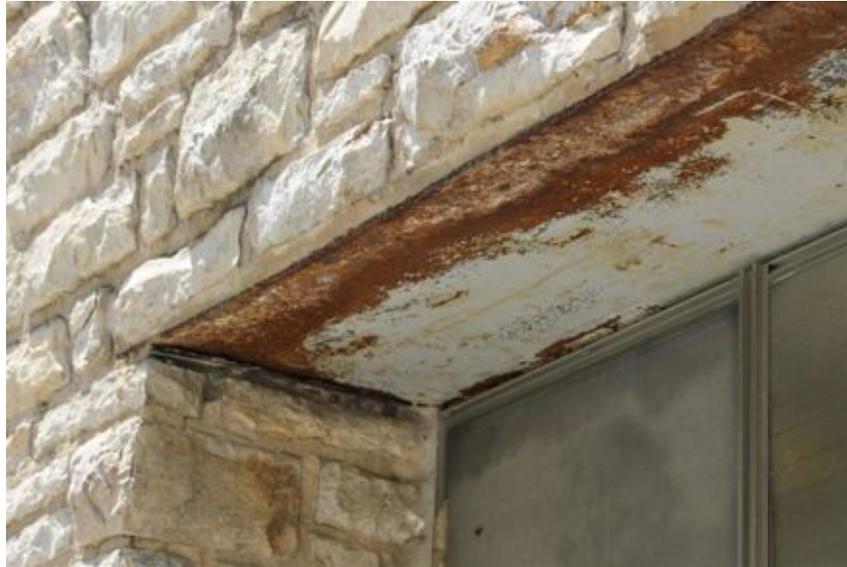
As with the other elevations of the structure the windows and door way openings have various stages of steel lintel corrosion issues. All of the lintels in the pitched face stone and the cast stone portions of the building have exposed steel plates. These plates are welded to C channels that are embedded in the stone or cast stone along with the backup material. Corrosion has caused these plates to warp in some locations creating cracks and damage to the stone and mortar joints. In addition at some of these locations the inner embedded C channels may be experiencing corrosion which is allowing the plates to move outward and also displacing some of the stone facades (Figure 82).

Fig. 82 South Elevation. Corroding lintel at first floor. (SEA 2012)

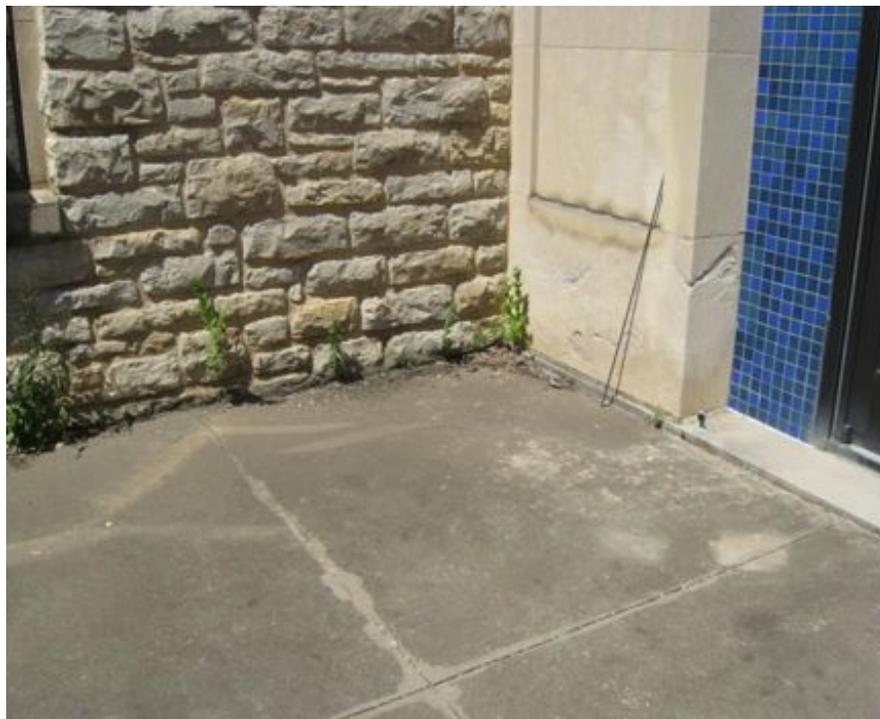
In addition the concrete topping slab and waterproofing material at the 1<sup>st</sup> floor exterior terrace that surrounds the south wing Hall of Springs is deteriorating. The waterproofing material is a tar based system that was applied over the structural slab and then a thinner concrete topping slab was applied over the top for protection and to create a walking surface. This material becomes brittle as it ages and loses the ability to expand and contract with the concrete surface. Cracks form and moisture travels through creating leaks to the space below and cause deterioration to the structural slab.

Fig. 83 South Elevation Hall of Springs deck with plants growing in the joint between the deck and the building. The deck has cracks which allows water to seep in between the topping slab and the structural concrete slab beneath. (SEA 2012)

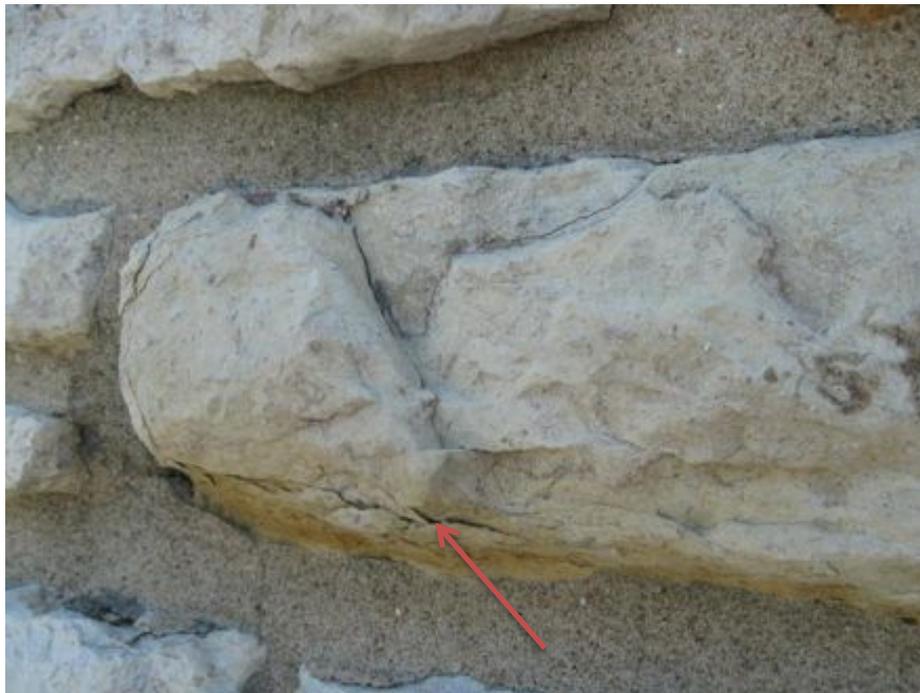
The stones also are experiencing damage from moisture infiltration and freeze-thaw cycling as indicated in (Figure 86). The stones have sections that have either de-bonded totally from the face or are in a state of partial de-bonding at this time.

Fig. 86 East elevation South end, rubble stone deterioration. (SEA 2012)

Pitched face stone is quite susceptible to moisture infiltration and freeze-thaw cycling due to the manufacturing techniques required to produce this particular surface. During this process micro-cracking occurs from the blunt impacts placed upon the faces of the stones in order to create the desired finish. These micro-cracks thru time allow moisture infiltration into the stone and as the stone weathers and freeze-thaw cycling occurs damage begins to separate the outer layers of the stone creating the de-bonded material to slough off.

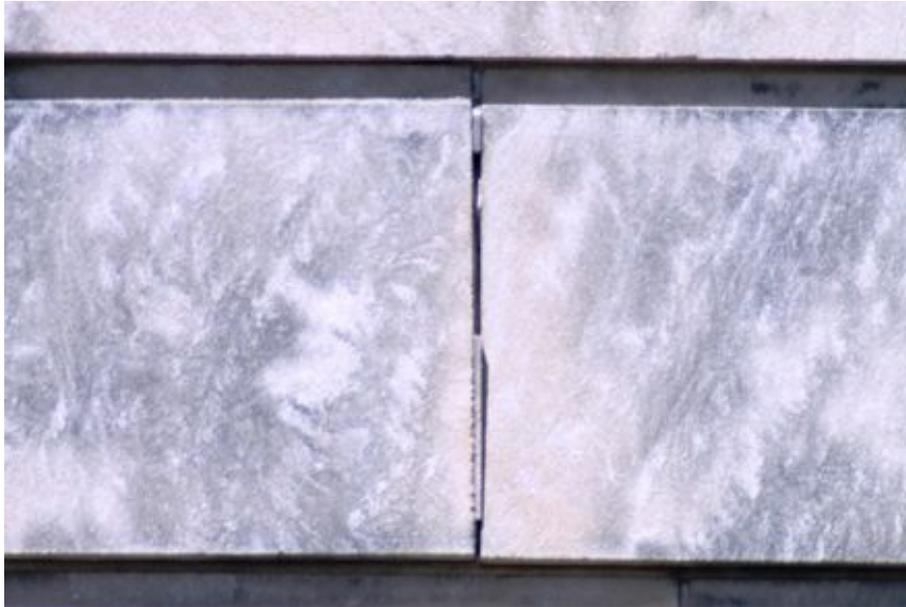
The cast stone has color and texture that mimic a cut limestone product. In most cases on the East Elevation of the structure the issues concerning the cast stone are mortar joints failures and severe organic staining. Mortar joints are experiencing the same high percentage of failure as noted in the rubble stone façade. At some of these locations the joints are completely void of the outer tuckpointing material (Figure 87).

Fig. 87 East Elevation of the South Wing. Mortar missing from joints. (SEA 2012)

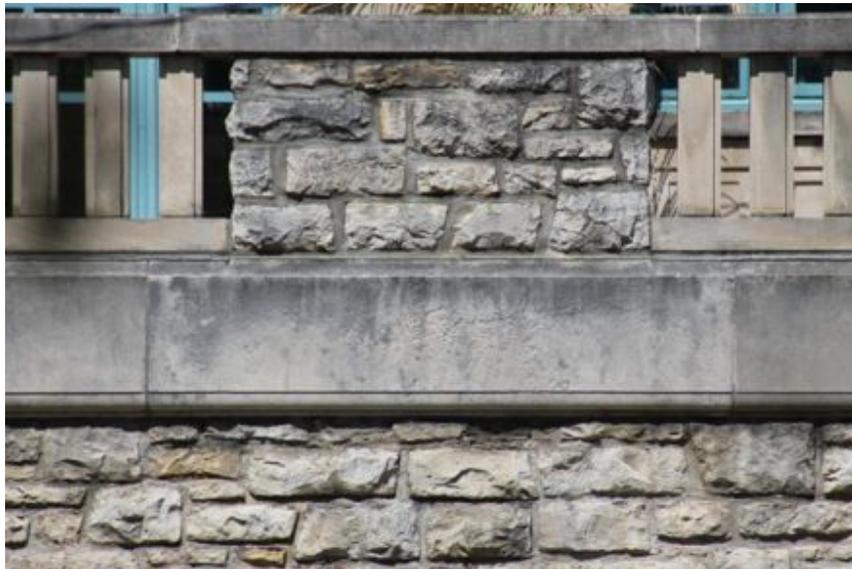
The large amount of organic and inorganic staining occurring on this face indicates the stone surface is becoming more susceptible to moisture infiltration. As the weathering process continues, dust particles and metal deposits are accumulating on the outer surface. Cast stone and limestone often mimic each other when exposed to the same harsh environments (Figure 88).

Fig. 88 East elevation of South wing. Biological staining. (SEA 2012)

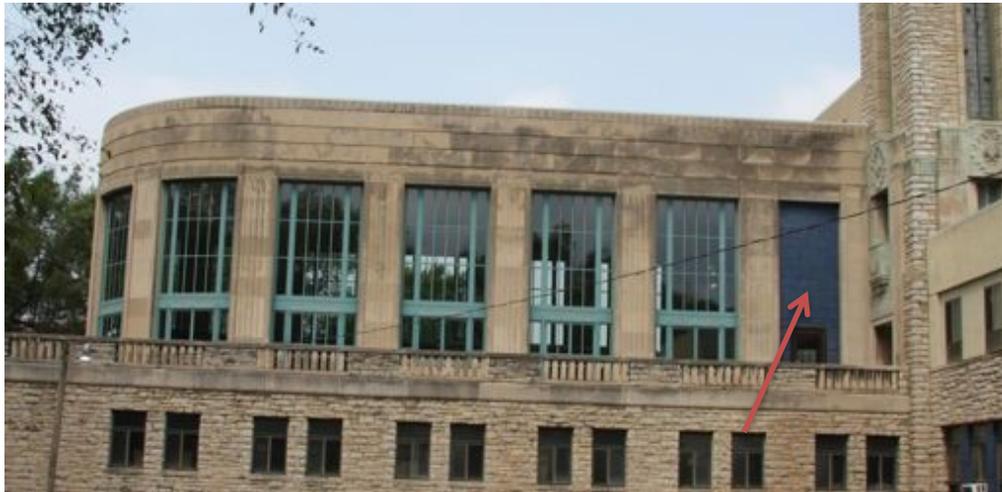
The East Elevation of the Hall of Springs has glazed 2"x2" tile installed above and around the doorway into the Hall (Figure 89). This is the same blue tile found on the West Elevation of the Hall of Springs. The tile is slightly recessed into the building. The glazed tile is experiencing some deterioration from exposure to weather and the grout joints have a slight skin coating of material in the joints over the original grout. This material is de-bonding and coming off the existing mortar joints in multiple locations.

Fig. 89 East Elevation blue tile at Hall of Springs. (SRJA 2012)

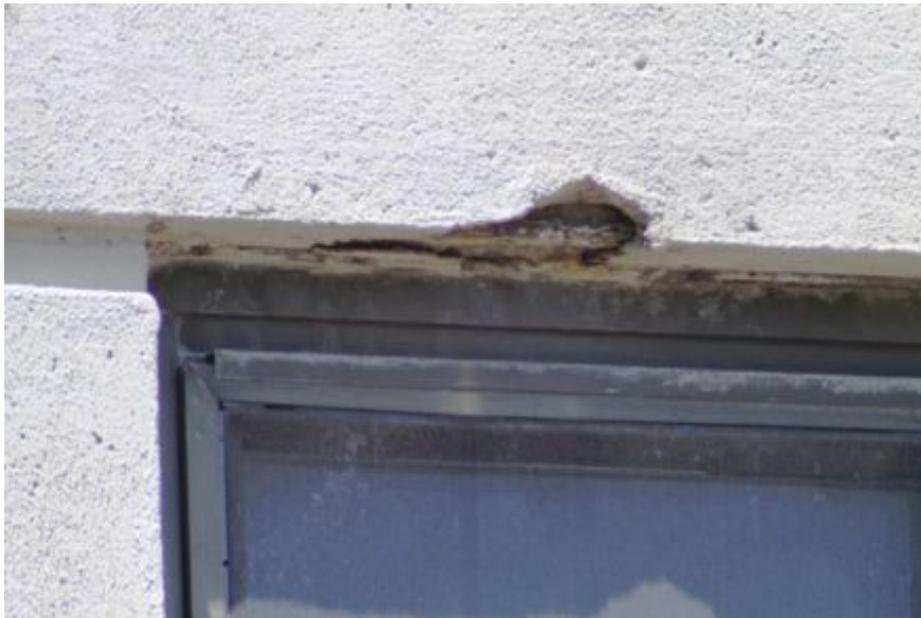
The cast concrete façade which encompasses the east wing or the northern section of the east façade has minor deterioration issues. Most of the issues found on this concrete façade are due to corrosion occurring in the reinforcing steel embedded in the concrete. From our observations most of this is occurring due to inadequate cover of concrete over the existing reinforcing steel (Figure 90).

Fig. 90 East Elevation of East Wing. Reinforcing bars for lintel at window opening are corroded. (SEA 2012)

Some of the corrosion of the reinforcing bars at these locations could also be attributed to carbonation contamination due to environmental conditions. Carbonation contamination occurs as buildings are exposed to natural pollutants in the air over time. This can occur from emissions, from petrochemical or coal-powered equipment. In some conditions if concrete is exposed to carbon dioxide at an early age, the uncured concrete can be more susceptible to infiltration of the carbonation. This can occur when concrete is cured with open flame heaters.

The carbon dioxide gas in the atmosphere interacts with the calcium hydroxide in the hydrated cement paste. This chemical process reduces the alkalinity of the concrete to a pH as low as 8.5. This low pH breaks down the protective layer surrounding steel in the concrete. Once the protective layer around the steel is broken down, corrosion can begin to occur. With reinforcing bars inadequately placed reducing the amount of concrete cover available as carbonation contamination reaches the reinforcing steel thru driven rains and environmental conditions the corrosion process can accelerate.

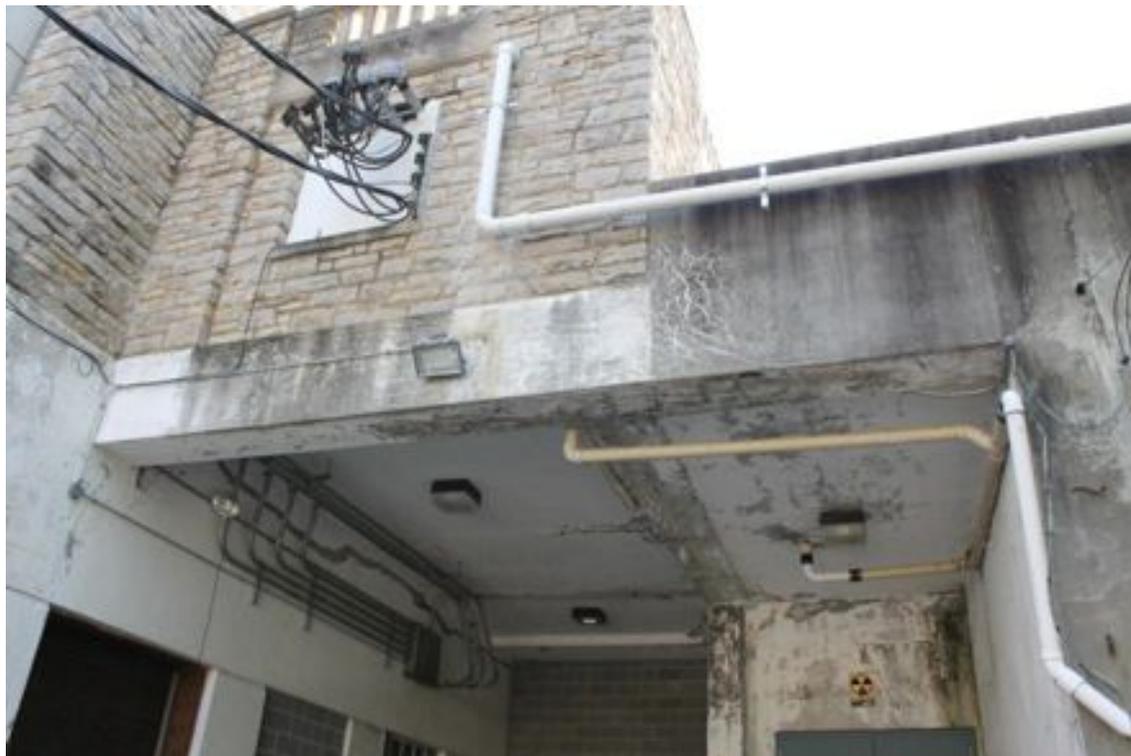
The loading dock area at the north end of the East Elevation was also found to exhibit deterioration. Along with the possible deterioration mechanisms listed above which are associated with the cast concrete, some additional deterioration forces may be occurring here (Figure 91).

Fig. 91 Loading Dock East Elevation. Delaminated concrete beam and soffit. (SEA 2012)

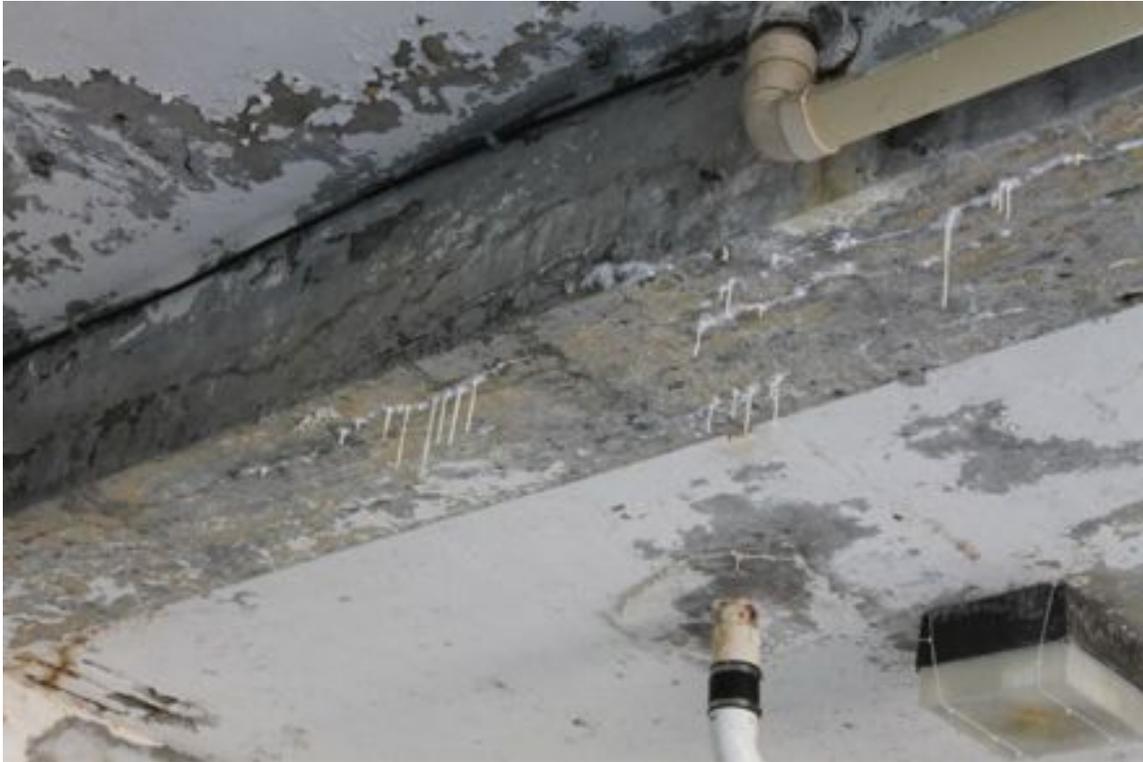
With the excessive amount of surface cracks at the beam and column supports Alkali Silica Reaction (ASR) contamination may be occurring. ASR reaction is a chemical reaction which takes place in aggregate particles between the cement paste and silica in the aggregate particles. When water is added into the reaction a alkali-calcium silica gel is formed. This gel begins to occupy more space than the original silica so the surface of the concrete is put under pressure. At a certain point in time these stresses exceed the strength and cracks propagate. The cracks radiate from the interior of the aggregate out into the surrounding paste. Over time freeze-thaw cycling open up these cracks and accelerate the deterioration of the concrete and corrosion of reinforcing steel (Figure 92).

Fig. 92 Loading Dock - Delaminated Concrete Beam. (SEA 2012)

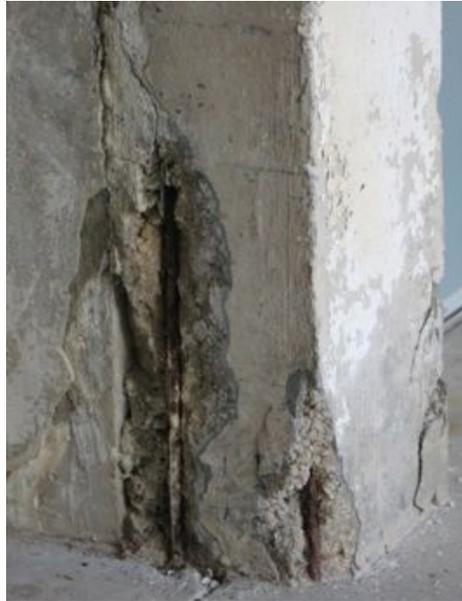
Another possibility for the excessive deterioration occurring at the loading dock is cast in place accelerators used during the original construction. It was common to add accelerators in concrete to reduce the curing time. One of these accelerators was Calcium Chloride. This particular chemical is also one of the main ingredients for corrosion development in steel. Corrosion is an electrochemical process that deteriorates metals. Typically, reinforcement embedded in concrete is protected by a thin oxide film on the surface of the metal resulting from the concrete's naturally high alkalinity. However, aggressive ions can penetrate the concrete and break down the oxide film. These ions are typically chloride ions from de-icing salts or chloride-bearing concrete admixtures. The corrosion process results from the formation of a corrosion "cell" that is an electrical circuit composed of an anode, a cathode, electrolyte (concrete in our case) and a metallic path from the anode to the cathode (the reinforcing bar itself). Similar to an ordinary battery, current flows from the anode through the electrolyte onto the cathode and completes the circuit through the metallic path to the anode. Metal loss occurs at the anode where current is discharged (Figure 93).

Fig. 93 Loading Dock. Delamination and corrosion at back of column. (SEA 2012)

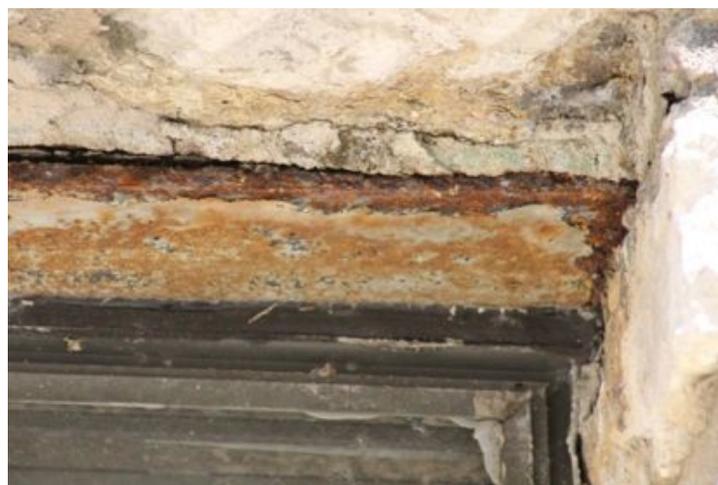
As with the other elevations of the structure, the windows and door way openings have various stages of steel lintel corrosion issues. All of the lintels in the pitched face stone and the cast stone sections of the building have exposed steel plates. These plates are welded to 'C' channels that are embedded in the stone or cast stone along with the backup material. Corrosion has caused these plates to warp in some locations creating cracks and damage to the stone and mortar joints. In addition at some of these locations the inner embedded 'C' channels may be experiencing corrosion which is allowing the plates to move outward and also displacing some of the stone facades (Figure 94).

Fig. 94 East Elevation of South Wing. Steel lintel corroding and perimeter window sealant failure. (SEA 2012)

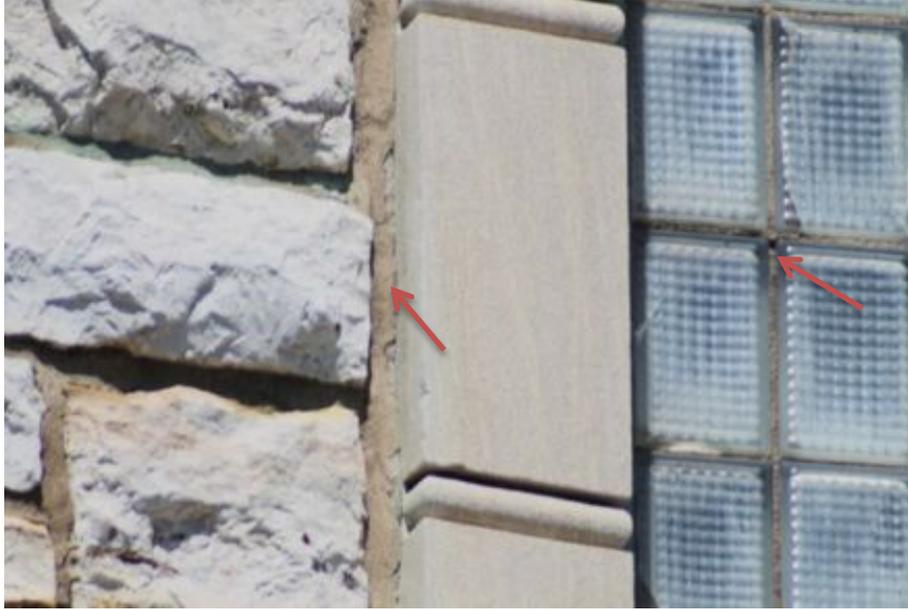
Visual observations on-site indicated that large portions of the limestone and glass block mortar joints have failed over time. The mortar has either separated from the stone/block or has cracked in the center portions. Additional mortar has flaked off which indicates a shallow surface applied repair done at a previous time (Figure 96).

Fig. 96 Tower East Elevation. Deteriorated mortar joints between cut stone and rubble stone. (SEA 2012)

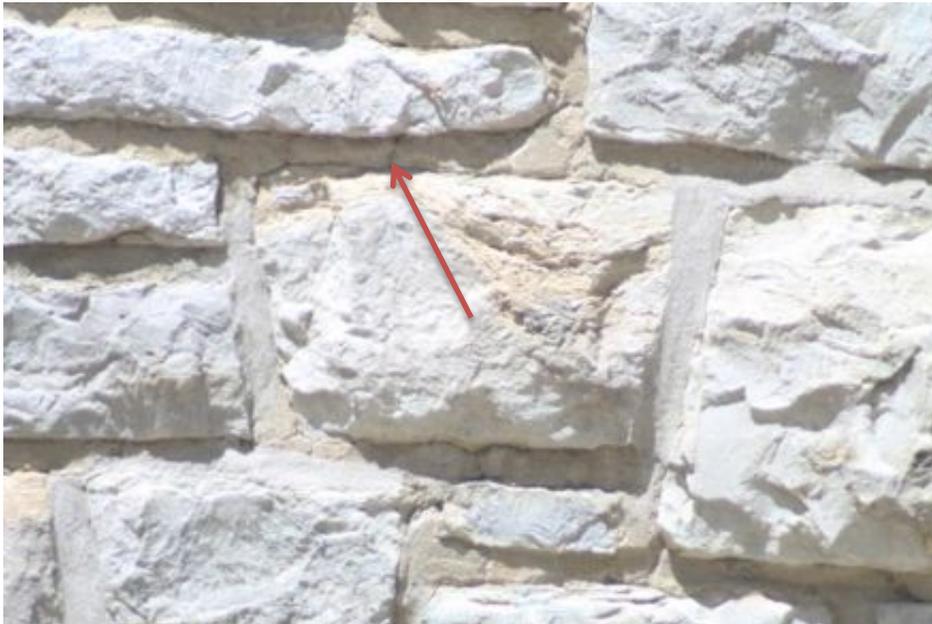
The pitched face stones are experiencing the same damage as the building façades from moisture infiltration and freeze thaw cycling. The stones have sections that have either de-bonded totally from the face or in a state of partial de-bonding at this time (Figure 97).

Fig. 97 Typical Deteriorated Mortar Joints in Pitched Face Stone Wall. (SEA 2012)

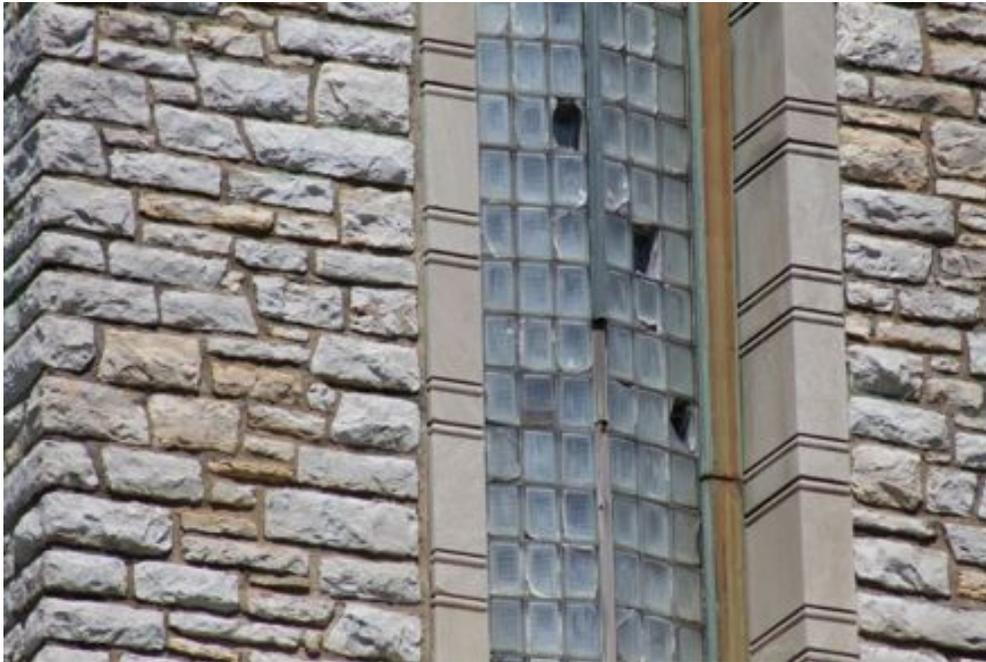
In addition to missing mortar joints, there are multiple glass block units either missing or broken. The missing glass is contributing to the moisture infiltrating the structure and has also allowed

pigeons to enter and roost within the tower and penthouse areas. The pigeon infestation appears to have been a long term issue due to the extent of issues found during the investigation (Figure 98).

Fig. 98 Tower South Elevation. Note broken glass block and deteriorated copper cladding. Exposed wood framing is deteriorated and is missing the metal cladding. (SEA 2012)

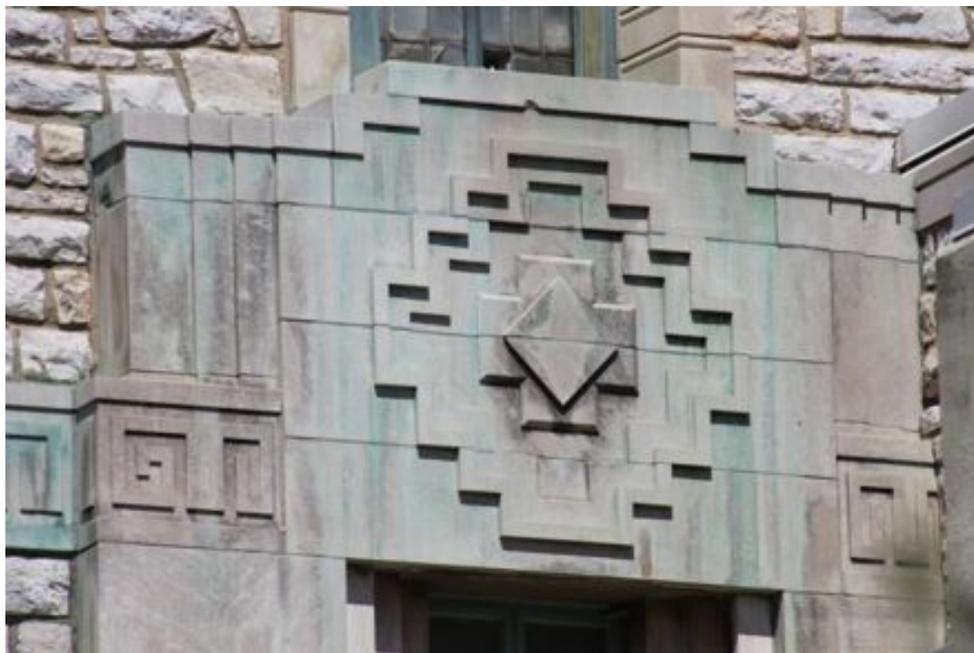
All elevations of the tower are experiencing the same types of organic and inorganic staining as found on the building façade with an addition of higher amounts of copper stains likely from the metal fascias (Figure 99).

Fig. 99 Typical Copper Staining at Tower Stones. (SEA 2012)

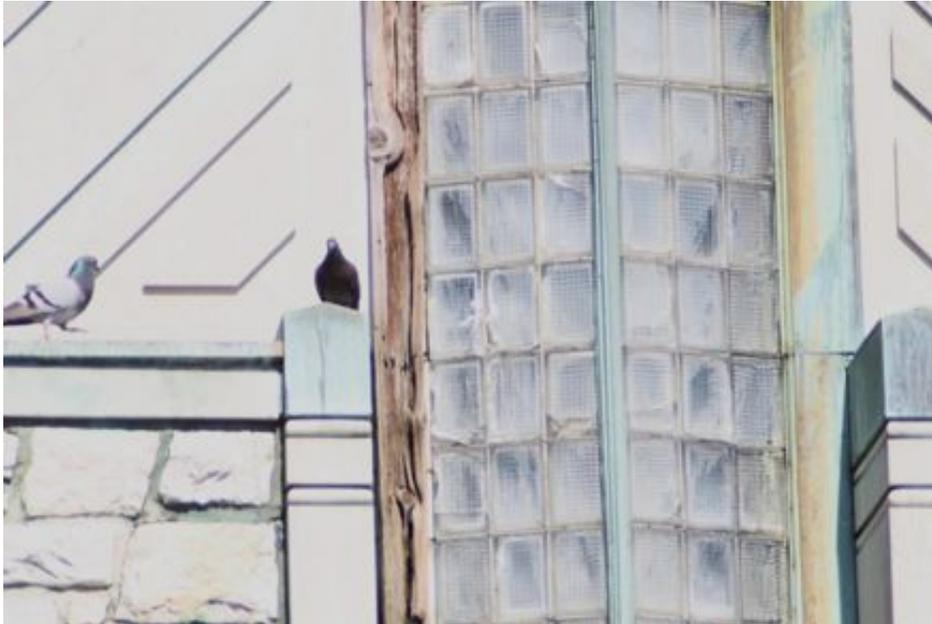
The copper flashing and wood backup found at the top and bordering the glass blocks have failed on the Tower. The copper is either missing in some locations or the soldered seams have failed. These open joints and missing flashing pieces have allowed moisture to infiltrate the structure and deteriorate the wood backup that once anchored the copper flashing (Figure 100).

Fig. 100 Tower North Elevation. Missing copper flashing and exposed wood backup. (SEA 2012)

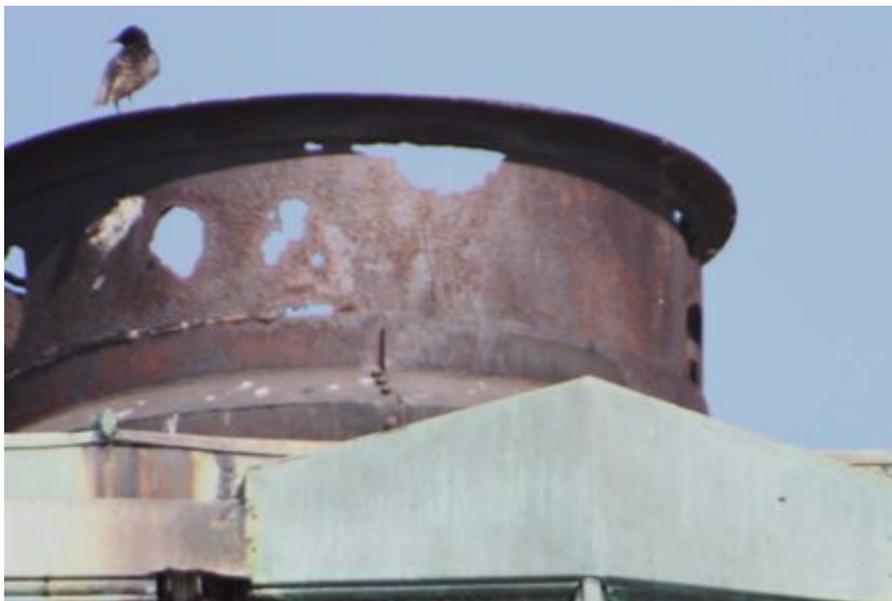
The large diameter metal pipe that contains the smoke has severe corrosion issues at the upper section above the structure portion of the smokestack. From our field investigation, it was discovered that large portions of the metal were completely corroded away leaving holes in the metal pipe at the stack's exhaust (Figure 101). The tower roof is also copper and is discussed in the Roof Section of this report.

Fig. 101 Tower North Elevation. Severely corroded steel exhaust pipe. (SEA 2012)
