## Windows, Exterior Doors and Decorative Metals

### Introduction

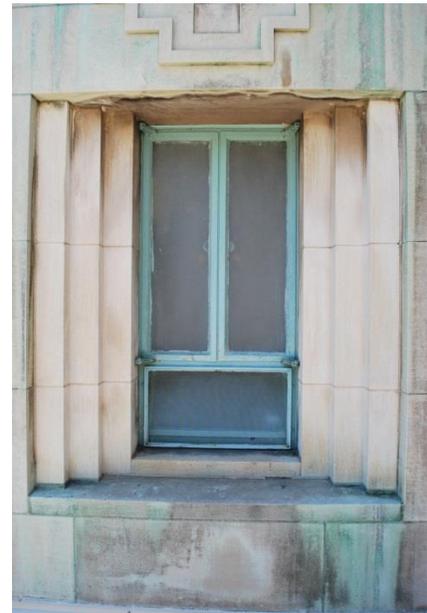
Fig. 147 Existing Steel Window in the Second Floor Tower Restroom. This window has privacy glazing and is located in Preservation Zone1 and is therefore recommended for preservation. (SRJA 2012)

Those steel windows located in the primary Preservation Zone 1 should be maintained and preserved during future rehabilitation. Those steel windows located in Rehabilitation Zones 2-4 should be carefully considered for restoration and individually reviewed prior to making a replacement recommendation. Replacements should be done with an in-kind window, created by a steel window manufacturer who can match the existing steel window profiles, operation, overall site lines and installation.

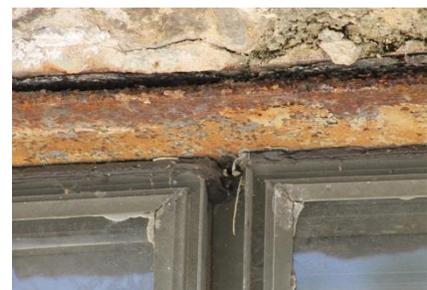
For the purposes of this report, windows and doors were observed from the exterior and interior of the building. They are noted by type and the overall assessment and recommendations are noted below. The lintels were observed during the masonry assessment and are discussed in that section of the report. Many of the existing window and door lintels are deteriorated and will require replacement, as they do not appear to have been treated or maintained since their original installation (Figure 147). Unfortunately, in order to access the lintels for repair or replacement, this work may affect several of the modern aluminum windows (Figure 148).

Fig. 148 Existing Deteriorated Lintel at a Modern Aluminum Window Installation. (SRJA 2012)

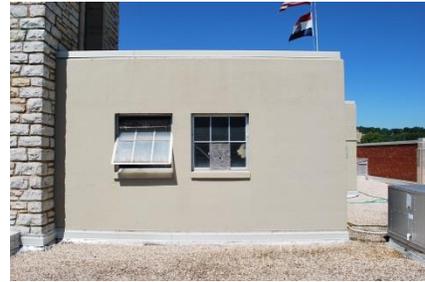
Fig. 149 Existing Steel Windows in Elevator Penthouse. These require rehabilitation, as there is missing glazing. (SRJA 2012)

The historic steel windows contain a variety of glass glazing, including several varieties of textures privacy glazing, decorative textured glazing and wire safety glazing. If glazing is broken, replacement glazing should match the historic glazing opacity, texture, coloring, thickness and overall design intent. Replacement glazing may be found through architectural salvage and historic restoration specialists.

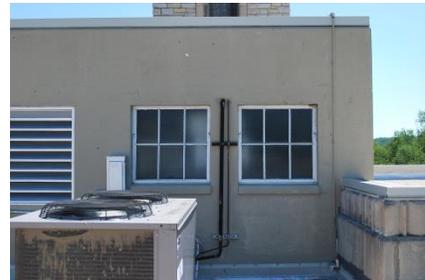
Fig. 150 Existing Steel Windows in Mechanical Penthouse. These appear to be in good overall condition. (SRJA 2012)

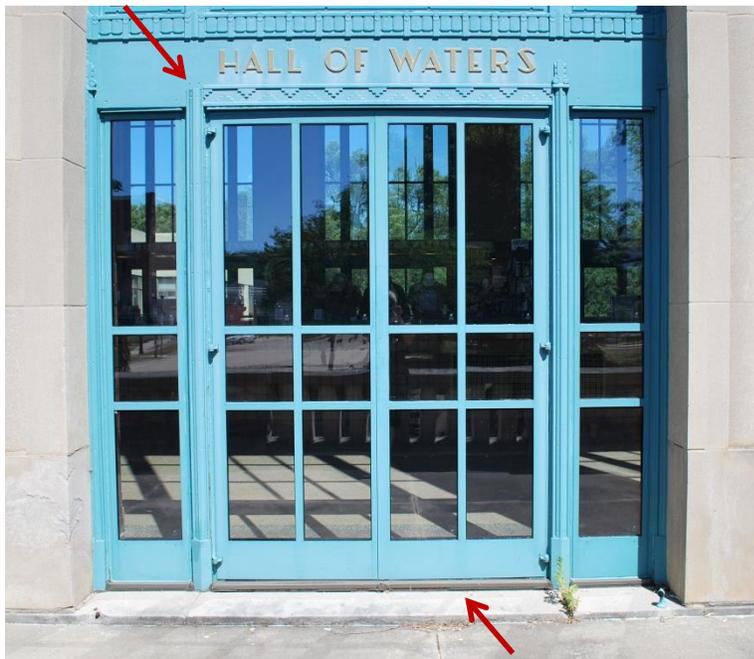
The existing steel window sash and doors are in good overall condition. The original steel frames and decorative elements are in fair to poor condition and require immediate attention. Many of the cast steel decorative elements are missing. Holes resulting from the missing elements may be allowing water into the steel frames. The windows require new sealant installation in select locations, most specifically at the door thresholds. Frames need rust removal and touch-up painting.

Fig. 152 Steel Window at the Hall of Springs. The top red arrow points to a missing cast steel detail, typical throughout the exterior. The bottom points to deteriorated sealant at the threshold. (SRJA 2012)

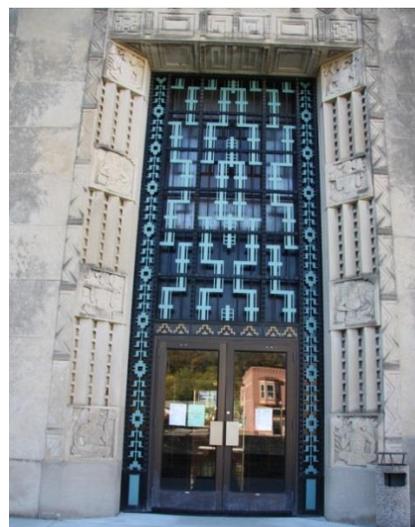
The decorative metal screen covers large second story steel windows (Figures 155 and 156) which can only be seen from the interior of the building. The steel windows are original and are composed of a series of rectangular openings, with reeded and textured glass, set around a pair of casement windows. The interior window jambs are surrounded with terra cotta tiles on the north window. These windows swing into the building and are operated with large brass handles. The window opening in the Courtroom is slightly different than the north opening located at the stair landing, in that the two outside units also operate. The window frames are both beginning to bow and show signs of distress. Several of the glass units are cracked. The terrazzo sill at the north window is also cracked (Figures 157 and 159). It appears that the overall steel window unit was installed tight to the structure with no allowance for expansion and contraction of the overall window system. Steel windows experience quite a bit of thermal movement and tend to creep over time.

Fig. 155 North Entrance.  
(SRJA 2012)

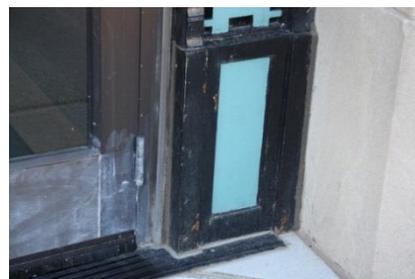
These entrance systems are in fair overall condition. The exterior metal surround is beginning to rust and has several cracks and broken pieces throughout that require repair. This repair and paint work needs to occur immediately so that the frames will be water tight and will not continue to rust and deteriorate. During rainstorms water is forced under the entry doors (especially at the west doors) and pools on the terrazzo flooring. The doors need a better sweep and/or threshold to keep water out of the building. The steel windows are significant historic fabric and should be preserved. They are in fair to poor condition. A thorough restoration plan should be compiled for these two locations, taking into account that the windows will likely need to be restored in situ.

Fig. 156 North Entrance  
Deteriorated Steel Surround Detail.  
(SRJA 2012)

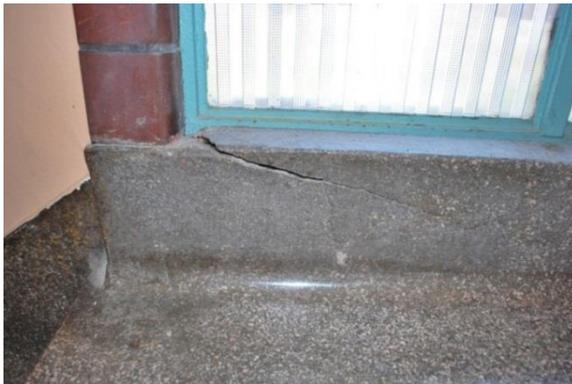
Fig. 159 North Entrance Steel Window Cracked Terrazzo Sill. (SRJA 2012)

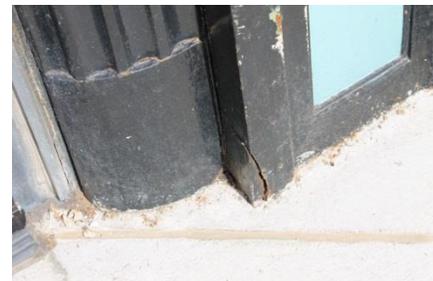
Fig. 161 West Entrance Deteriorated Steel Surround Detail. (SRJA 2012)

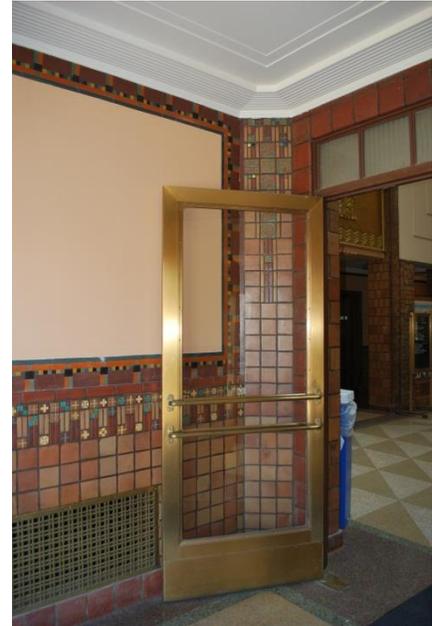
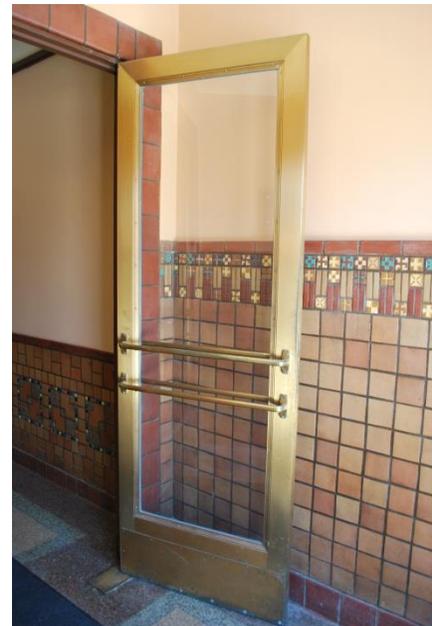
replacement. The north and west vestibule also contain original brass doors set in steel frames. These doors should be carefully maintained and preserved (Figures 167 and 168). The interior north doors are set in a decorative painted steel frame with a transom window. The transom glass are squares of reeded and textured glass. This decorative surround and door system should be carefully maintained and preserved.

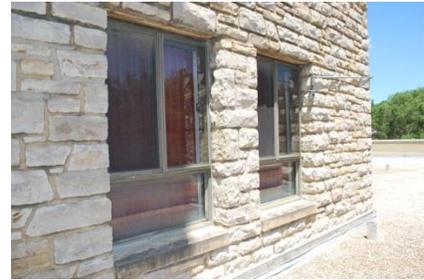
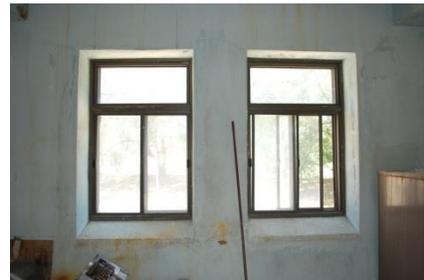
Overall, the aluminum windows currently installed in the office and spa spaces are similar in design to the fenestration patterns of the original steel windows (Figures 169 and 170). The aluminum replacement windows have fixed transoms. The new aluminum windows have sliding units, whereas the original steel windows had operable casements of a similar proportion. The bottom sections of the original steel windows that were operable hoppers are now fixed units or have been in-filled with window air conditioning units (Figure 171). The aluminum windows are a light bronze or brown color.

For future replacement windows, it is recommended to utilize the appropriate historic preservation guidelines during the product selection. First, review historic photographs to determine the as-built condition of the original steel window that is now being replaced, in many cases, for the second time. The historic drawings are also good to review, but they are not 100% accurate as far as reflecting the final as-built conditions of the building. Also, it is unknown at the time of this study what the original window frame color was. It is recommended to determine the original window frame color(s) through paint sample analysis of the historic windows and to match the earliest top coat color if at all possible. Refer to the National Park Service Technical Preservation Services Preservation Tech Notes, *Windows, Number 20 – Aluminum Replacement Windows for Steel Projecting Units with True Divided Lights and Matching Profiles*.

Care shall be taken to specify an aluminum replacement window that closely replicates the original historic steel windows in overall design and manufacturing as closely as possible. This includes matching the visible glass (sightlines) of the original windows to the replacement windows as closely as possible and to provide custom extrusions to mimic a steel window (muntins, simulated glazing putty, rails and stiles). There are several manufacturers who have a proven track record in manufacturing historically appropriate aluminum replacement windows for buildings with original steel windows.

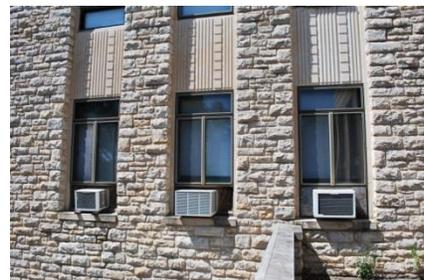
The window air conditioning units are creating extensive of damage to the stone building sills and stone walls. The condensate water that drips from them saturates the stone below and allows for significant moisture build-up which slowly destroys the mortar. The result is dirty and damaged stone. The air conditioning units do not fit into the windows properly and therefore plywood filler panels are required to fit around the air conditioner units. These filler panels are not well-sealed to the frame or the air conditioner units, allowing conditioned air to seep through and bugs and condensate to enter into the building. Several window sills on the interior of the building show signs of this deterioration.

Fig. 171 Typical Window Air Conditioning Unit. Note In Lower Section of Aluminum Replacement Windows. (SRJA 2012)

It is unlikely that these windows can be repaired cost effectively and therefore, it would be recommended to implement a replacement plan for the window work as a phased approach. This work must occur as part of an overall larger plan which would incorporate new air conditioning so that the existing window air conditioning units would no longer be required.

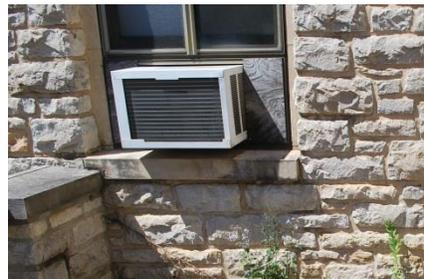
In general, the aluminum replacement windows are in fair to poor condition. Many of them leak and are difficult operate. Several have missing or damaged screens and others have been modified to fit window air conditioners with plywood filler panels (Figure 172). Many of the lower level windows have glazing that has turned opaque due to failed insulating seals and deterioration.

Fig. 172 Typical Plywood Infill at Window Air Conditioning Units. (SRJA 2012)

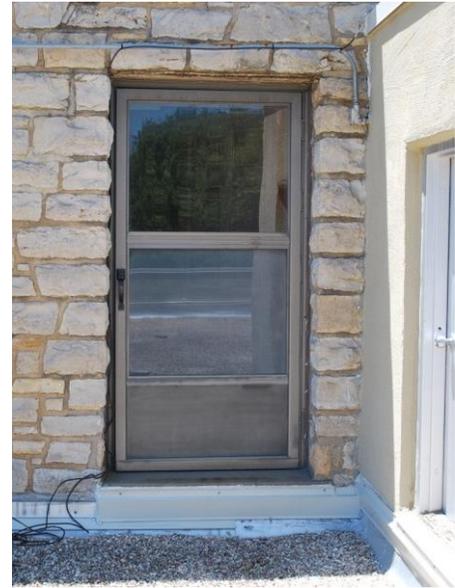
Fig. 177 Council Chambers  
Residential Screen Door.  
(SRJA 2012)

For instance, the door to the roof in the Council Chamber is a residential grade door, frame and screened door (Figures 176 and 177). Recommendations for this door opening would include removal and installation of a commercial grade insulated steel door and frame and painted to be consistent with other exterior doors found throughout the building. Many other steel doors throughout the building require immediate maintenance, including the installation of new perimeter sealants and prepping, priming and painting of the doors and frames.

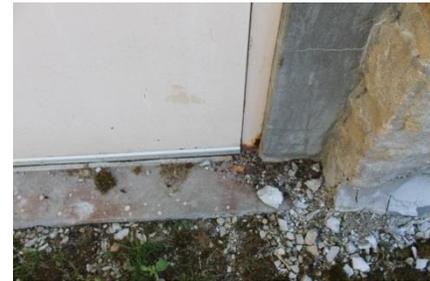
Fig. 178 North Terrace Steel Door  
Frame Deterioration Detail.  
(SRJA 2012)

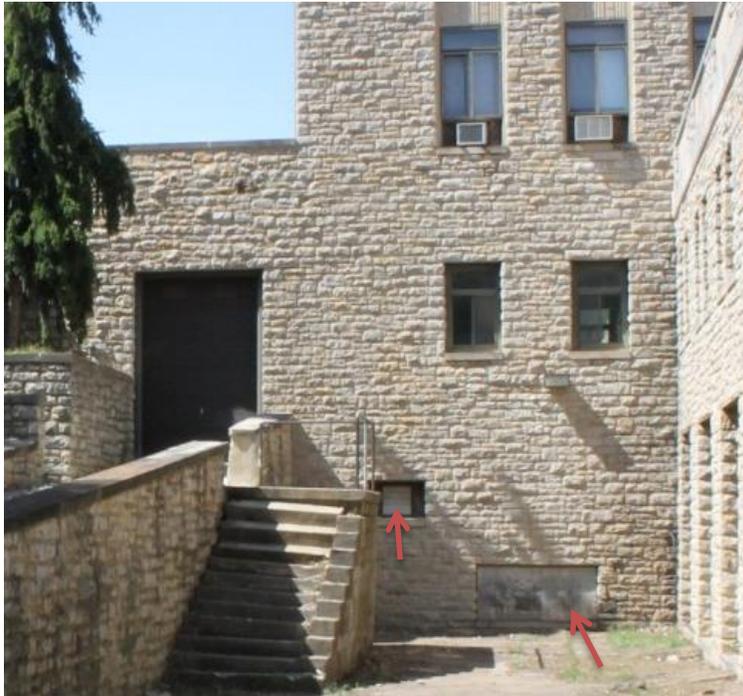
There are several mechanical louvers installed throughout the building. They should be individually inspected and maintained. All louvers should have the perimeter sealants maintained. Many of the louvers require interior screens. One louver on the south elevation currently is installed in a plywood board that needs to be painted. There is also one opening in the south wall that is currently boarded over. This opening needs to be addressed and an appropriate in-fill material should be installed.

Fig. 180 South Elevation. Note new overhead door on the left, a smaller louver installed in plywood and a lower opening in-filled with plywood. (SRJA 2012)

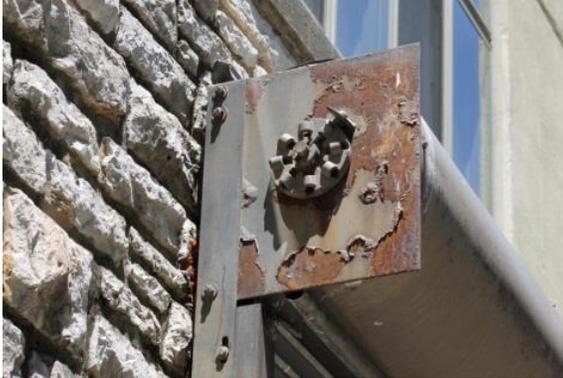
Overhead doors are installed on the south, east and north elevations. These doors are all in varying ages and require varied maintenance. The east door requires painting. Each door needs to be individually inspected and maintained to prevent deterioration, water and weather infiltration.

Fig. 181 East Overhead Door. (SRJA 2012)
