STRUCTURAL ENGINEERING ASSOCIATES, INC.

Re: Hall of Waters North Terrace Well Pump Room

Hall of Waters North Terrace
(Springs) Basement Condition
Assessment

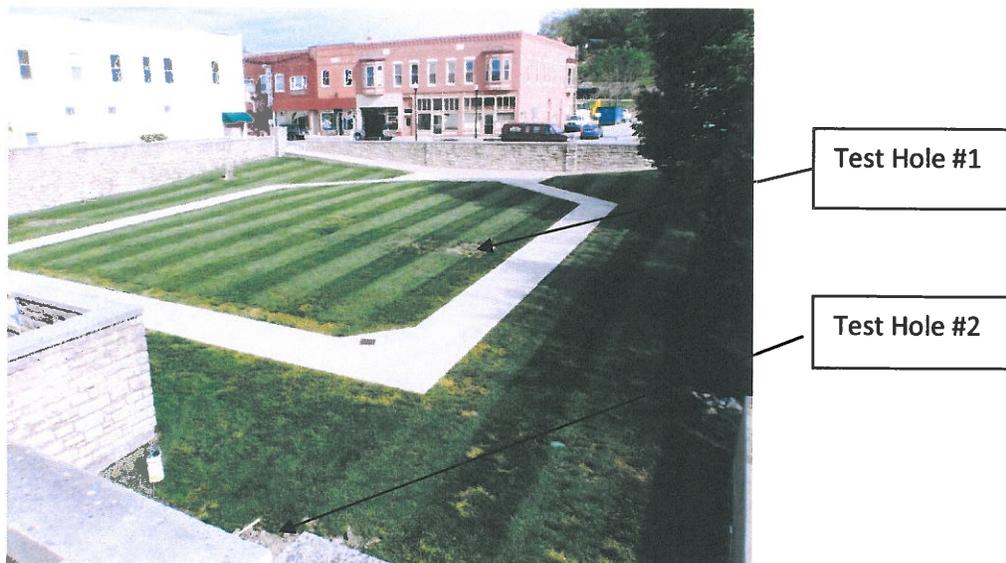
Hall of Waters, North Terrace Well Pump Room Test Holes

In the picture above, Test Holes #3 and #4 were located on the west side of the terrace, adjacent to the HOW north terrace area, and the access ramp leading to Broadway St. respectively. With the assistance of the Public Works Dept. staff, we were able to excavate the soil over the existing roof slab below, and then determine the elevations of both the existing grade at the test holes and the top of concrete roof slab, using an assumed elevation datum of 100.00 from the slab at the bottom of the north terrace stairs. The table below illustrates the elevations of the existing ground at the four test holes, as well as the exposed top of roof slab.

<u>Test Hole</u>	<u>Location</u>	<u>Ground Elevation</u>	<u>Top Roof Slab Elevation</u>
T.H. #1	N.E. Roof Corner	100.7	98.8
T.H. #2	S.W. Roof Corner	99.2	97.8
T.H. #3	S.W. Roof Corner	99.5	98.0
T.H. #4	N.W. Roof Corner	100.5	98.8

The above table indicates that the existing terrace tends to slope from the north to the south, and that the soil overburden ranges from 1.4' to 1.9' on top of the concrete roof slab.

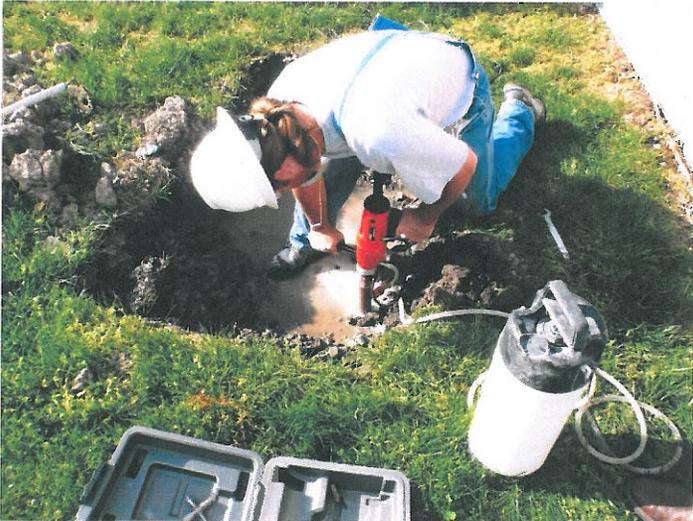
Coring existing roof slab at Test Hole #2

SEA also retained MTS Contracting to assist with obtaining a slab core of the reinforced concrete roof slab at Test Hole ##2, so as to determine the slab thickness (see picture below). The 3" diameter test core at the exposed T.H. #2 location found that the reinforced concrete roof slab thickness was approximately 13" thick in this location, which is fortunate, given the deteriorated condition of the 80+ year-old concrete in this basement structure, and the fact that it is subjected to some two feet of soil overburden.

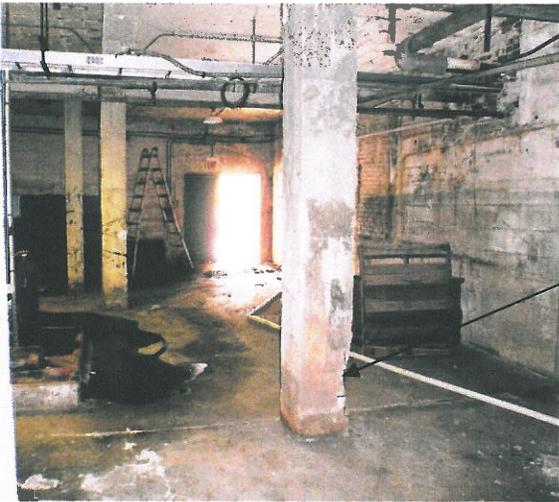
Existing column delaminations in Well Pump Room

Many of the existing concrete beams exhibit significant deterioration from corrosion, and the existing reinforcing steel in these beams have lost section, thus reducing their ability to carry the imposed loads. Further, some of the existing concrete columns should also be repaired, since there are moderate to severe corrosion delaminations at the lower few feet of many of the columns. The two pictures below help to further illustrate these observed structural deficiencies.

Typical column delamination from corrosion. S.E. Entrance Door is in the background.

Also, the shoring will require that a restoration type contractor be secured to provide grouting at the irregular surfaces of the distressed concrete beams, where they will be bearing on the shoring towers and posts. Lastly, we recommend that the same restoration contractor perform partial depth structural concrete repairs to the bottom few feet of the delaminated columns in the well pump house.

These discrete concrete column repairs would entail chipping out the unsound concrete on the 16" square columns, removing (sandblasting) the rebar corrosion and applying an epoxy bonding and corrosion inhibitor product, then forming and pouring new repair concrete around the existing column sections. There are some 20 columns in the structure. The required shoring grouting for bearing seats, and the columns repairs, is estimated to cost \$8,000 to \$10,000.

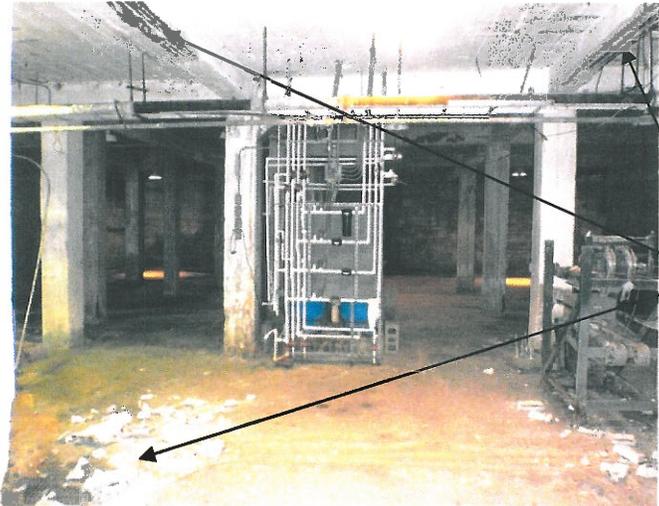
Concrete beam and slab framing deterioration

Moderate to severe reinforced concrete beams delaminations due to corrosion. Note spalled concrete on slab floor.

These structural (corrosion) delaminations at beams, slab-soffit and columns, make it necessary to either repair the reinforced concrete elements in whole, or erect temporary shoring and bracing to ensure the well pump room does not collapse in part, or whole.

SEA obtained a preliminary proposal to provide a temporary or long term (as the case may be) shoring system from HARSCO Infrastructure, which will consist of 20 kip (20,000 lb. rated) shoring towers to support the distressed reinforced concrete framing beams that support the roof slab of this structure. HARSCO estimates that in designing, erecting and dismantling the proposed shoring system the cost would be approximately \$29,000. The monthly rental for the shoring would be approximately \$1,202, with the annual rental rate being \$15,673.

In summary, SEA recommends that a temporary shoring system be erected to support the roof framing of this well pump house structure to provide structural stability and life safety. The estimated shoring loads do take into account a potential assembly live load of 100 psf, but even with the new shoring system in place, we do not recommend large assemblies and/or equipment loads above the existing well pump room structure.
