**HALL OF WATERS
POOL RENOVATION STUDY**

**EXCELSIOR SPRINGS,
MISSOURI**

November 9, 2004

**Prepared By:
BUCHER, WILLIS & RATLIFF CORPORATION
&
WATER'S EDGE AQUATIC DESIGN**

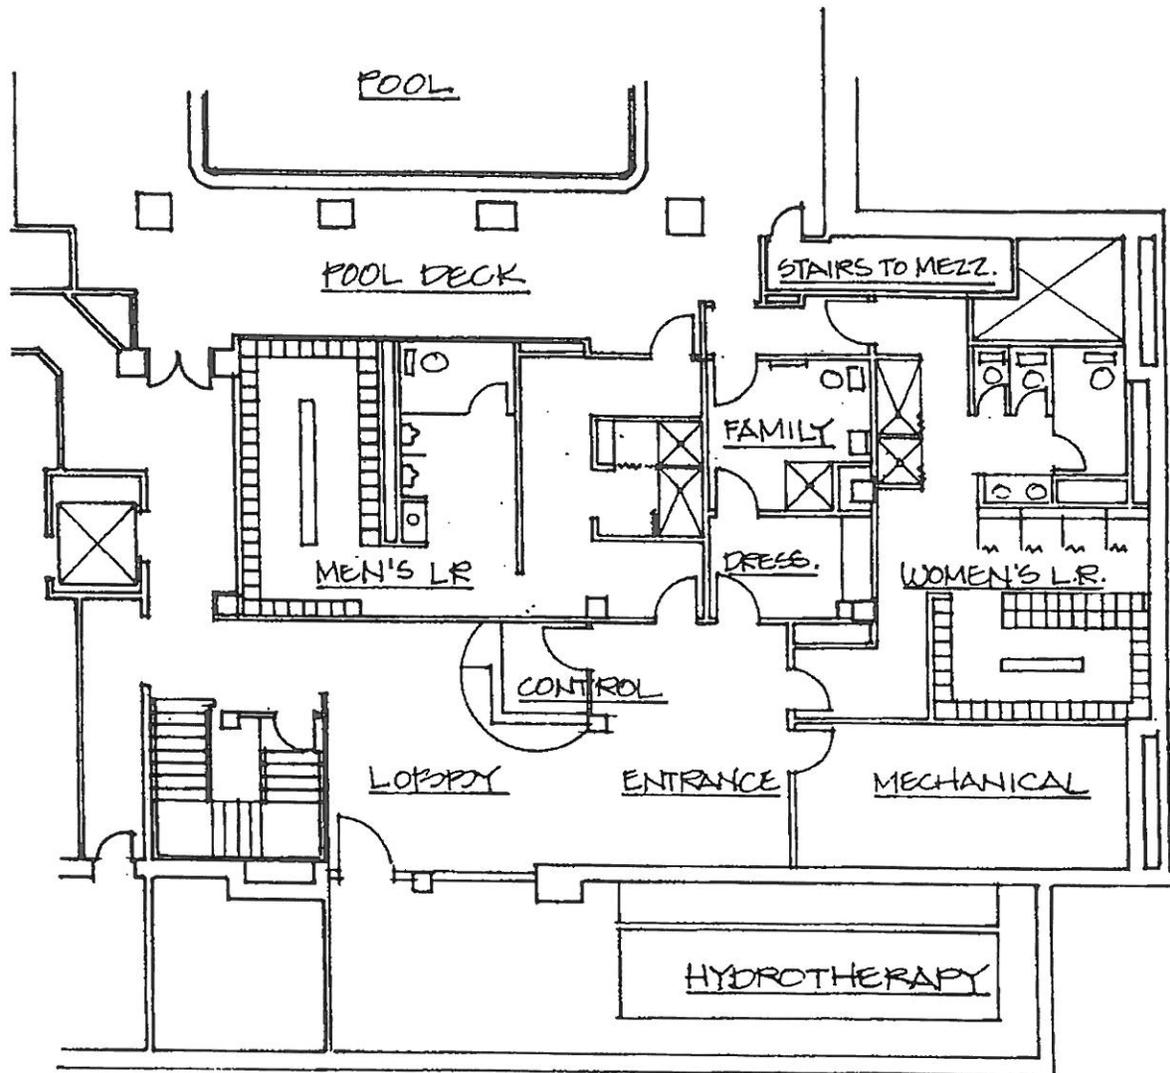
FIGURE 1: GROUND LEVEL LOCKER ROOM PLAN

Figure 1 of the lobby and locker room area illustrates a possible solution that provides a men's and women's locker room and a family room at the main pool level. The family room provides an area where an adult can help their child of the opposite gender or disabled spouse change clothes and shower. This plan shows users entering locker rooms from the lobby and from the locker rooms going directly to the pool without having to pass back through the lobby.
