**Subject: Asbestos-Containing Materials and Lead-Based Paint Inspection Report  
Former Wyman High School Site, Excelsior Springs, Missouri  
Missouri Environmental Assessment Services Contract, Contract No. CS210096002  
Vendor No. 48120656000**

**ASBESTOS-CONTAINING MATERIALS AND LEAD-BASED PAINT INSPECTION**

**FORMER WYMAN HIGH SCHOOL SITE  
EXCELSIOR SPRINGS, MISSOURI**

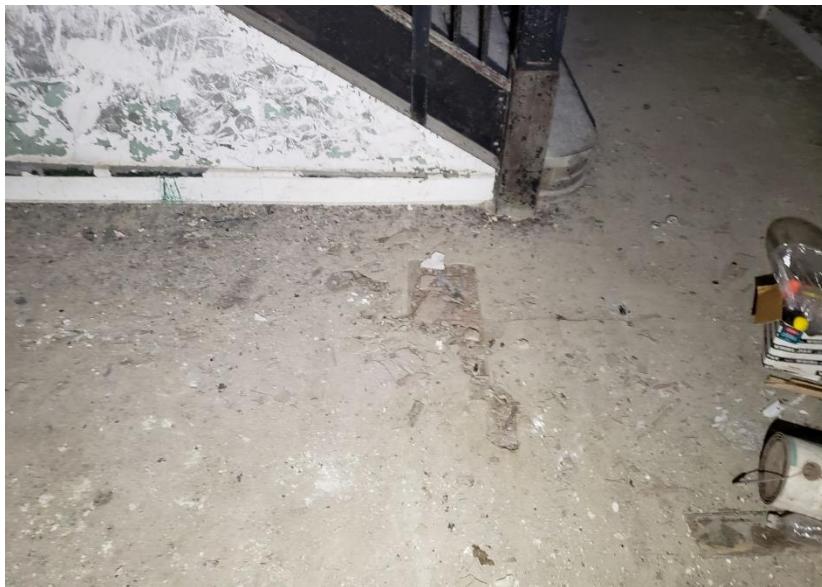
Client: Missouri Department of Natural Resources	Description: Photograph of 9-inch by 9-inch floor tiles on the first floor of the former school building. These tiles and mastic were represented by samples FT1-1, FT1-2, and FT1-3 for asbestos analysis. The tile tested positive for asbestos (2% chrysotile).	Photograph Number: 2
Direction: Not applicable (NA)	Photographer: Lynn Parman	Date: 10/13/2021

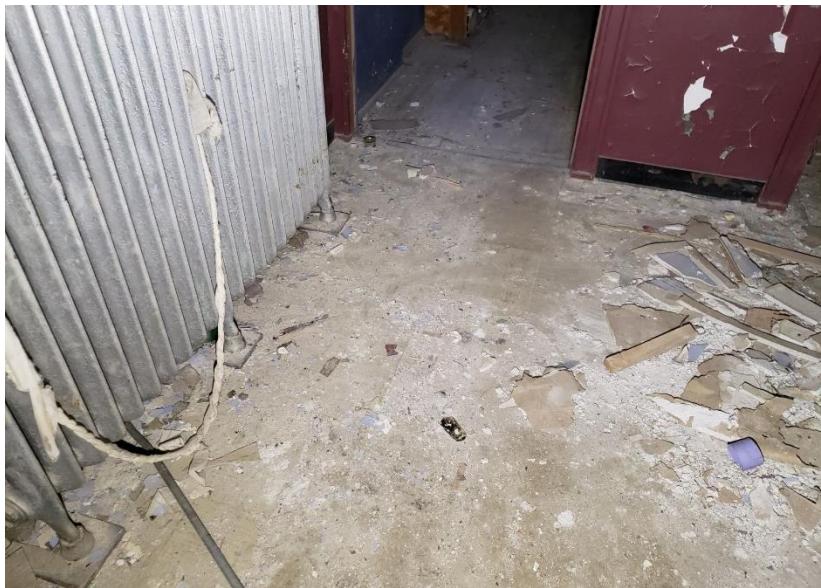
Client: Missouri Department of Natural Resources	Description: Photograph of 12-inch by 12-inch floor tiles that were sporadically located throughout the former school building. These tiles and mastic were represented by samples FT2-1, FT2-2, and FT2-3 for asbestos analysis. The tile tested positive for asbestos (2% chrysotile).  Direction: NA	Photograph Number: 3  Photographer: Lynn Parman  Date: 10/13/2021
--	---	---

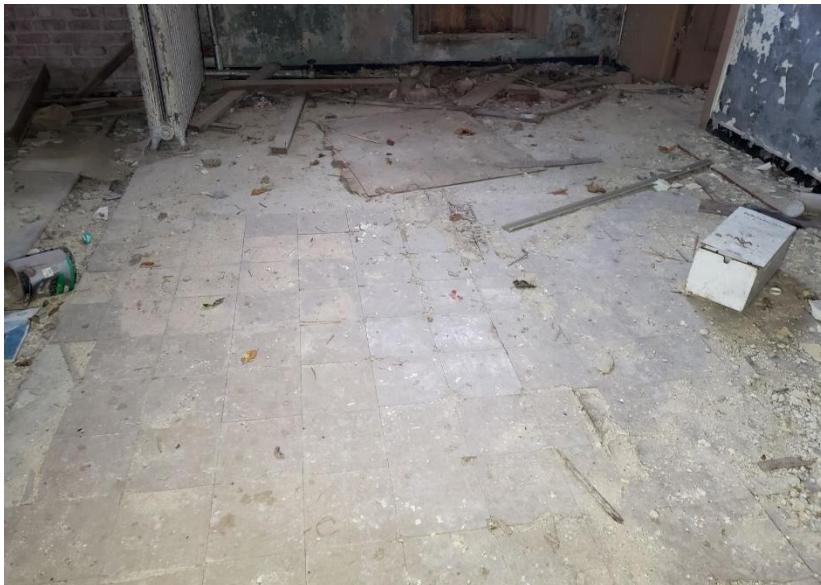
Client: Missouri Department of Natural Resources	Description: Photograph of 9-inch by 9-inch floor tiles that were on the second and third floors of the former school building. These tiles and mastic were represented by samples FT3-1, FT3-2, and FT3-3 for asbestos analysis. The tile tested positive for asbestos (8% chrysotile).  Direction: NA	Photograph Number: 4  Photographer: Lynn Parman  Date: 10/13/2021
--	---	---

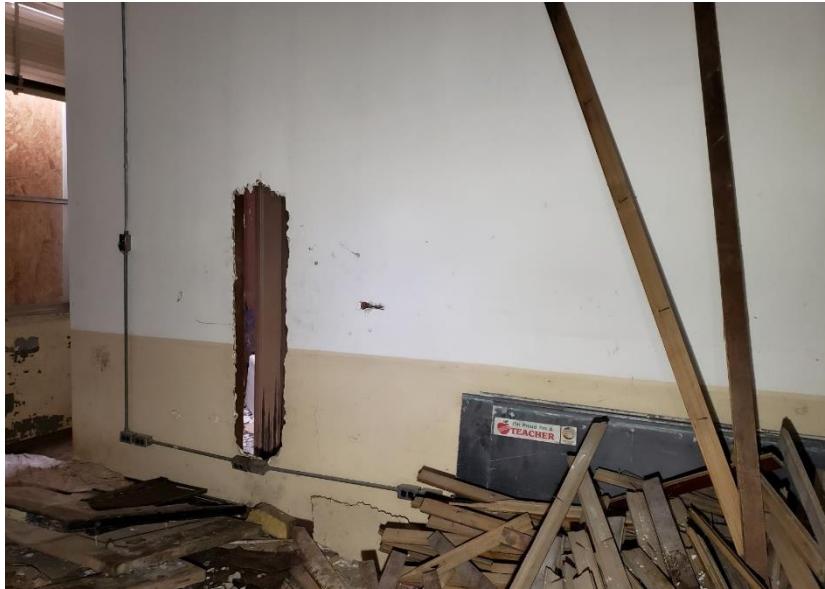
Client: Missouri Department of Natural Resources	Description: Photograph of wallboard that was on the second and third floors of the former school building. This wallboard was represented by samples WB1-1, WB1-2, and WB1-3 for asbestos analysis.	Photograph Number: 5
Direction: NA	Photographer: Lynn Parman	Date: 10/13/2021

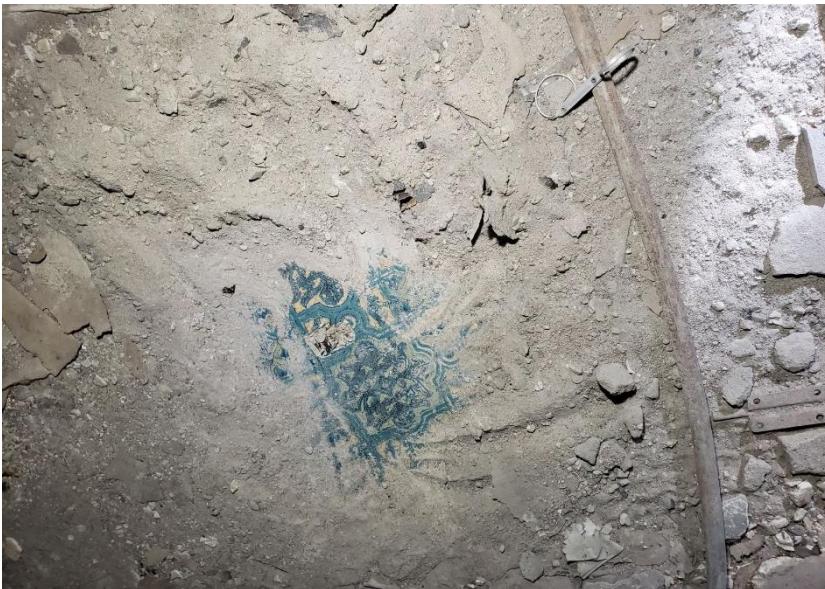
Client: Missouri Department of Natural Resources	Description: Photograph of sheet vinyl flooring (under dust/debris) in Room 21 on the second floor of the former school building. This material was represented by samples SV1-1 and SV1-2 for asbestos analysis. The sheet vinyl tested positive for asbestos (15% chrysotile).	Photograph Number: 6
Direction: NA	Photographer: Lynn Parman	Date: 10/13/2021

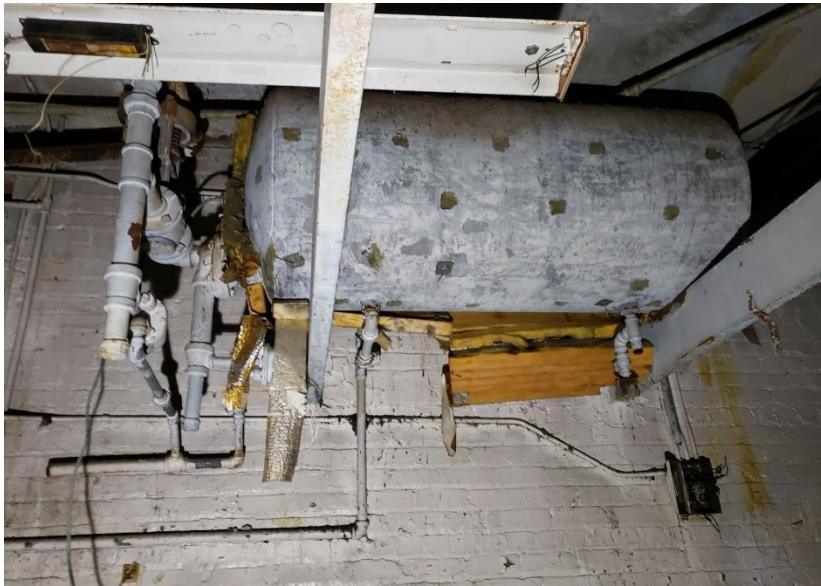
Client: Missouri Department of Natural Resources	Description: Photograph of an overhead water tank in Room 13 on the first floor of the former school building. Insulation around the tank and duct tape that had been used to secure the insulation were represented by samples TI1-1, TI1-2, TI1-3, DT1-1, and DT1-2 for asbestos analysis.	Photograph Number: 7
Direction: NA	Photographer: Lynn Parman	Date: 10/13/2021

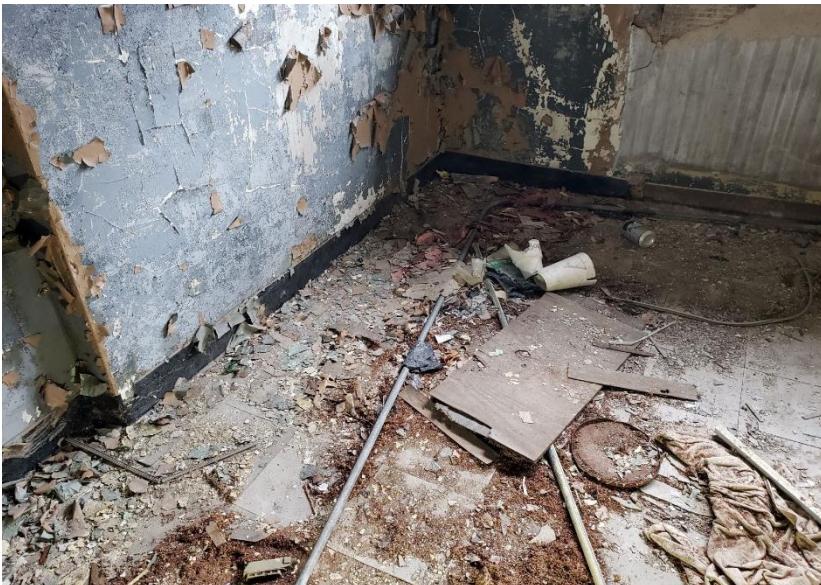
Client: Missouri Department of Natural Resources	Description: Photograph of cove base that was located throughout the second and third floors of the former school building. This cove base and mastic were represented by samples CB1-1, CB1-2, and CB1-3 for asbestos analysis.	Photograph Number: 8
Direction: NA	Photographer: Lynn Parman	Date: 10/13/2021

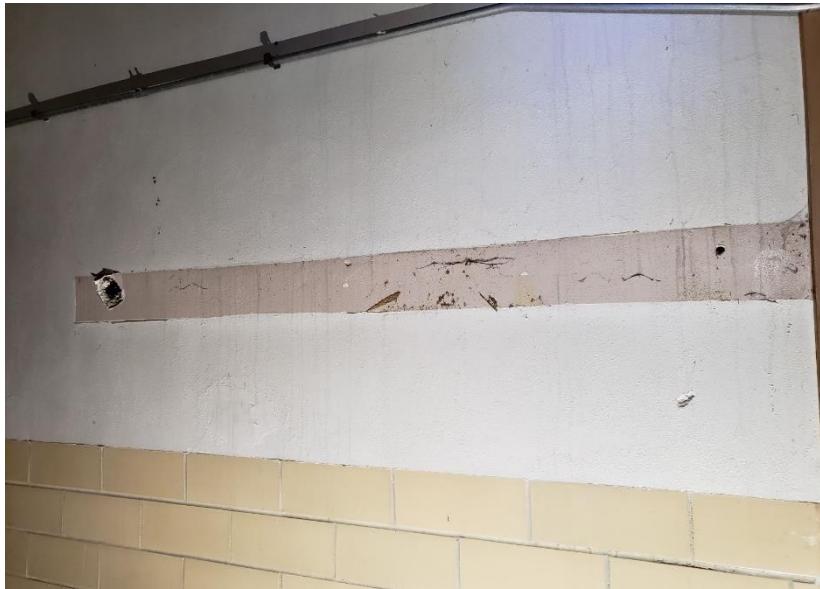
Client: Missouri Department of Natural Resources	Description: Photograph of plaster that was located on walls and ceilings throughout the former school building. This plaster was represented by samples PL1-1 through PL1-7 for asbestos analysis.	Photograph Number: 9
Direction: NA	Photographer: Lynn Parman	Date: 10/13/2021

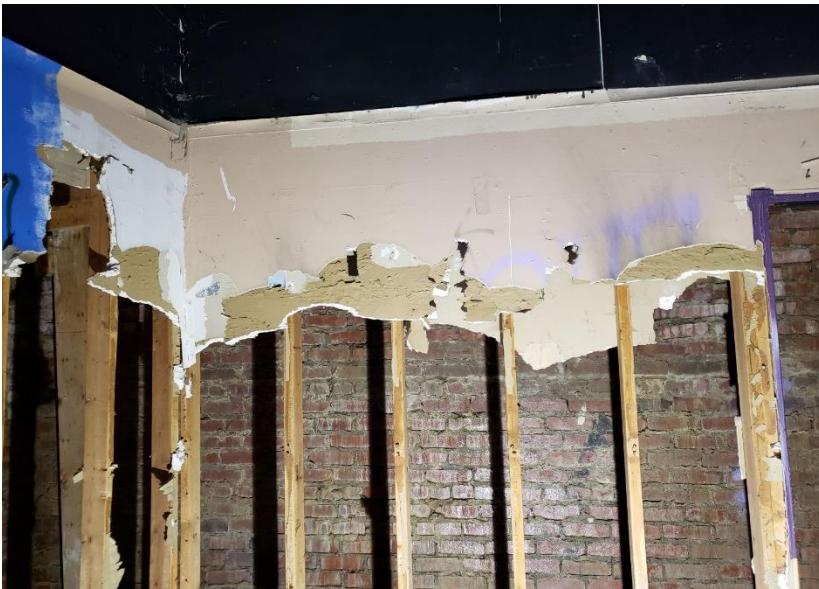
Client: Missouri Department of Natural Resources	Description: Photograph of wallboard that was in the auditorium (lower level) of the former school building. This wallboard and mastic were represented by samples WB2-1, WB2-2, and WB2-3 for asbestos analysis.	Photograph Number: 11
Direction: NA	Photographer: Lynn Parman	Date: 10/13/2021

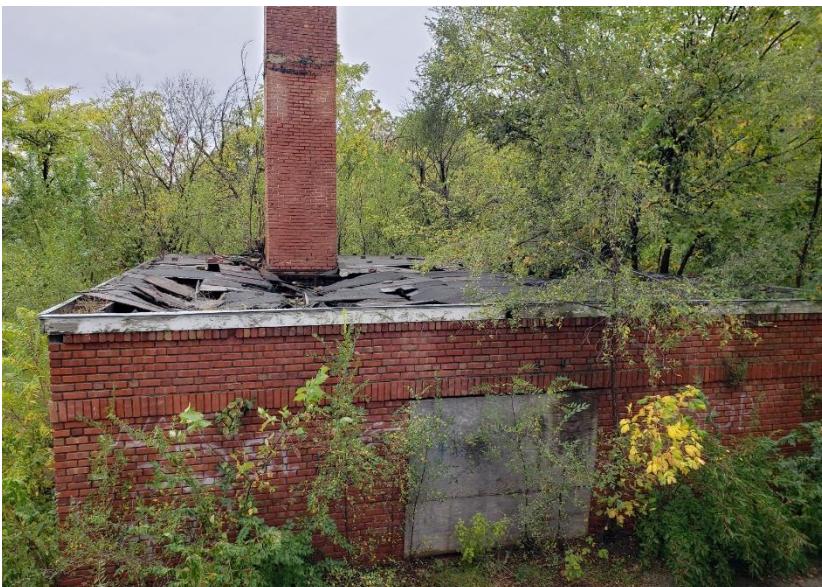
Client: Missouri Department of Natural Resources	Description: Photograph of the roof of the former heating plant building. Roofing material from this building was represented by samples RM1-1 and RM1-2 for asbestos analysis.	Photograph Number: 12
Direction: South	Photographer: Lynn Parman	Date: 10/13/2021

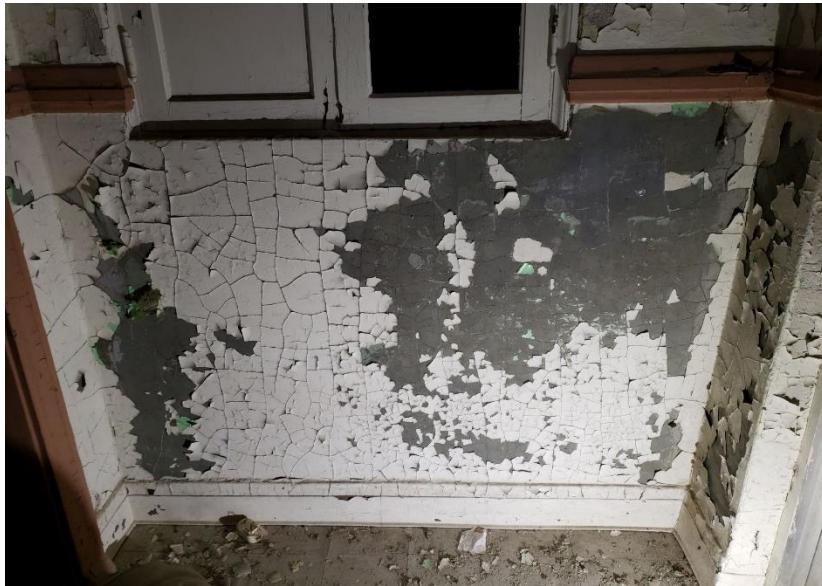
Client: Missouri Department of Natural Resources	Description: Photograph of the lower portion of the north wall in Room 5a that was positive for LBP.	Photograph Number: 17
Direction: NA	Photographer: Lynn Parman	Date: 10/12/2021

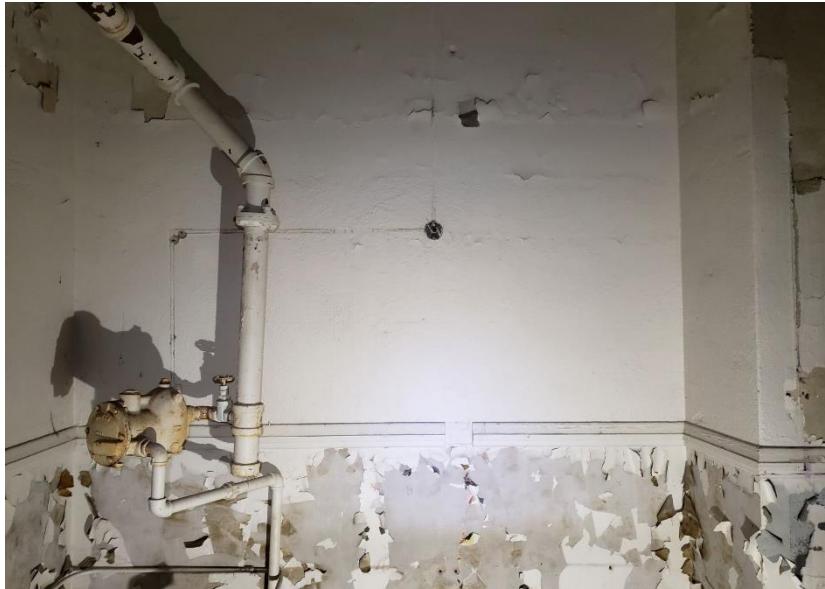
Client: Missouri Department of Natural Resources	Description: Photograph of the lower portion of the west wall in Room 8 that was positive for LBP.	Photograph Number: 19
Direction: NA	Photographer: Lynn Parman	Date: 10/12/2021

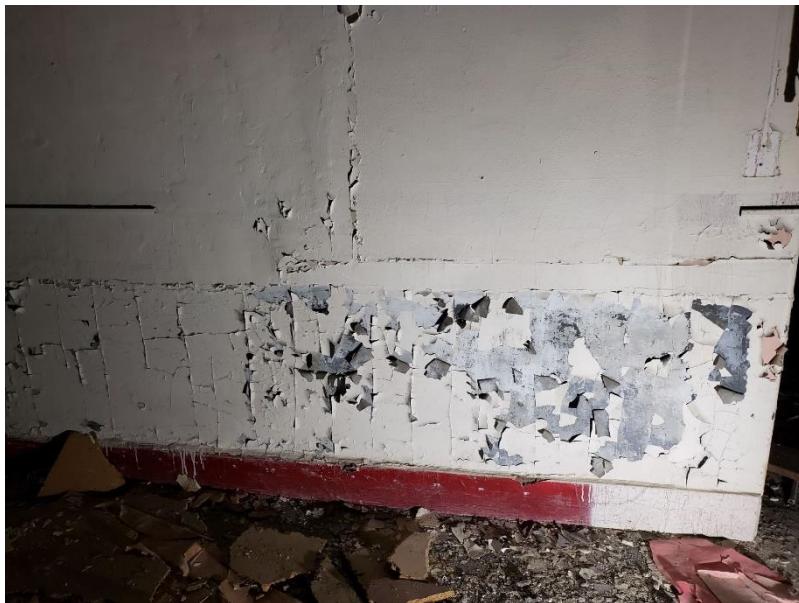
Client: Missouri Department of Natural Resources	Description: Photograph of the lower portion of the north wall in Room 8 that was positive for LBP.	Photograph Number: 20
Direction: NA	Photographer: Lynn Parman	Date: 10/12/2021

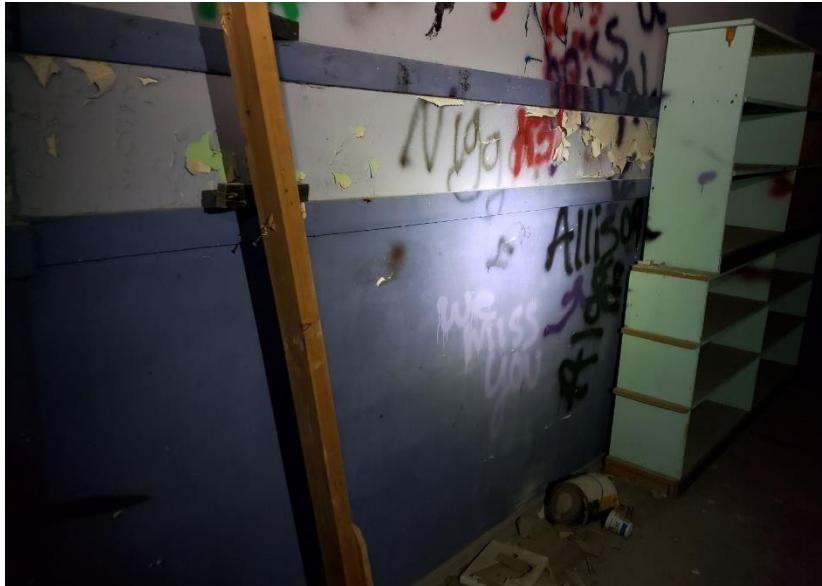
Client: Missouri Department of Natural Resources	Description: Photograph of the lower portion of the south wall in Room 11 that was positive for LBP.	Photograph Number: 21
Direction: NA	Photographer: Lynn Parman	Date: 10/12/2021

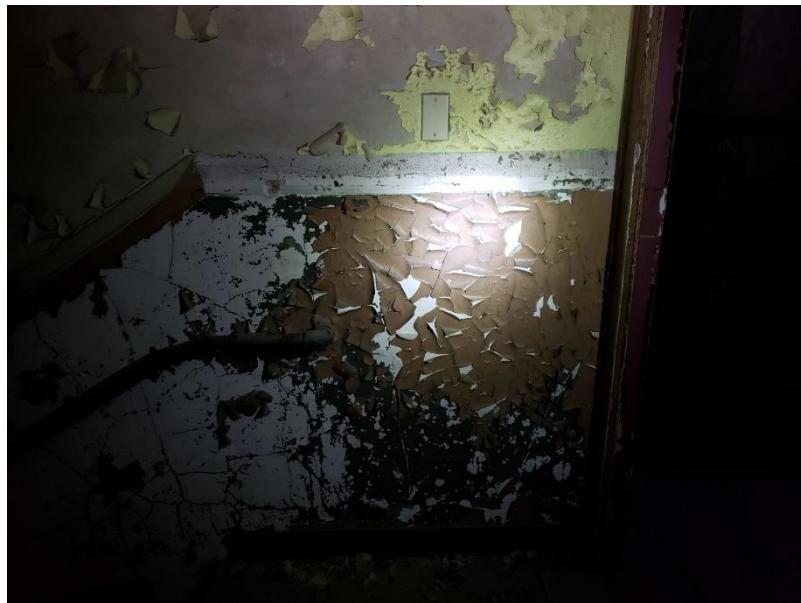
Client: Missouri Department of Natural Resources	Description: Photograph of the lower portion of the north wall in Room 11 that was positive for LBP.	Photograph Number: 22
Direction: NA	Photographer: Lynn Parman	Date: 10/12/2021

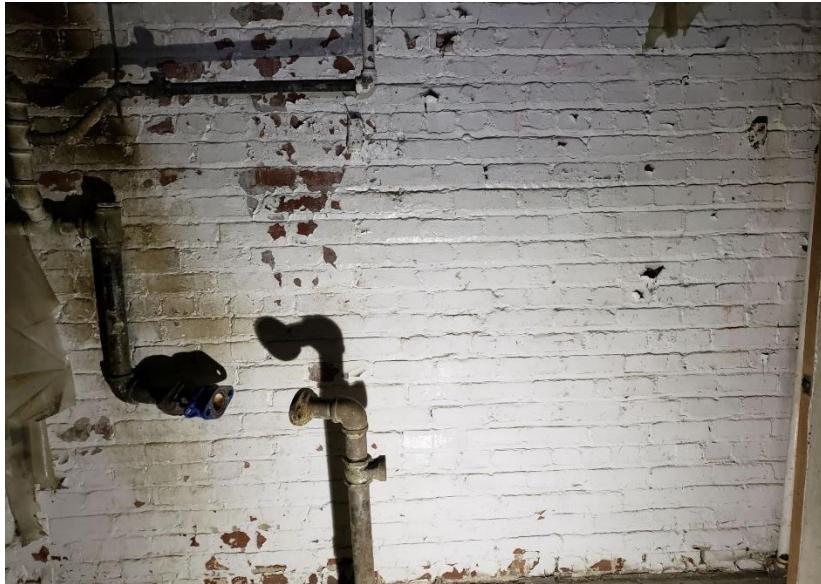
Client: Missouri Department of Natural Resources	Description: Photograph of a brick wall on the west side of Room 13 that was positive for LBP.	Photograph Number: 23
Direction: NA	Photographer: Lynn Parman	Date: 10/12/2021

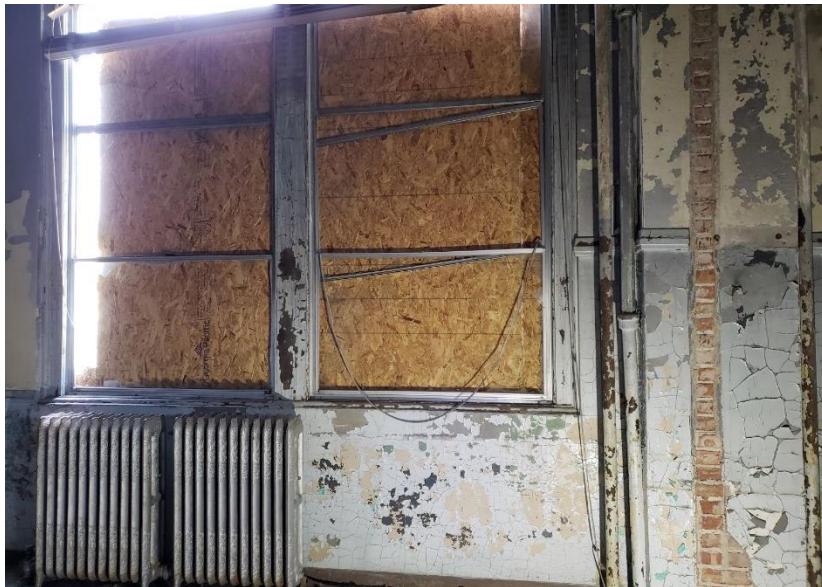
Client: Missouri Department of Natural Resources	Description: Photograph of a window frame and a vertical water pipe on the west wall in Room 17 that were positive for LBP.	Photograph Number: 25
Direction: NA	Photographer: Lynn Parman	Date: 10/12/2021

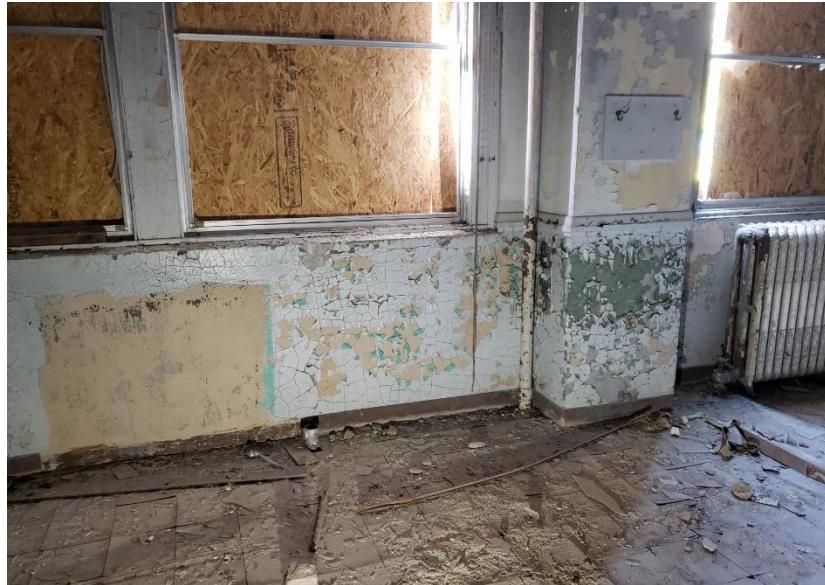
Client: Missouri Department of Natural Resources	Description: Photograph of the lower portion of the west wall in Room 17 that was positive for LBP.	Photograph Number: 27
Direction: NA	Photographer: Lynn Parman	Date: 10/12/2021

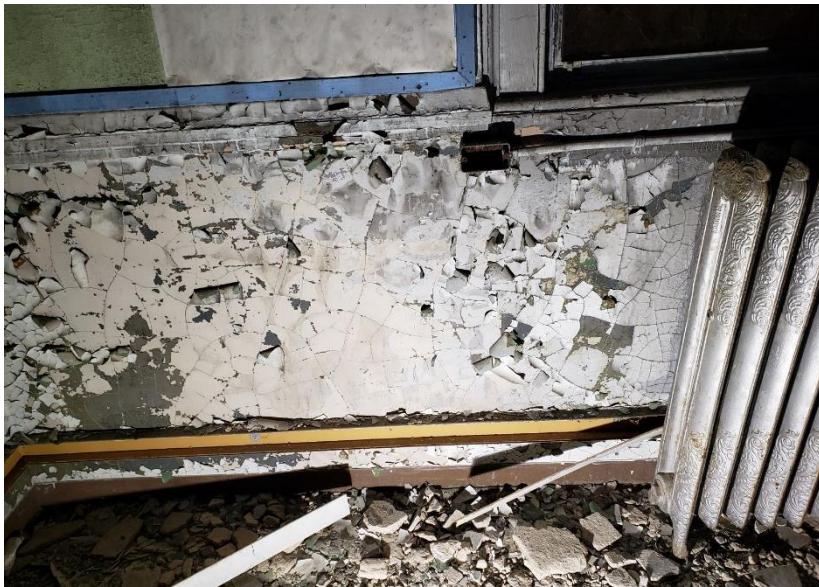
Client: Missouri Department of Natural Resources	Description: Photograph of the lower portion of the east wall in Room 20 that was positive for LBP.	Photograph Number: 29
Direction: NA	Photographer: Lynn Parman	Date: 10/12/2021

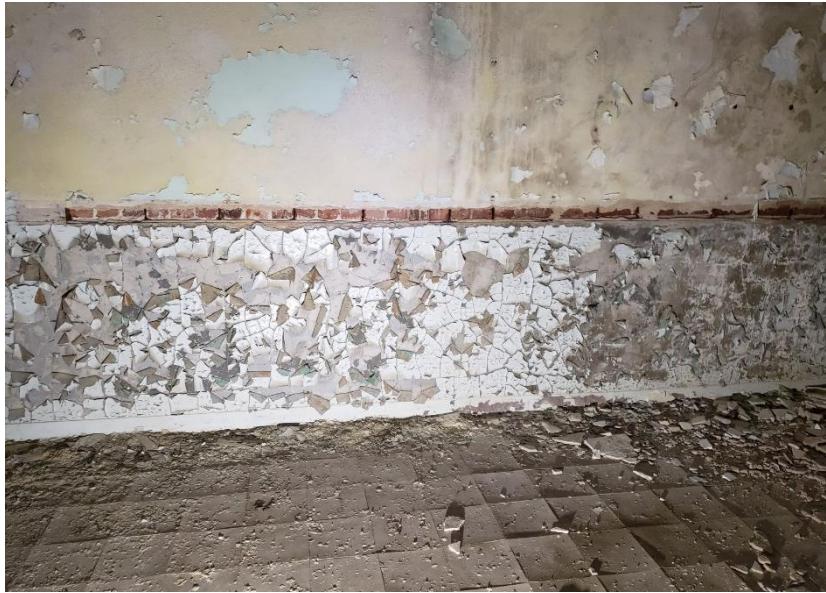
Client: Missouri Department of Natural Resources	Description: Photograph of the lower portion of the east wall in Room 25 that was positive for LBP.	Photograph Number: 33
Direction: NA	Photographer: Lynn Parman	Date: 10/12/2021

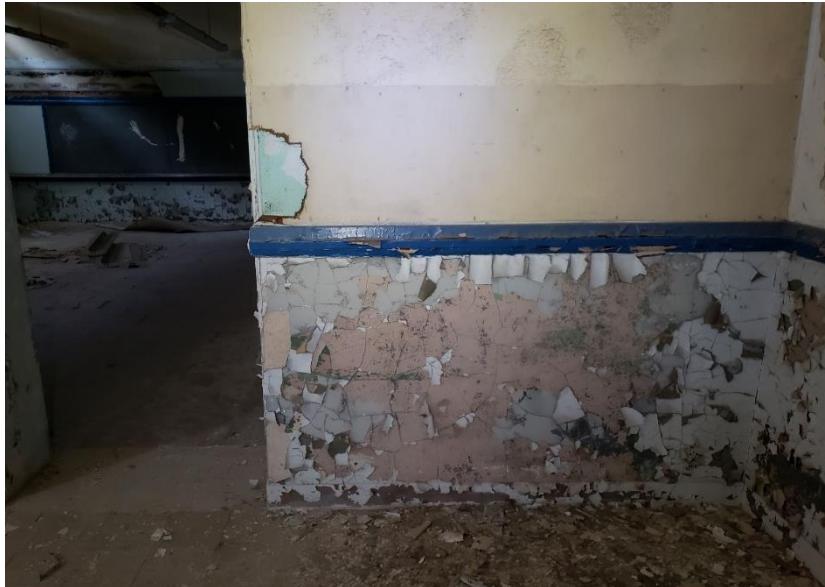
Client: Missouri Department of Natural Resources	Description: Photograph of the lower portion of the north wall in Room 25 that was positive for LBP.	Photograph Number: 35
Direction: NA	Photographer: Lynn Parman	Date: 10/12/2021

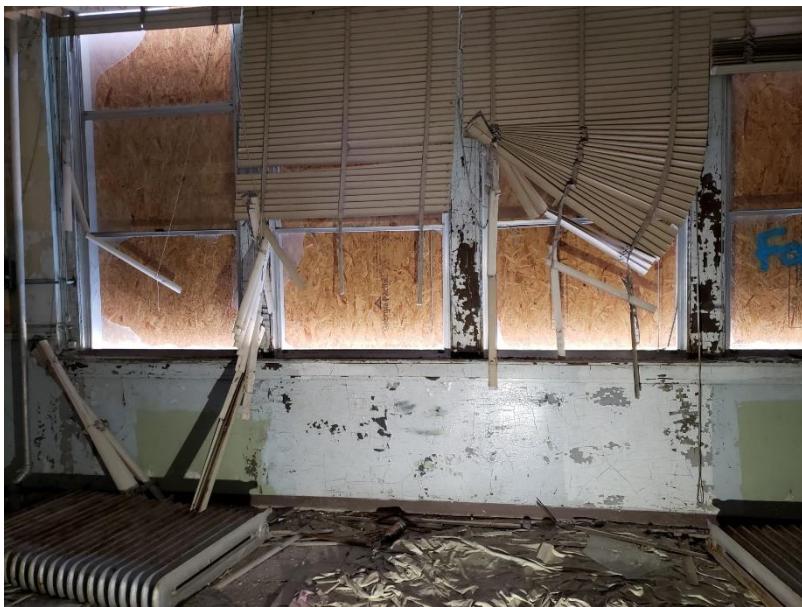
Client: Missouri Department of Natural Resources	Description: Photograph of the lower portion of the west wall in Room 26 that was positive for LBP.	Photograph Number: 36
Direction: NA	Photographer: Lynn Parman	Date: 10/12/2021

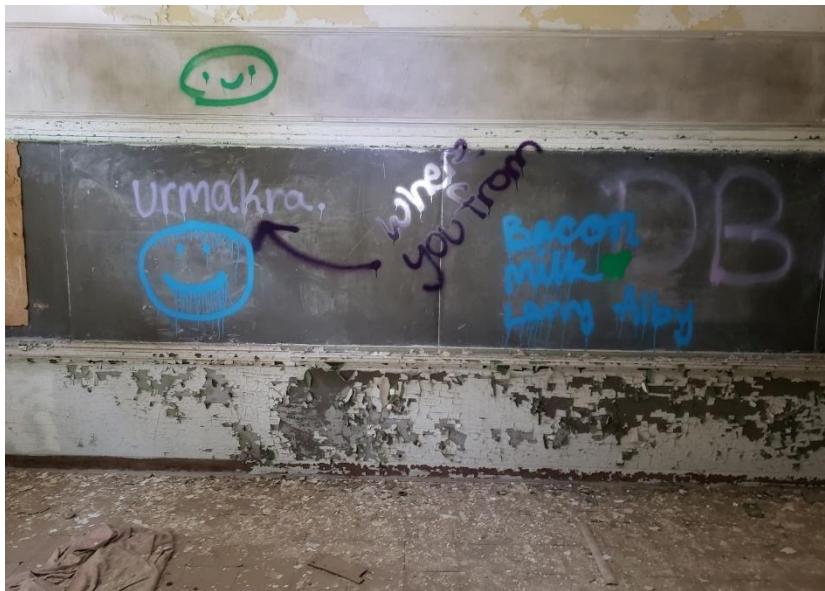
Client: Missouri Department of Natural Resources	Description: Photograph of the lower portion of the north wall in Room 26 that was positive for LBP.	Photograph Number: 37
Direction: NA	Photographer: Lynn Parman	Date: 10/12/2021

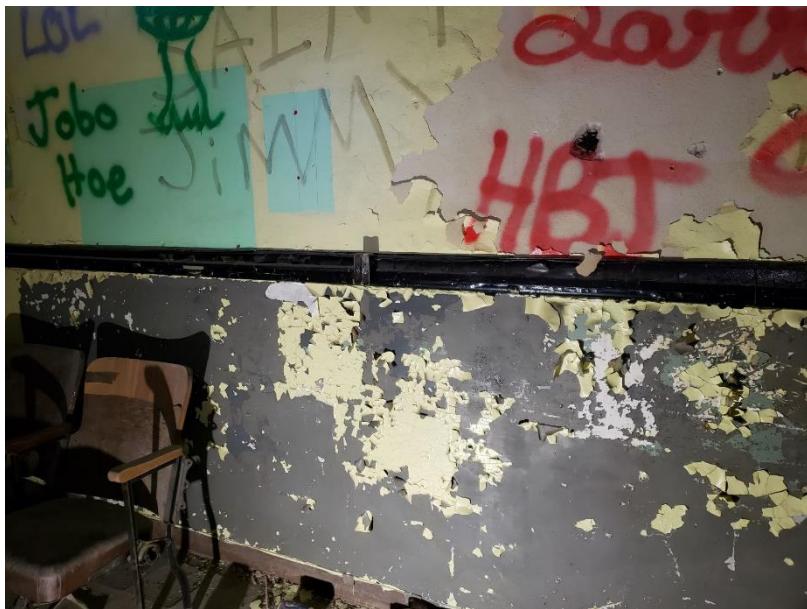
Client: Missouri Department of Natural Resources	Description: Photograph of the lower portion of the west wall in Room 27 that was positive for LBP.	Photograph Number: 38
Direction: NA	Photographer: Lynn Parman	Date: 10/12/2021

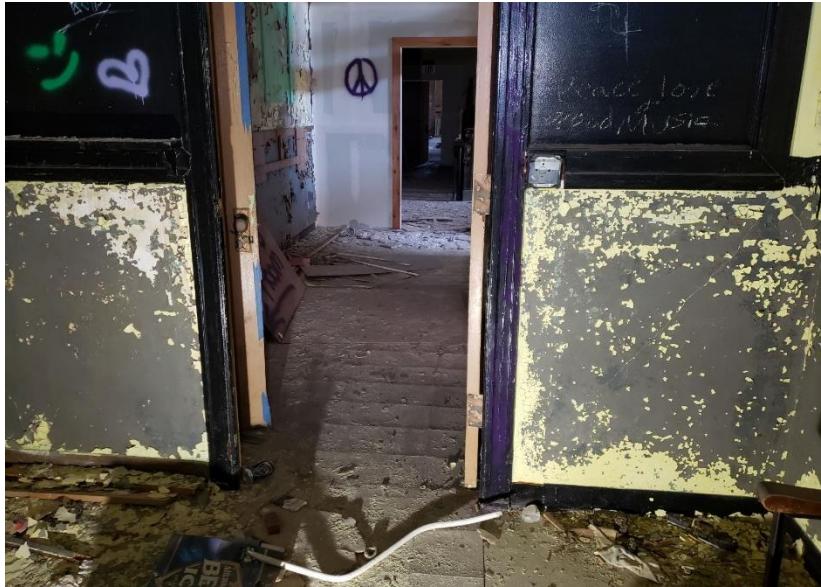
Client: Missouri Department of Natural Resources	Description: Photograph of the lower portion of the north wall in Room 27 that was positive for LBP.	Photograph Number: 39
Direction: NA	Photographer: Lynn Parman	Date: 10/12/2021

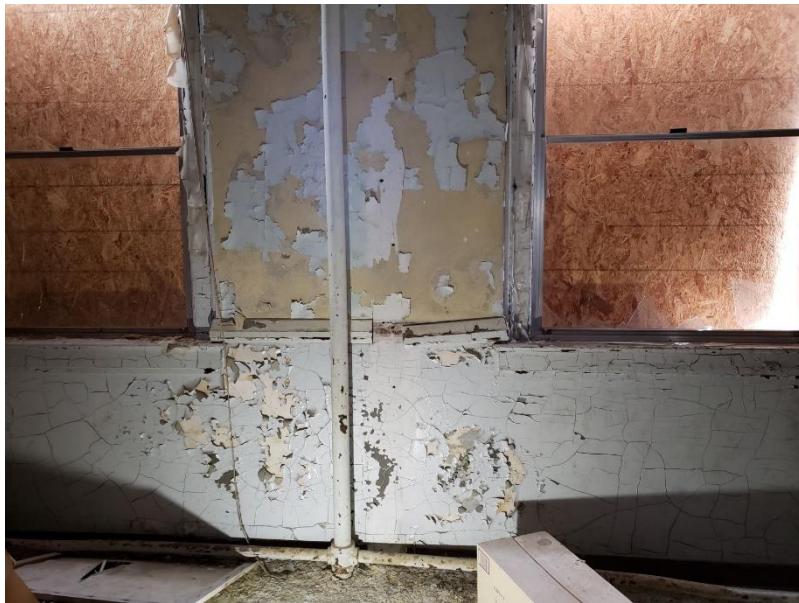
Client: Missouri Department of Natural Resources	Description: Photograph of the lower portion of the east wall in Room 28 that was positive for LBP.	Photograph Number: 40
Direction: NA	Photographer: Lynn Parman	Date: 10/12/2021

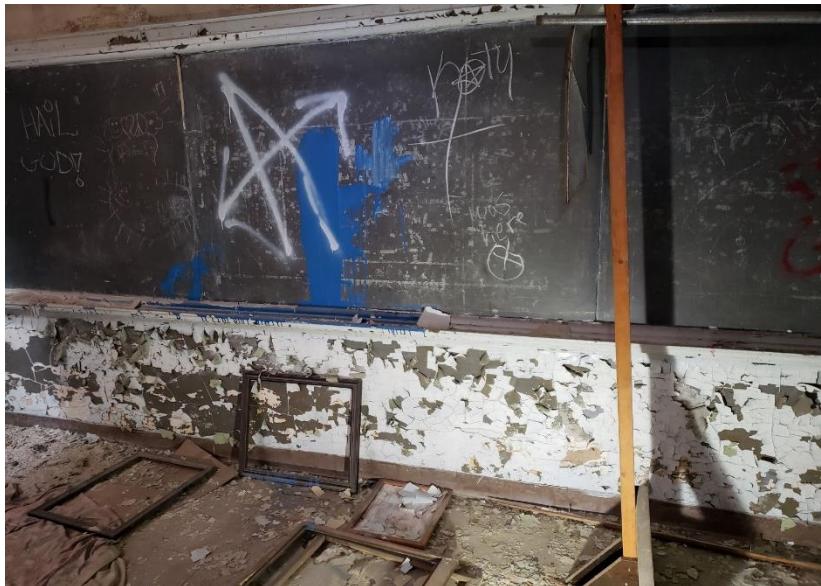
Client: Missouri Department of Natural Resources	Description: Photograph of the lower portion of the south wall in Room 28 that was positive for LBP.	Photograph Number: 41
Direction: NA	Photographer: Lynn Parman	Date: 10/12/2021

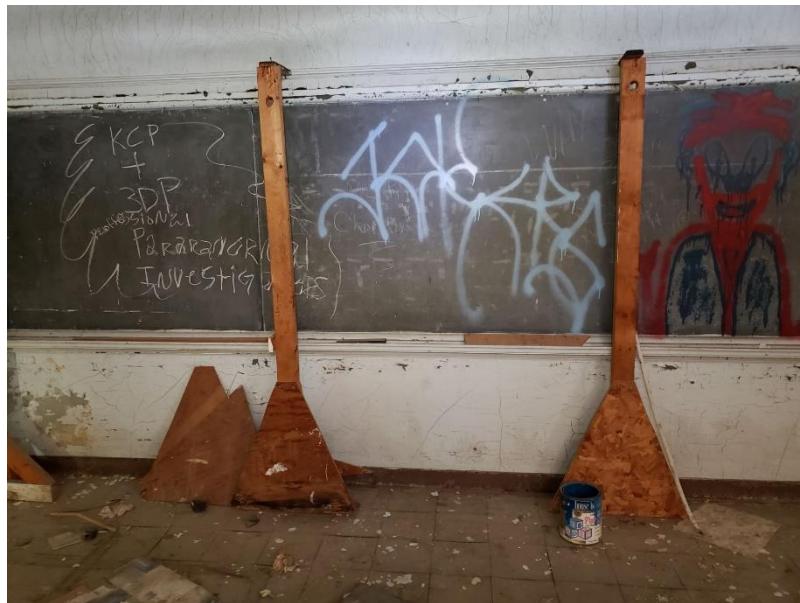
Client: Missouri Department of Natural Resources	Description: Photograph of the lower portion of the west wall in Room 28 that was positive for LBP.	Photograph Number: 42
Direction: NA	Photographer: Lynn Parman	Date: 10/12/2021

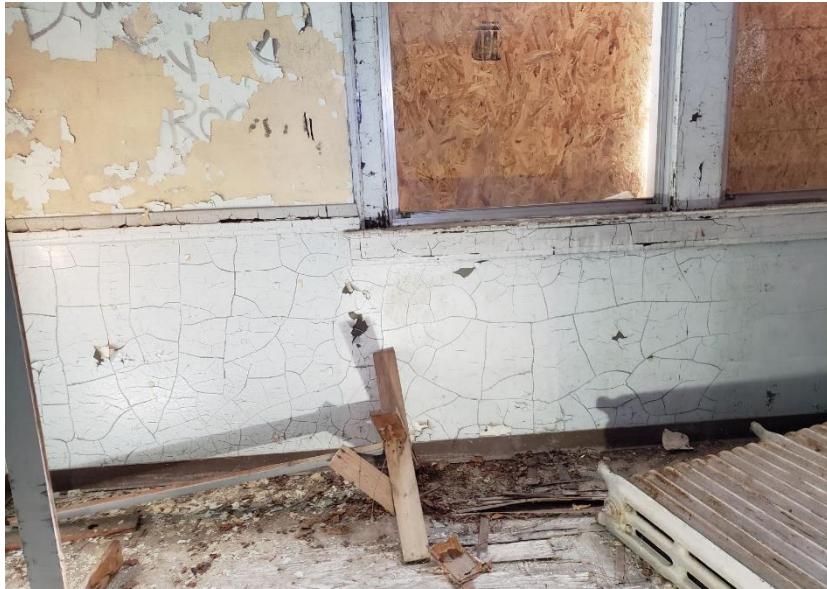
Client: Missouri Department of Natural Resources	Description: Photograph of the lower portion of the east wall in Room 29 that was positive for LBP.	Photograph Number: 43
Direction: NA	Photographer: Lynn Parman	Date: 10/12/2021

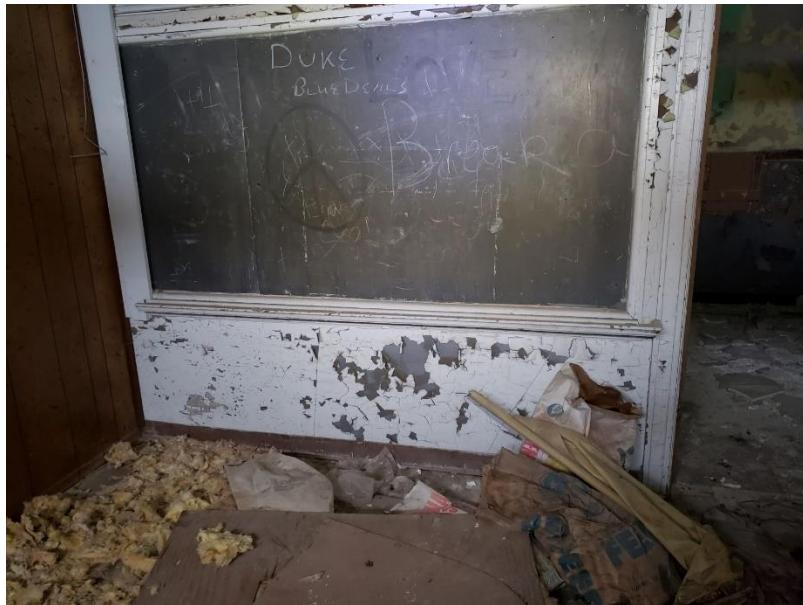
Client: Missouri Department of Natural Resources	Description: Photograph of the lower portion of the west wall in Room 29 that was positive for LBP.	Photograph Number: 44
Direction: NA	Photographer: Lynn Parman	Date: 10/12/2021

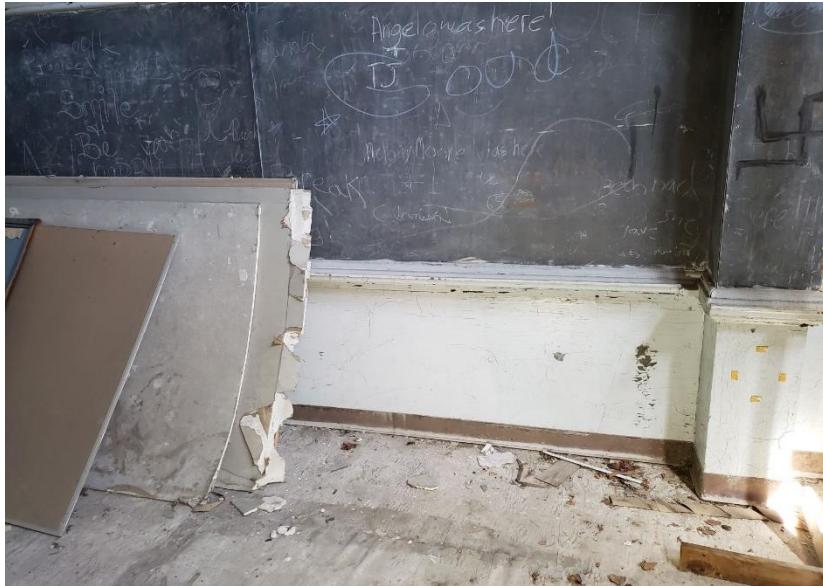
Client: Missouri Department of Natural Resources	Description: Photograph of the lower portion of the north wall in Room 29 that was positive for LBP.	Photograph Number: 45
Direction: NA	Photographer: Lynn Parman	Date: 10/12/2021

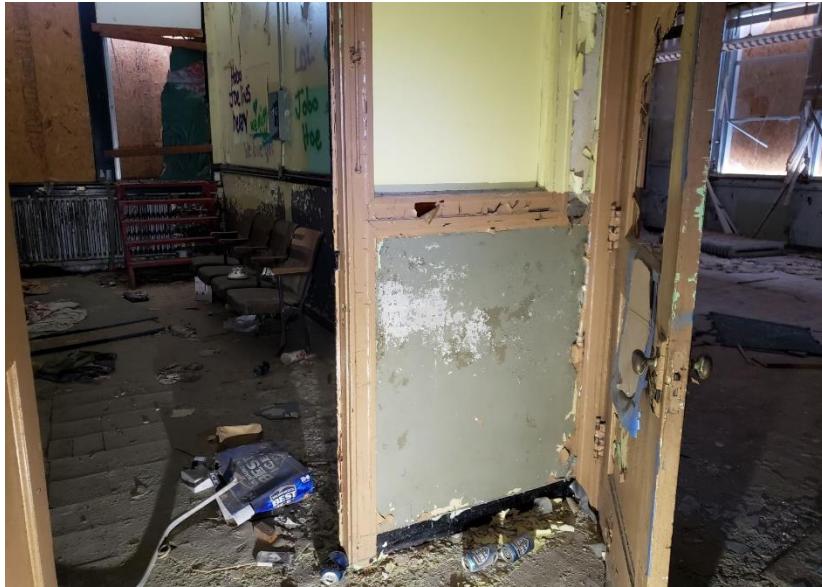
Client: Missouri Department of Natural Resources	Description: Photograph of the lower portion of the south wall in Room 30 that was positive for LBP.	Photograph Number: 47
Direction: NA	Photographer: Lynn Parman	Date: 10/12/2021

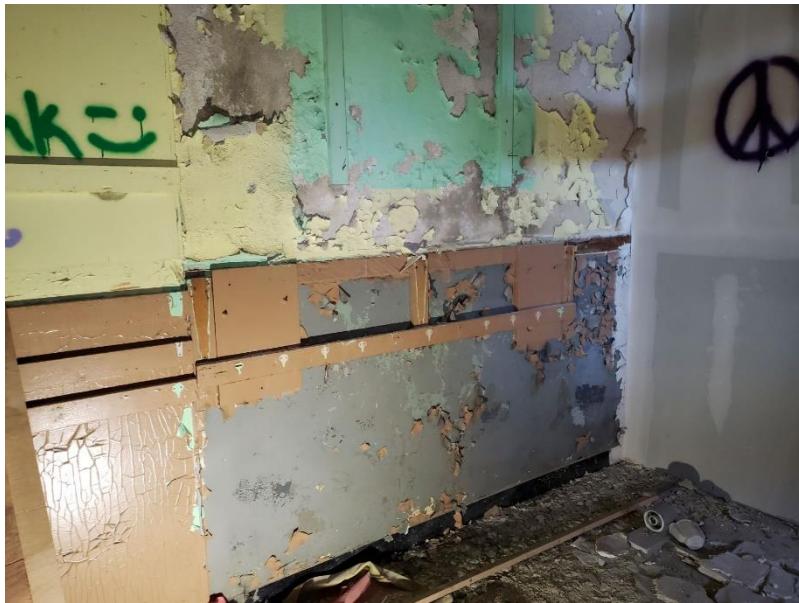
Client: Missouri Department of Natural Resources	Description: Photograph of the lower portion of the west wall in Room 30 that was positive for LBP.	Photograph Number: 48
Direction: NA	Photographer: Lynn Parman	Date: 10/12/2021

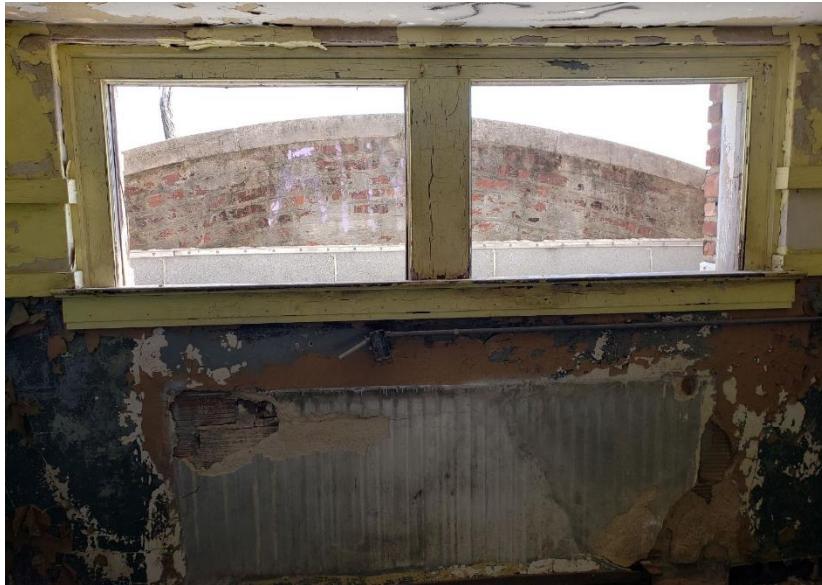
Client: Missouri Department of Natural Resources	Description: Photograph of the lower portion of the east wall and a window frame in Room 31 that were positive for LBP.	Photograph Number: 49
Direction: NA	Photographer: Lynn Parman	Date: 10/12/2021

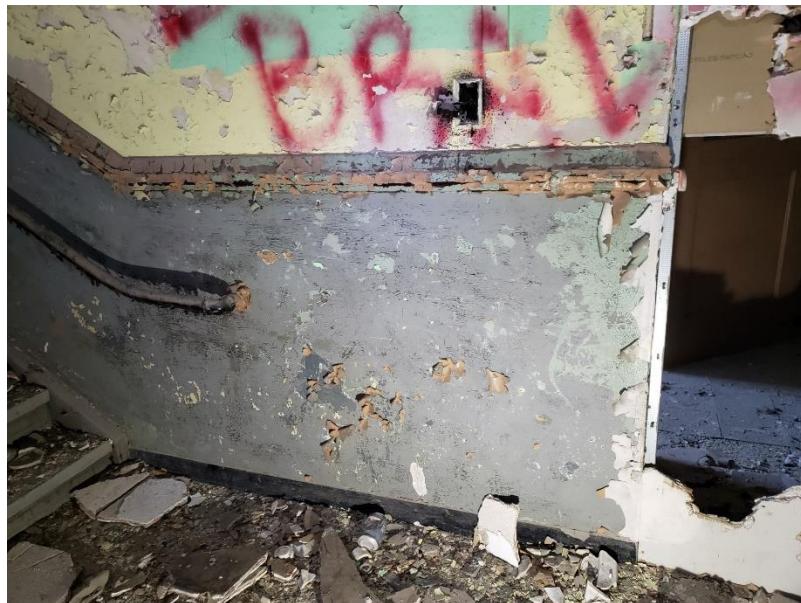
Client: Missouri Department of Natural Resources	Description: Photograph of the lower portion of the south wall in Room 31 that was positive for LBP.	Photograph Number: 50
Direction: NA	Photographer: Lynn Parman	Date: 10/12/2021

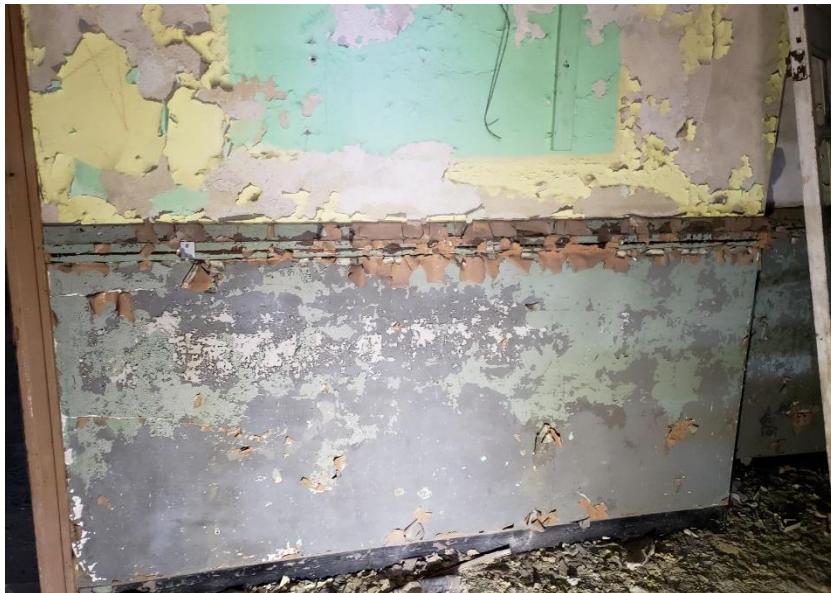
Client: Missouri Department of Natural Resources	Description: Photograph of the lower portion of the west wall in Room 31 that was positive for LBP.	Photograph Number: 51
Direction: NA	Photographer: Lynn Parman	Date: 10/12/2021

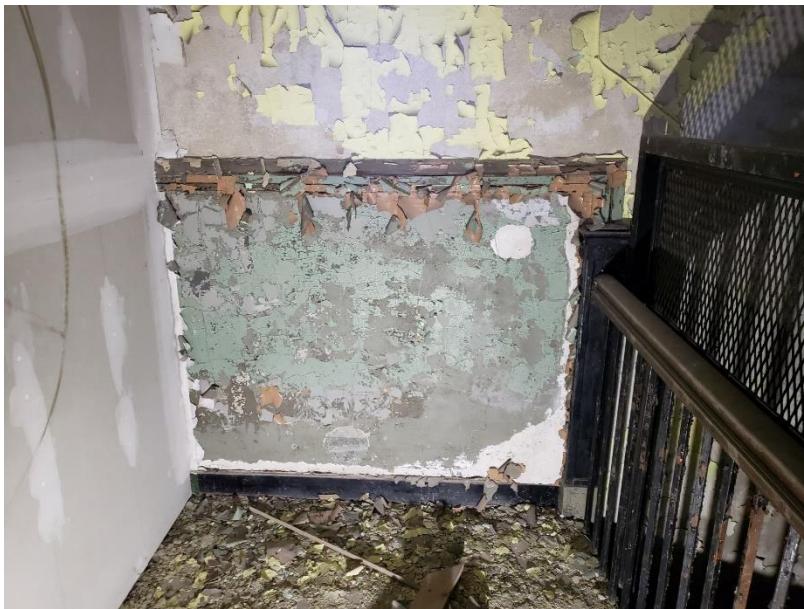
Client: Missouri Department of Natural Resources	Description: Photograph of the lower portion of the east wall in Room 32 that was positive for LBP.	Photograph Number: 52
Direction: NA	Photographer: Lynn Parman	Date: 10/12/2021

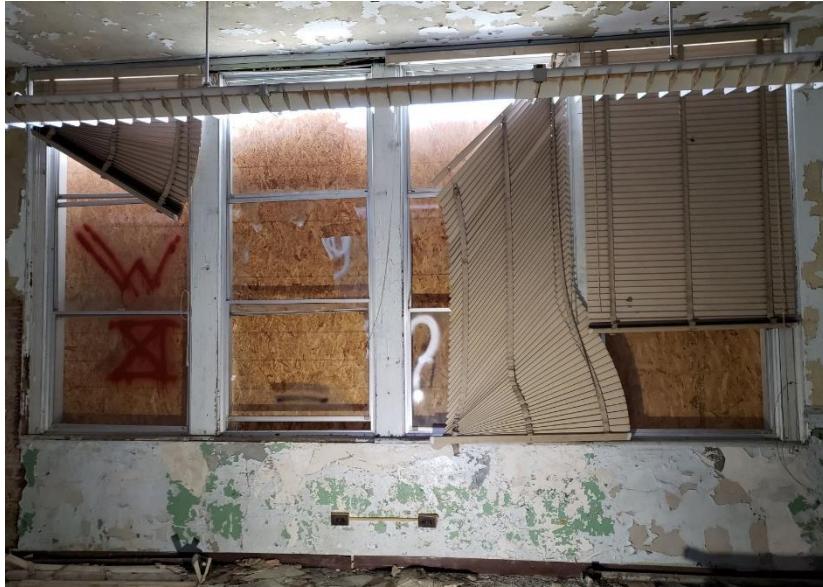
Client: Missouri Department of Natural Resources	Description: Photograph of window frames on the east wall in Room 33 that were positive for LBP.	Photograph Number: 53
Direction: NA	Photographer: Lynn Parman	Date: 10/12/2021

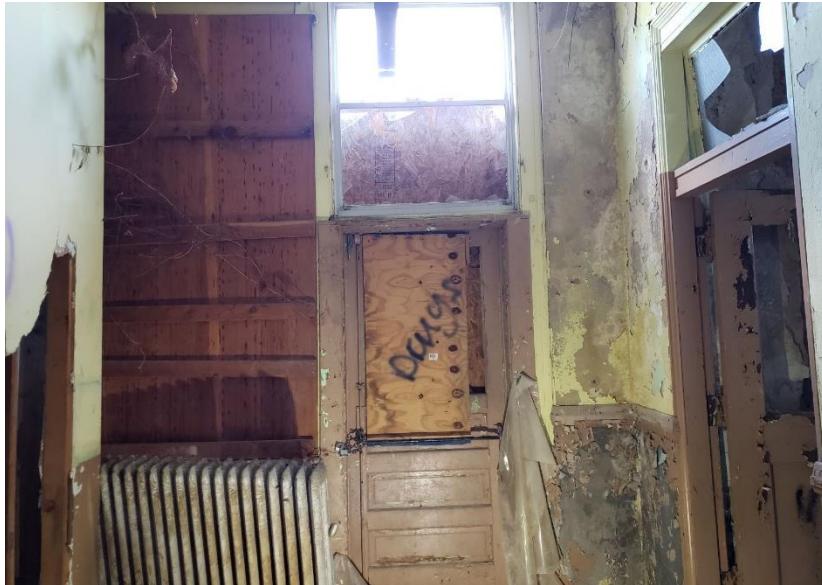
Client: Missouri Department of Natural Resources	Description: Photograph of a window frame above an exterior door on the north wall in Room 34 that was positive for LBP.	Photograph Number: 55
Direction: NA	Photographer: Lynn Parman	Date: 10/12/2021

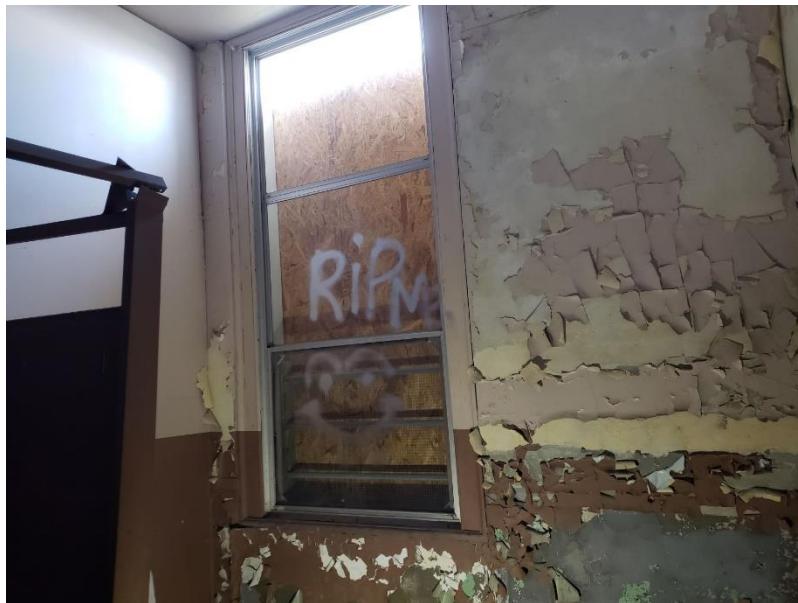
Client: Missouri Department of Natural Resources	Description: Photograph of a window frame on the east wall in Room 35 that was positive for LBP.	Photograph Number: 56
Direction: NA	Photographer: Lynn Parman	Date: 10/12/2021

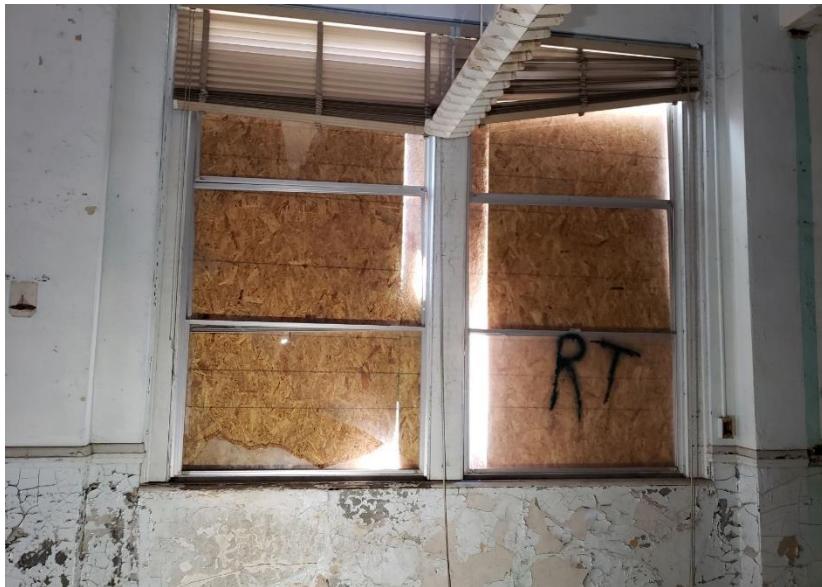
Client: Missouri Department of Natural Resources	Description: Photograph of window frames on the west wall in Room 36 that were positive for LBP.	Photograph Number: 57
Direction: NA	Photographer: Lynn Parman	Date: 10/12/2021
