**Subject: Asbestos-Containing Materials and Lead-Based Paint Inspection Report  
Former Wyman High School Site, Excelsior Springs, Missouri  
Missouri Environmental Assessment Services Contract, Contract No. CS210096002  
Vendor No. 48120656000**

**ASBESTOS-CONTAINING MATERIALS AND LEAD-BASED PAINT INSPECTION**

**FORMER WYMAN HIGH SCHOOL SITE  
EXCELSIOR SPRINGS, MISSOURI**

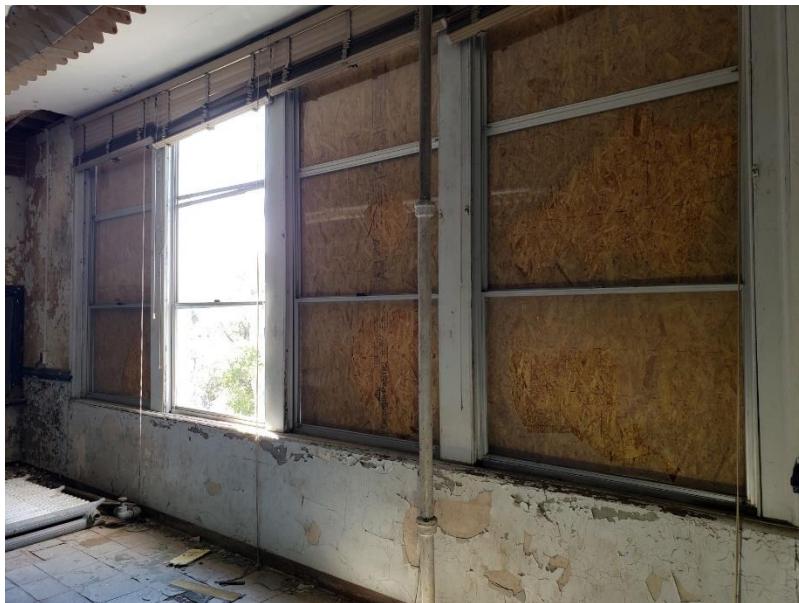
Client: Missouri Department of Natural Resources	Description: Photograph of window frames on the west wall in Room 37 that were positive for LBP.	Photograph Number: 58
Direction: NA	Photographer: Lynn Parman	Date: 10/12/2021

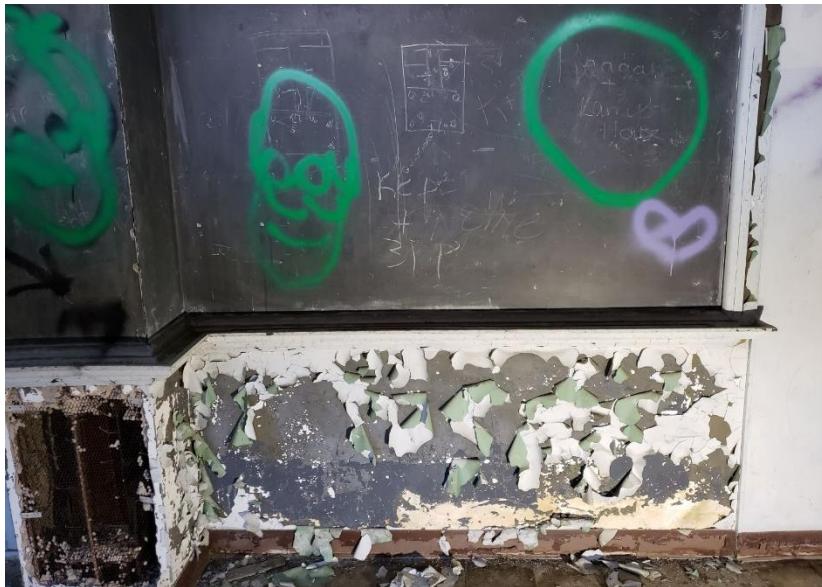
Client: Missouri Department of Natural Resources	Description: Photograph of the lower portion of the east wall in Room 38 that was positive for LBP.	Photograph Number: 59
Direction: NA	Photographer: Lynn Parman	Date: 10/12/2021

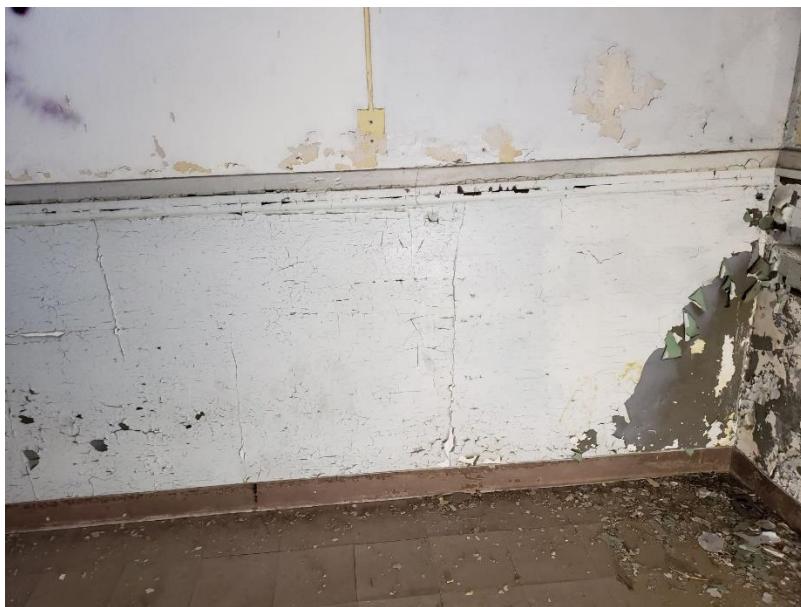
Client: Missouri Department of Natural Resources	Description: Photograph of the lower portion of the south wall in Room 38 that was positive for LBP.	Photograph Number: 60
Direction: NA	Photographer: Lynn Parman	Date: 10/12/2021
