Architectural Significance and Preservation Treatment Zones

Statement of Significance

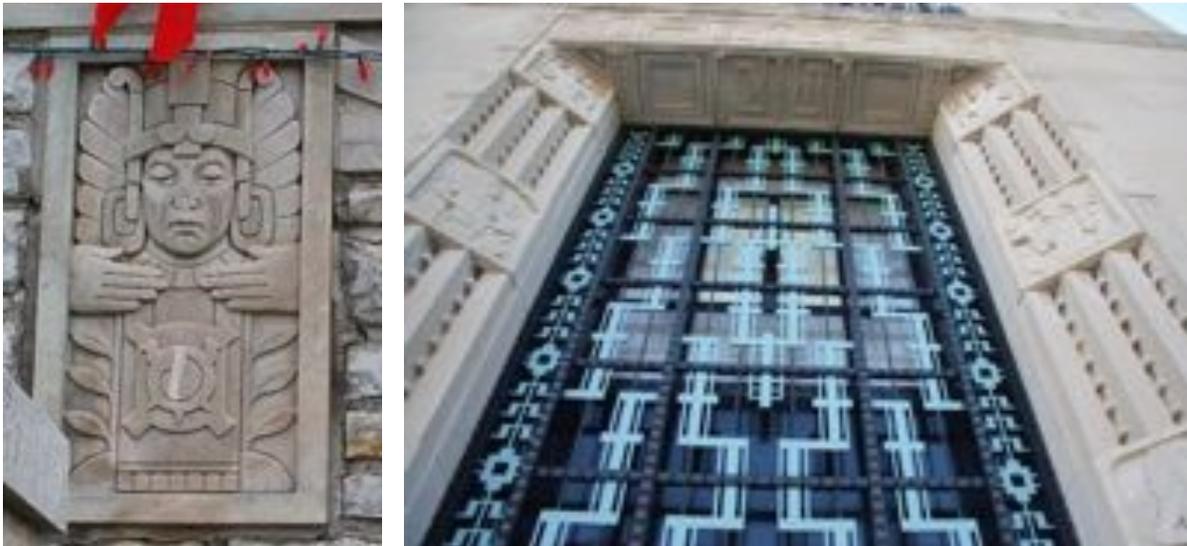
Fig. 16 & 17 Left: Carved limestone detail. Right: Carved limestone and metal screen at main entrance on west elevation. (SRJA 2012)

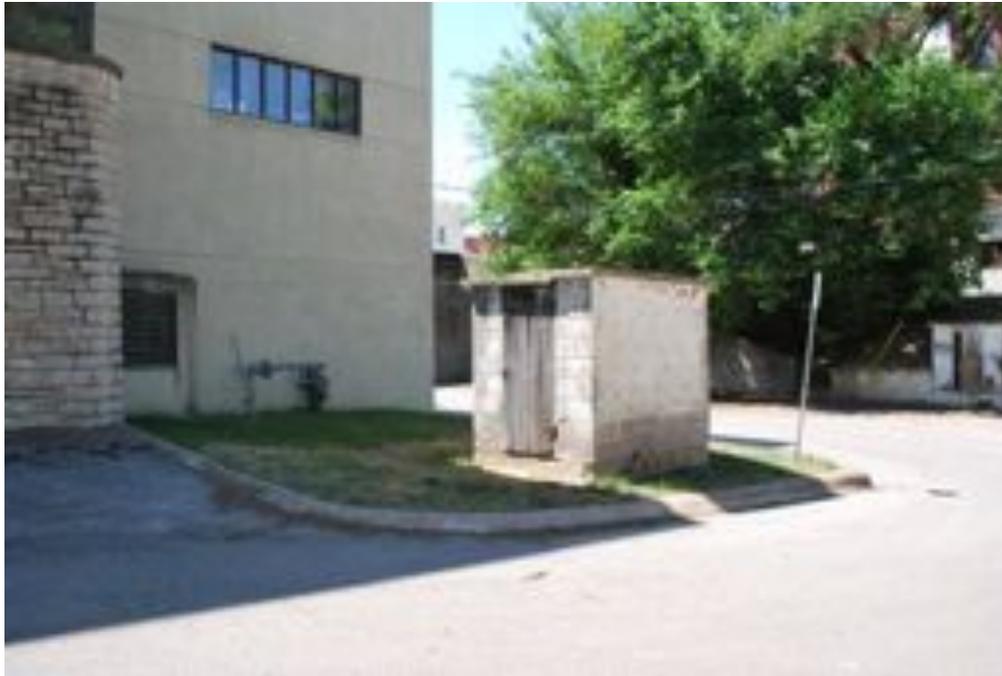
Fig. 18 View of pump house building located on the east of the building. (SRJA 2012)

There is one other known mineral water well on the site located just east of the building in a small pump house. The original name of this well is unknown at this time. Another pump house is built into the retaining wall and appears to be on the site just north of the parking lot. More research should be undertaken in order to verify the history of these structures.

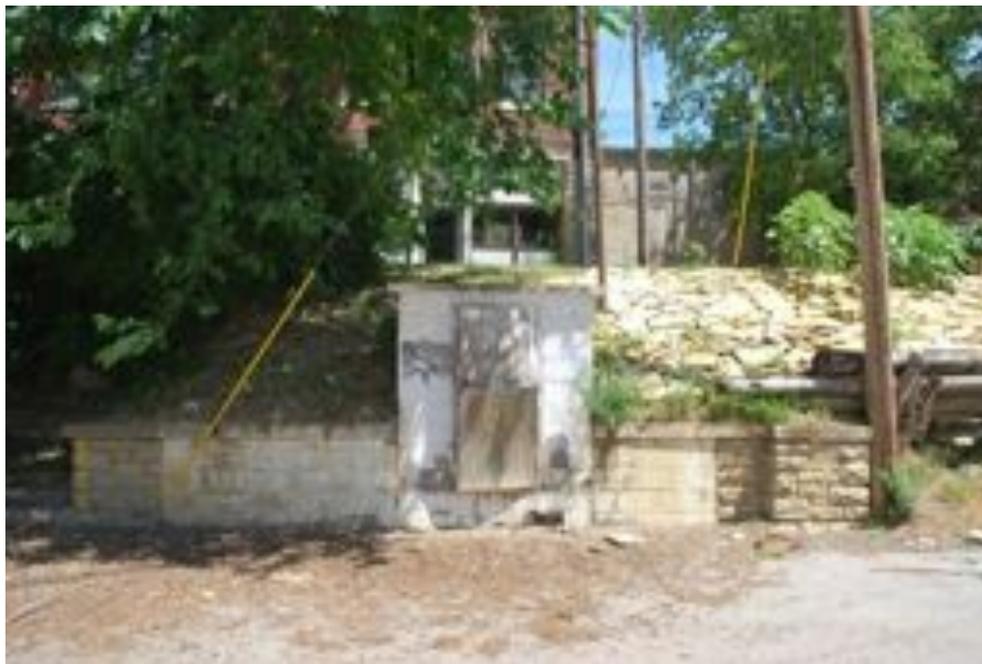
Fig. 19 View of a pump house building located to the north of the parking lot built into the retaining wall. (SRJA 2012)

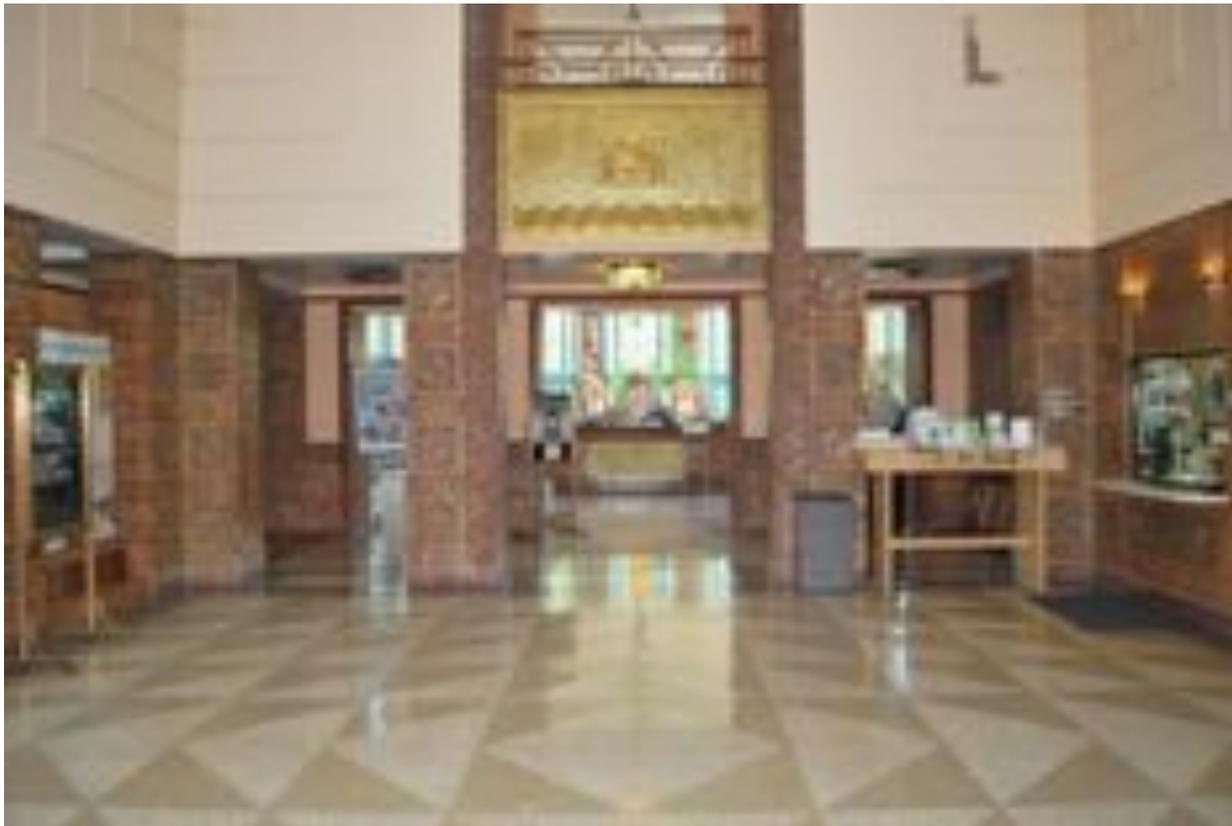
Fig. 28 View of the First Floor lobby looking south to the Hall of Springs. (SRJA 2012)

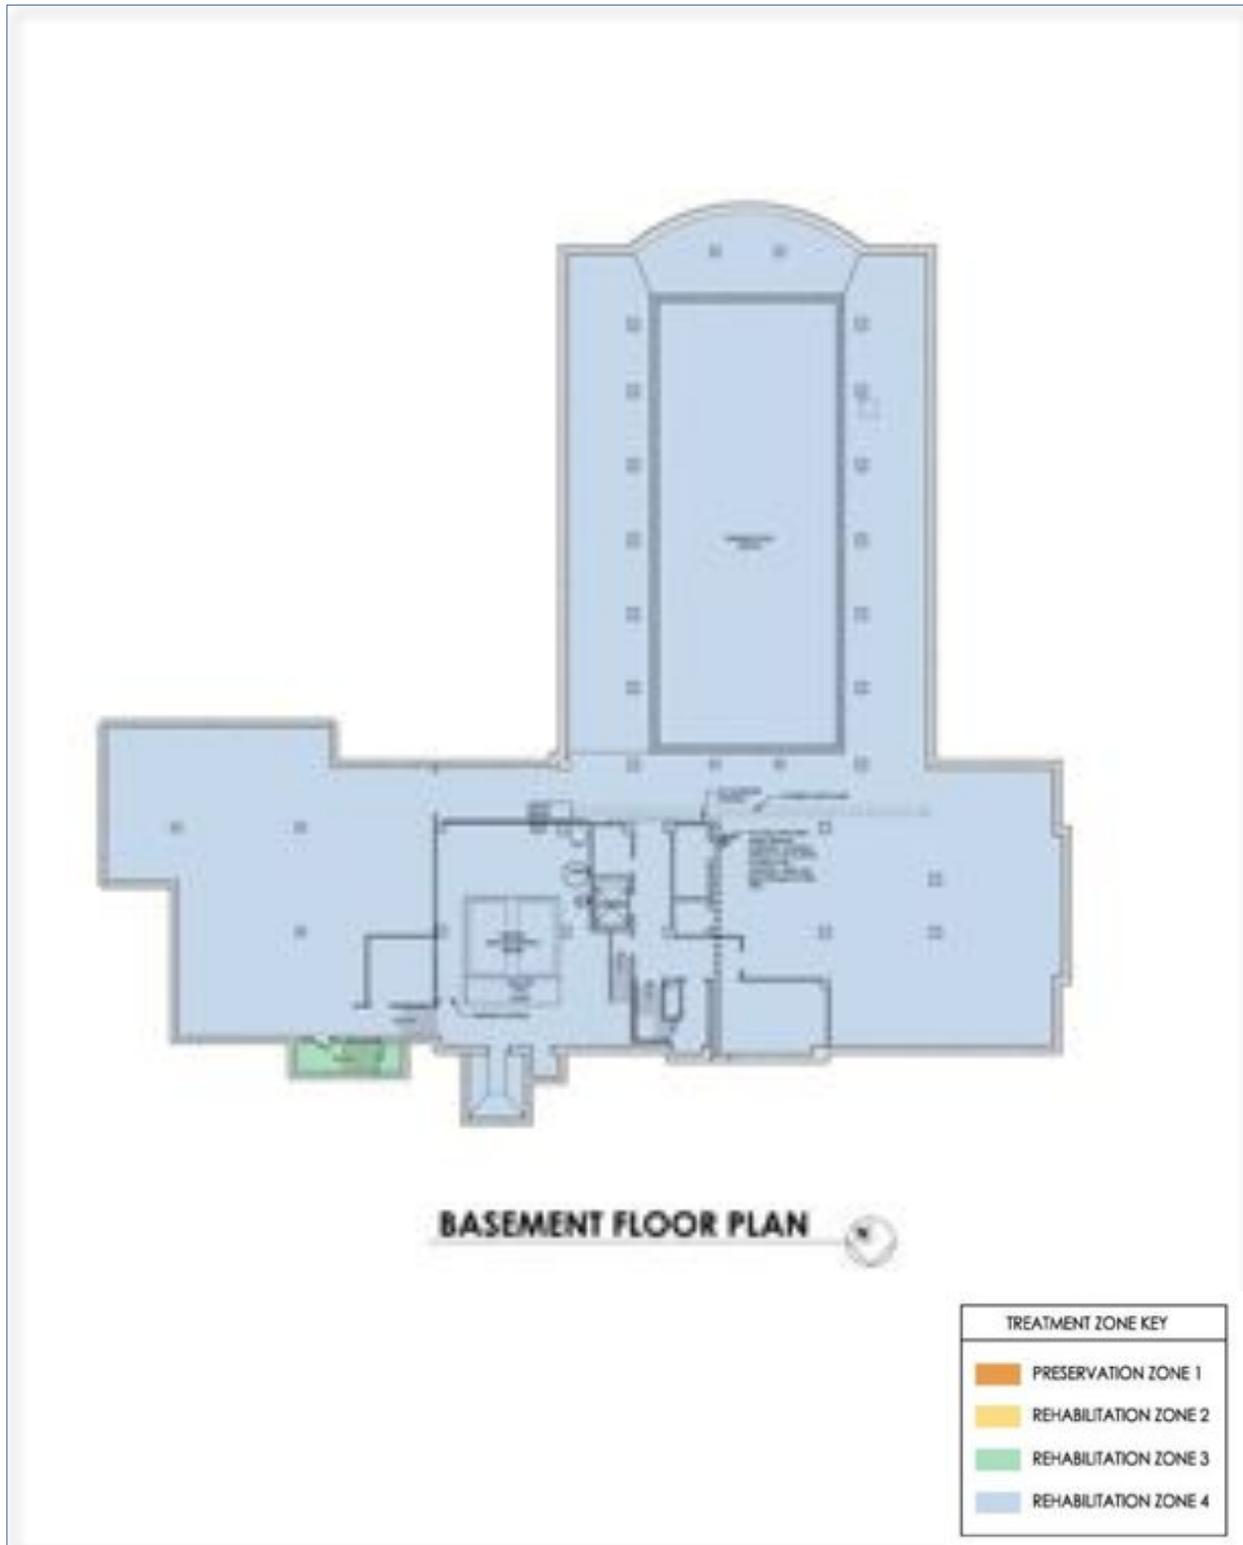
Fig. 29 Preservation Treatment Zone Diagram – Basement Floor Plan (SRJA 2013)

The basement floor level, which originally contained the sub-basement boiler pit and mechanical equipment and storage, is all considered to be tertiary space. The only exception to this treatment is the basement entrance stair, which is visible from the exterior of the building along the north exterior wall. This stair is considered to be of secondary importance.

For the purposes of this report, the treatment selected for the site and building will be 'Rehabilitation'. The site and building have been divided into different zones in order to understand and identify the level of historic significance and integrity of individual spaces. These zones are identified on the following Treatment Zone Diagrams (Figures 29 through 35) and are colored accordingly.

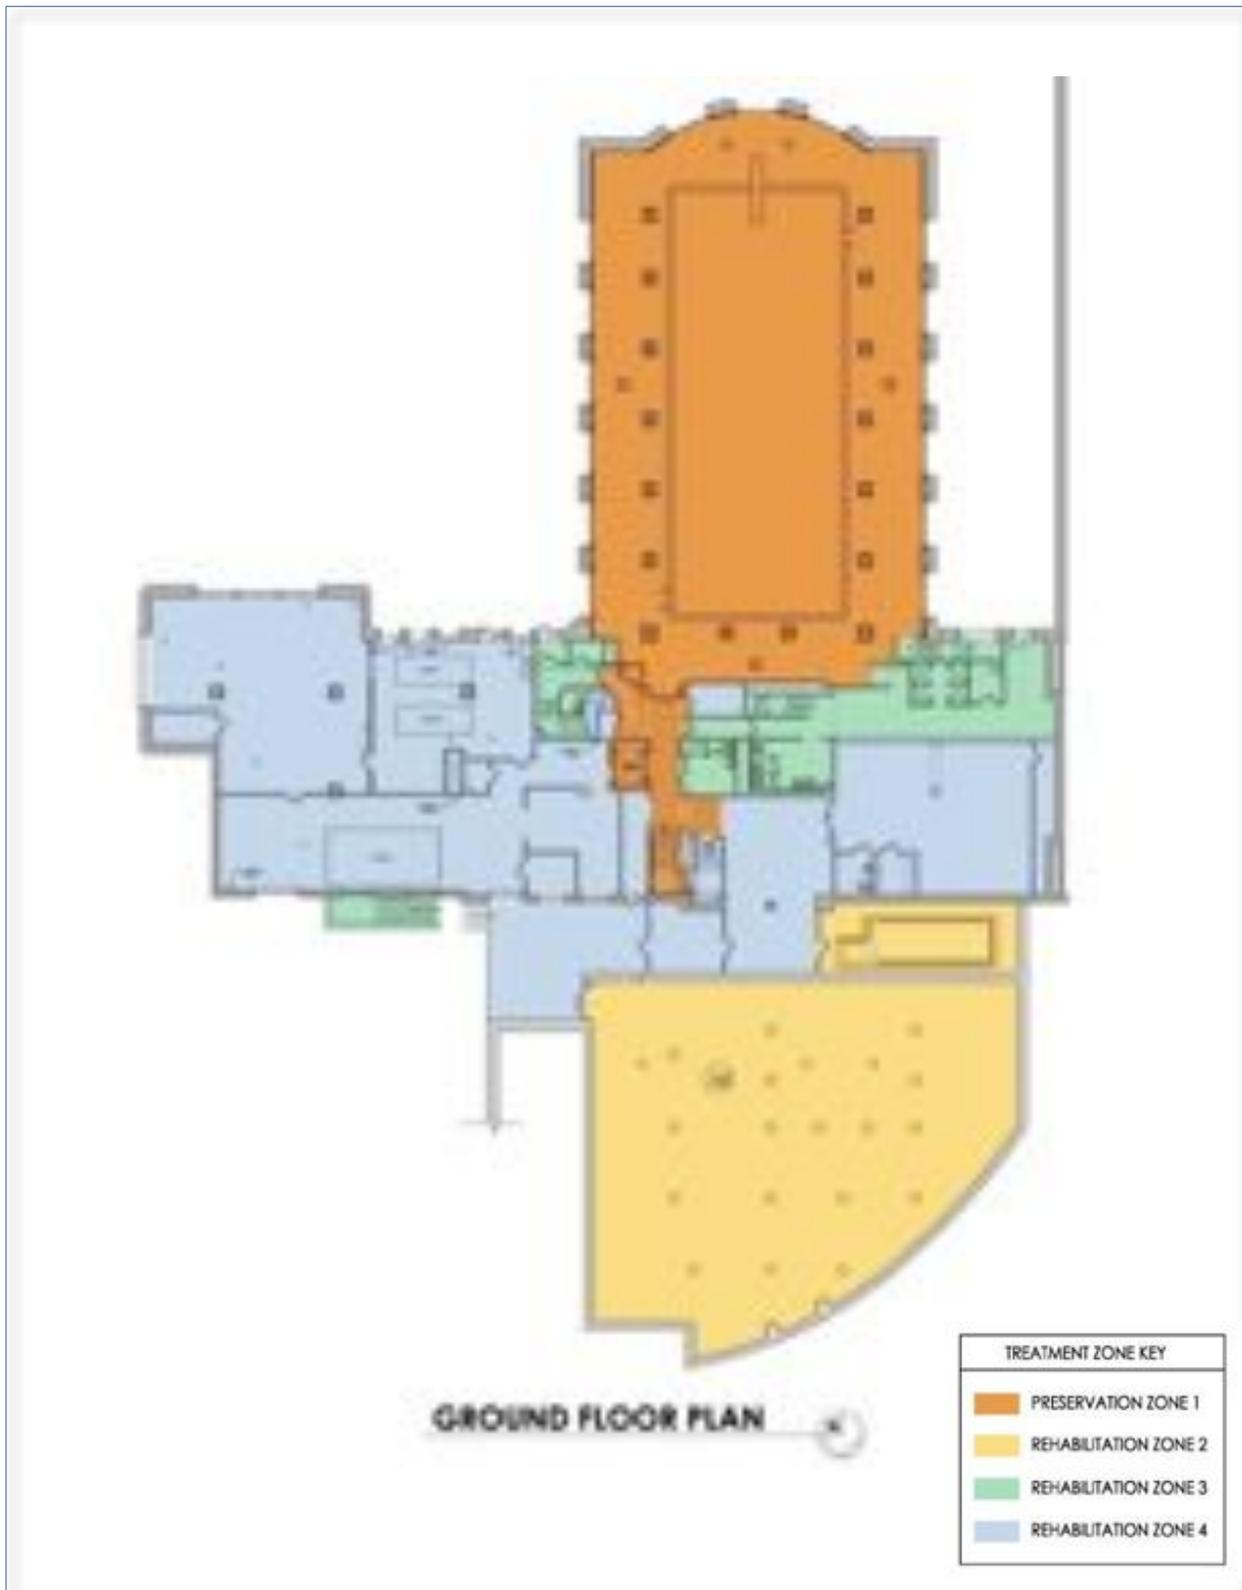
Fig. 30 Preservation Treatment Zone Diagram – Ground Floor Plan (SRJA 2013)

The ground floor contains the two-story indoor pool and adjacent space. This area projects to the south of the main building and is surrounded by windows on three sides. The pool and the main circulation corridor to the pool are considered to be primary spaces. The locker rooms and support spaces are considered to be secondary. Much of the ground floor is considered to be tertiary, as a number of changes to the original historic fabric have been made in these areas. For instance, the original bottling facility now accommodates indoor parking, the boiler room and ancillary mechanical spaces. Many employees use this level to access parking lot at the rear of the building. The original well pump room located under the north courtyard and the smaller therapy pool are also considered to be primary spaces, but of less importance than the larger main pool space, so they are identified as a Rehabilitation Zone rather than a Preservation Zone.

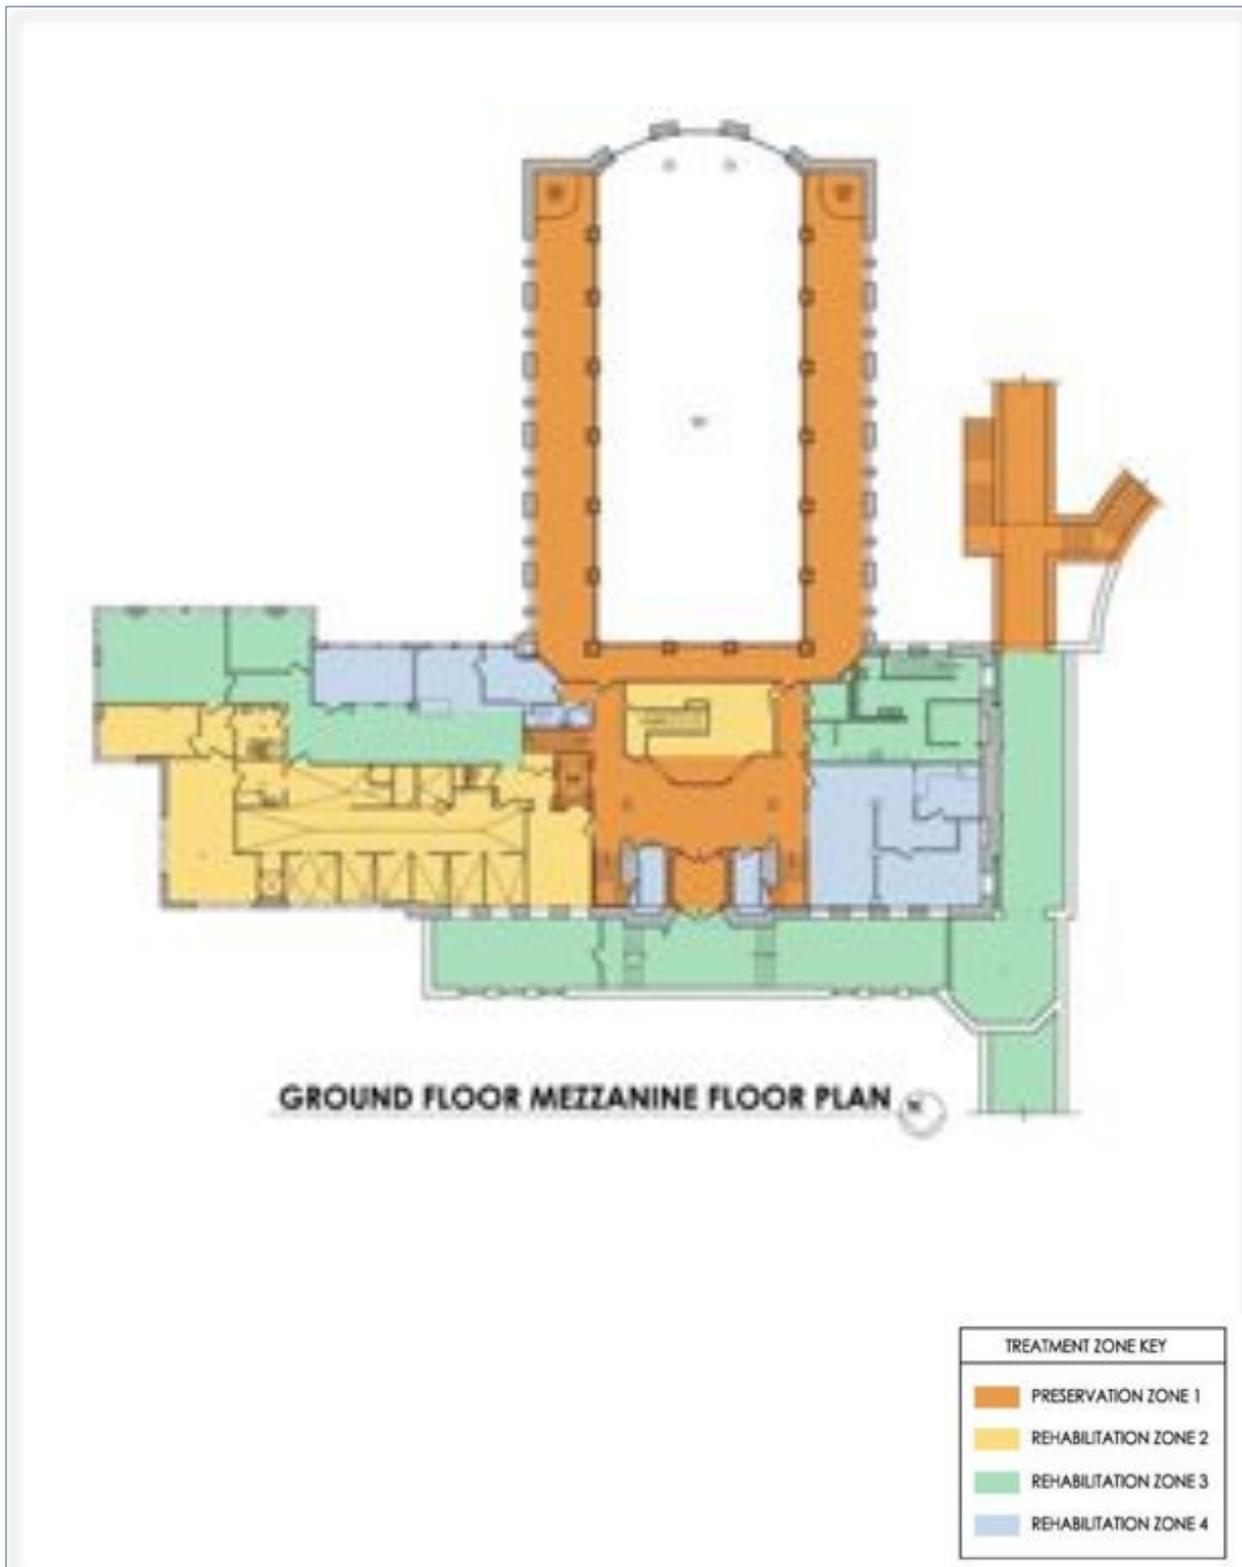
Fig. 31 Preservation Treatment Zone Diagram – Ground Floor Mezzanine Plan (SRJA 2013)

The ground floor mezzanine level is directly above the first floor. This level contains the mezzanine which surrounds and overlooks three sides of the indoor pool. The mezzanine and circulation to the mezzanine are all considered to be primary spaces. There are also original locker rooms, the pool check-in desk, original spa spaces and city offices located on this level. Some interior modifications have occurred in several spaces and therefore, there is a combination of primary, secondary and tertiary spaces. Access to the spaces below the upper entrance terraces is also at this level. This was once open circulation which was able to be accessed by the general public, but this space had been in-filled and is now considered to be secondary.

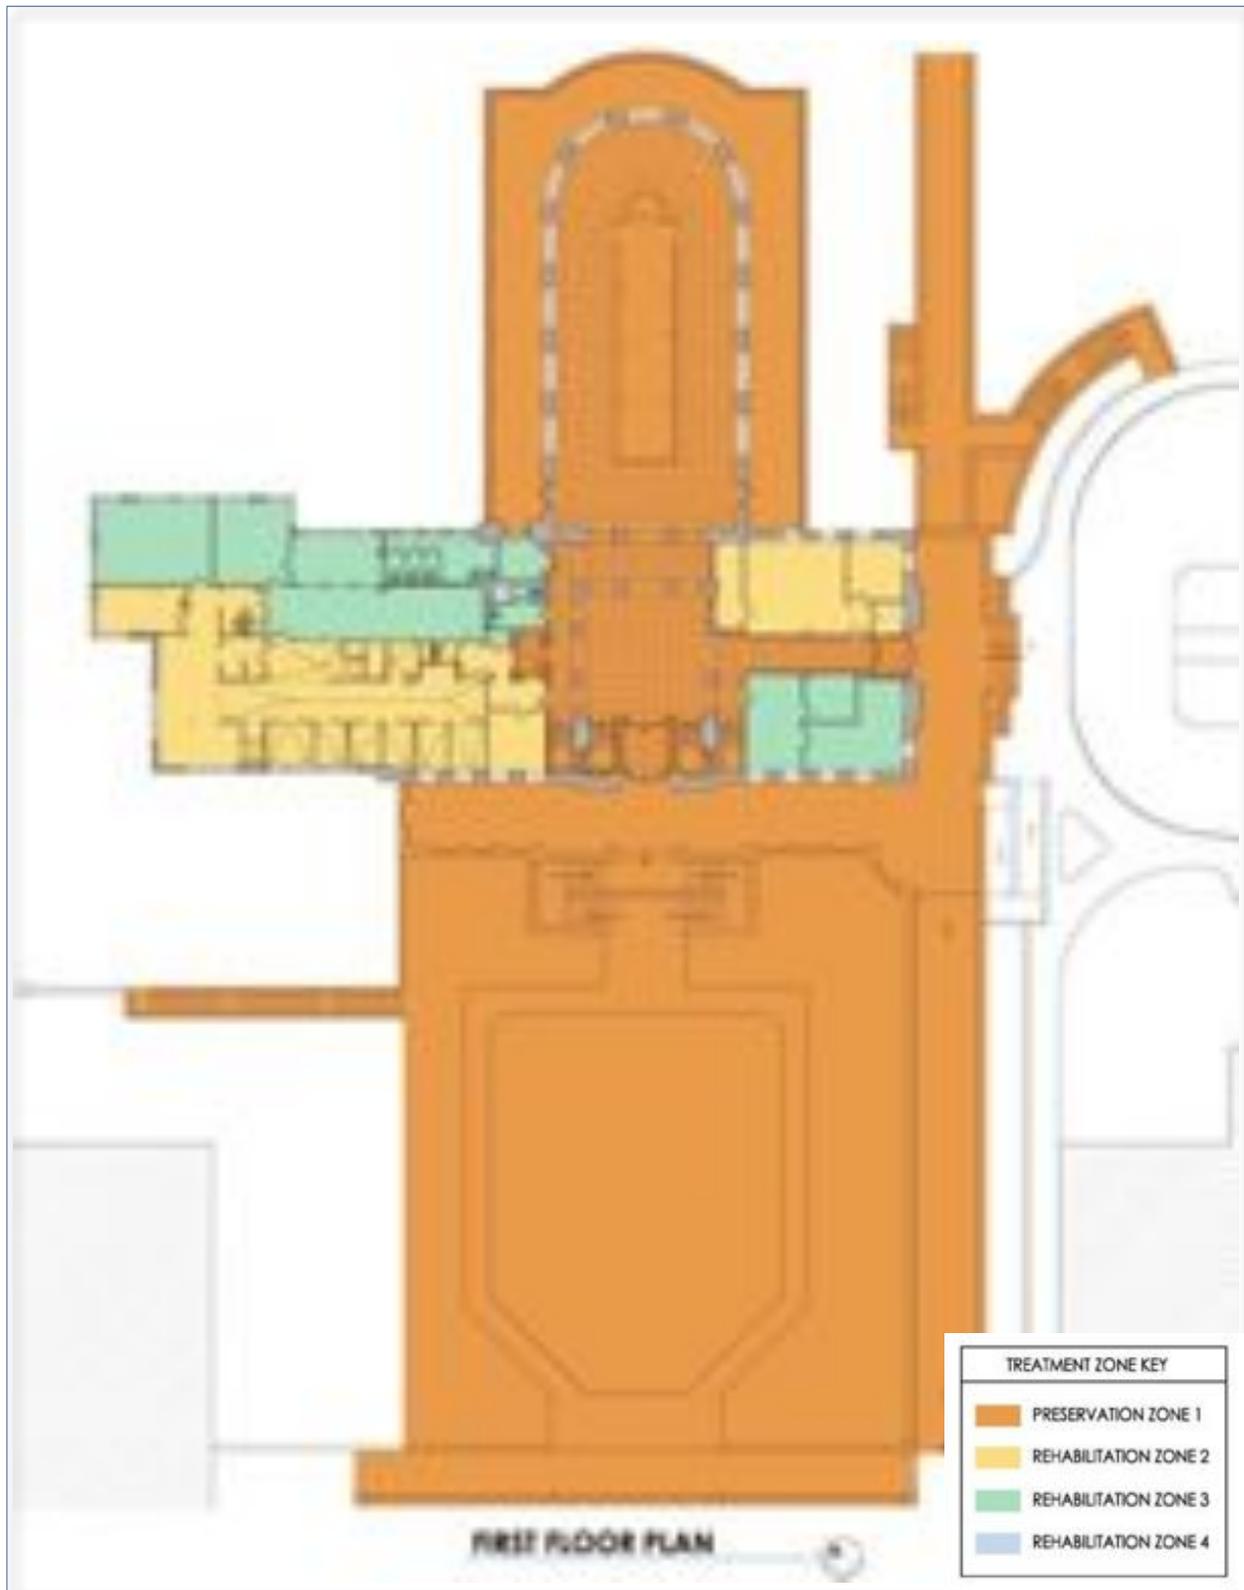
Fig. 32 Preservation Treatment Zone Diagram – First Floor Plan (SRJA 2013)

The first floor serves as the primary entrance into the building for use by the general public. The voluminous entrance hall and the Hall of Springs are hugely significant spaces and retain a large amount of original historic finishes. These are considered to be primary spaces. The west portion of the first floor contains city offices with only some of the original floor plan remaining. The east portion of the first floor contains restrooms (in-filled in the original sun porch), city offices and the original women's spa. These rooms are all secondary spaces.

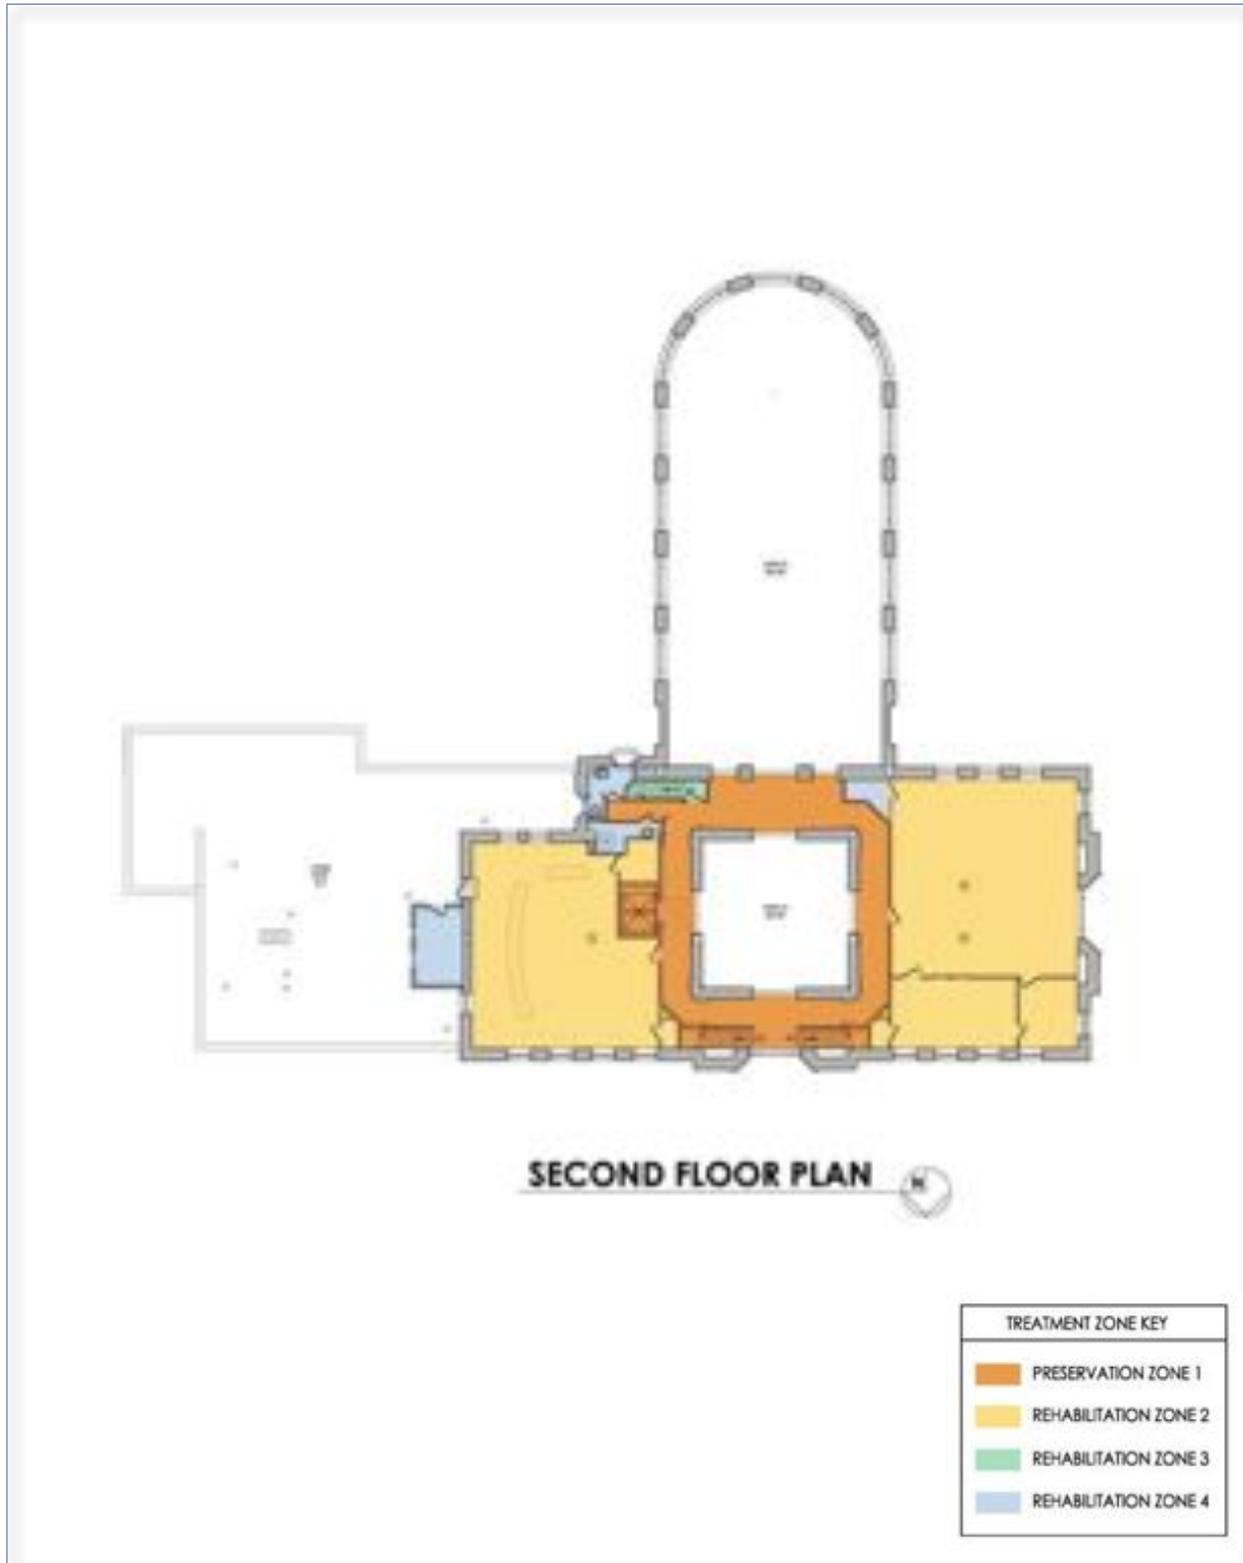
Fig. 33 Preservation Treatment Zone Diagram – Second Floor Plan (SRJA 2013)

The second floor contains a mezzanine overlooking the entrance lobby. The City Council Chambers are on located on the east side of the floor and the Circuit Court is located on the west side. A majority of the second floor is considered to be comprised of primary spaces, though only the mezzanine space is specifically identified as a Preservation Zone.

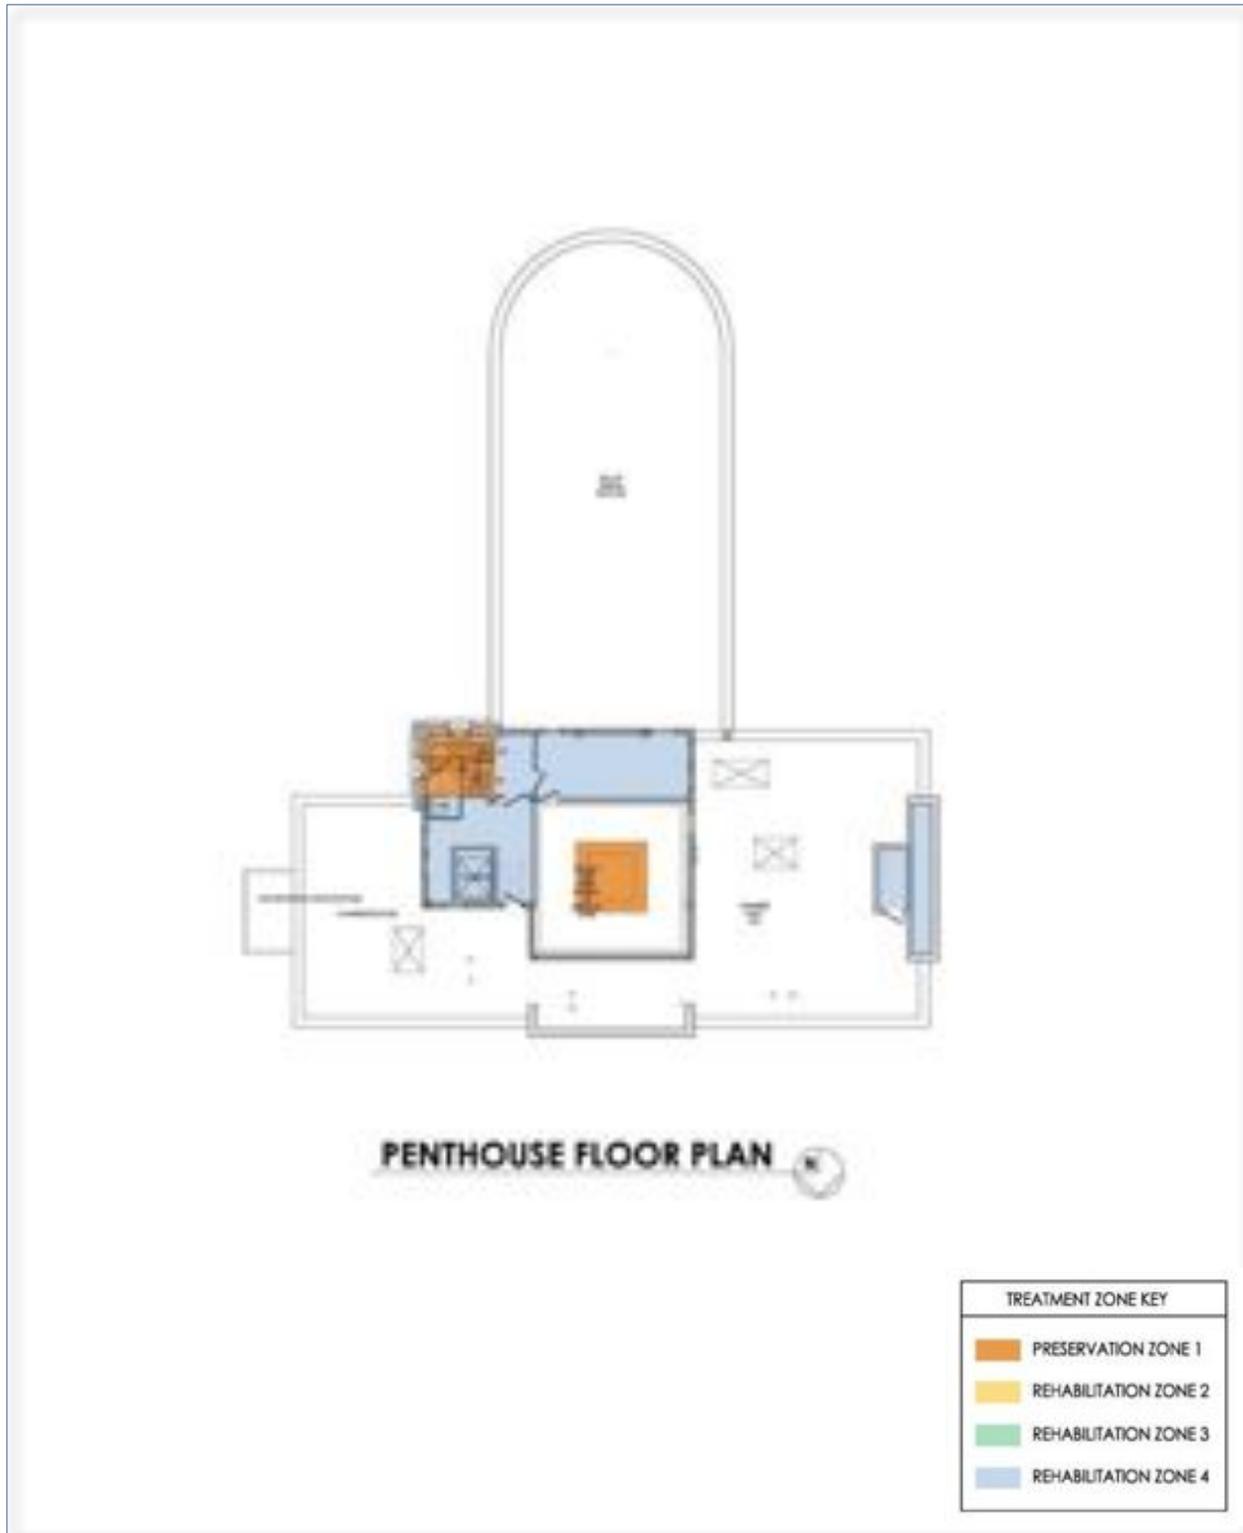
Fig. 34 Preservation Treatment Zone Diagram – Penthouse Floor Plan (SRJA 2013)

The upper levels contain the tower, elevator penthouse and mechanical access spaces. The tower is considered to be a significant feature of the overall building.

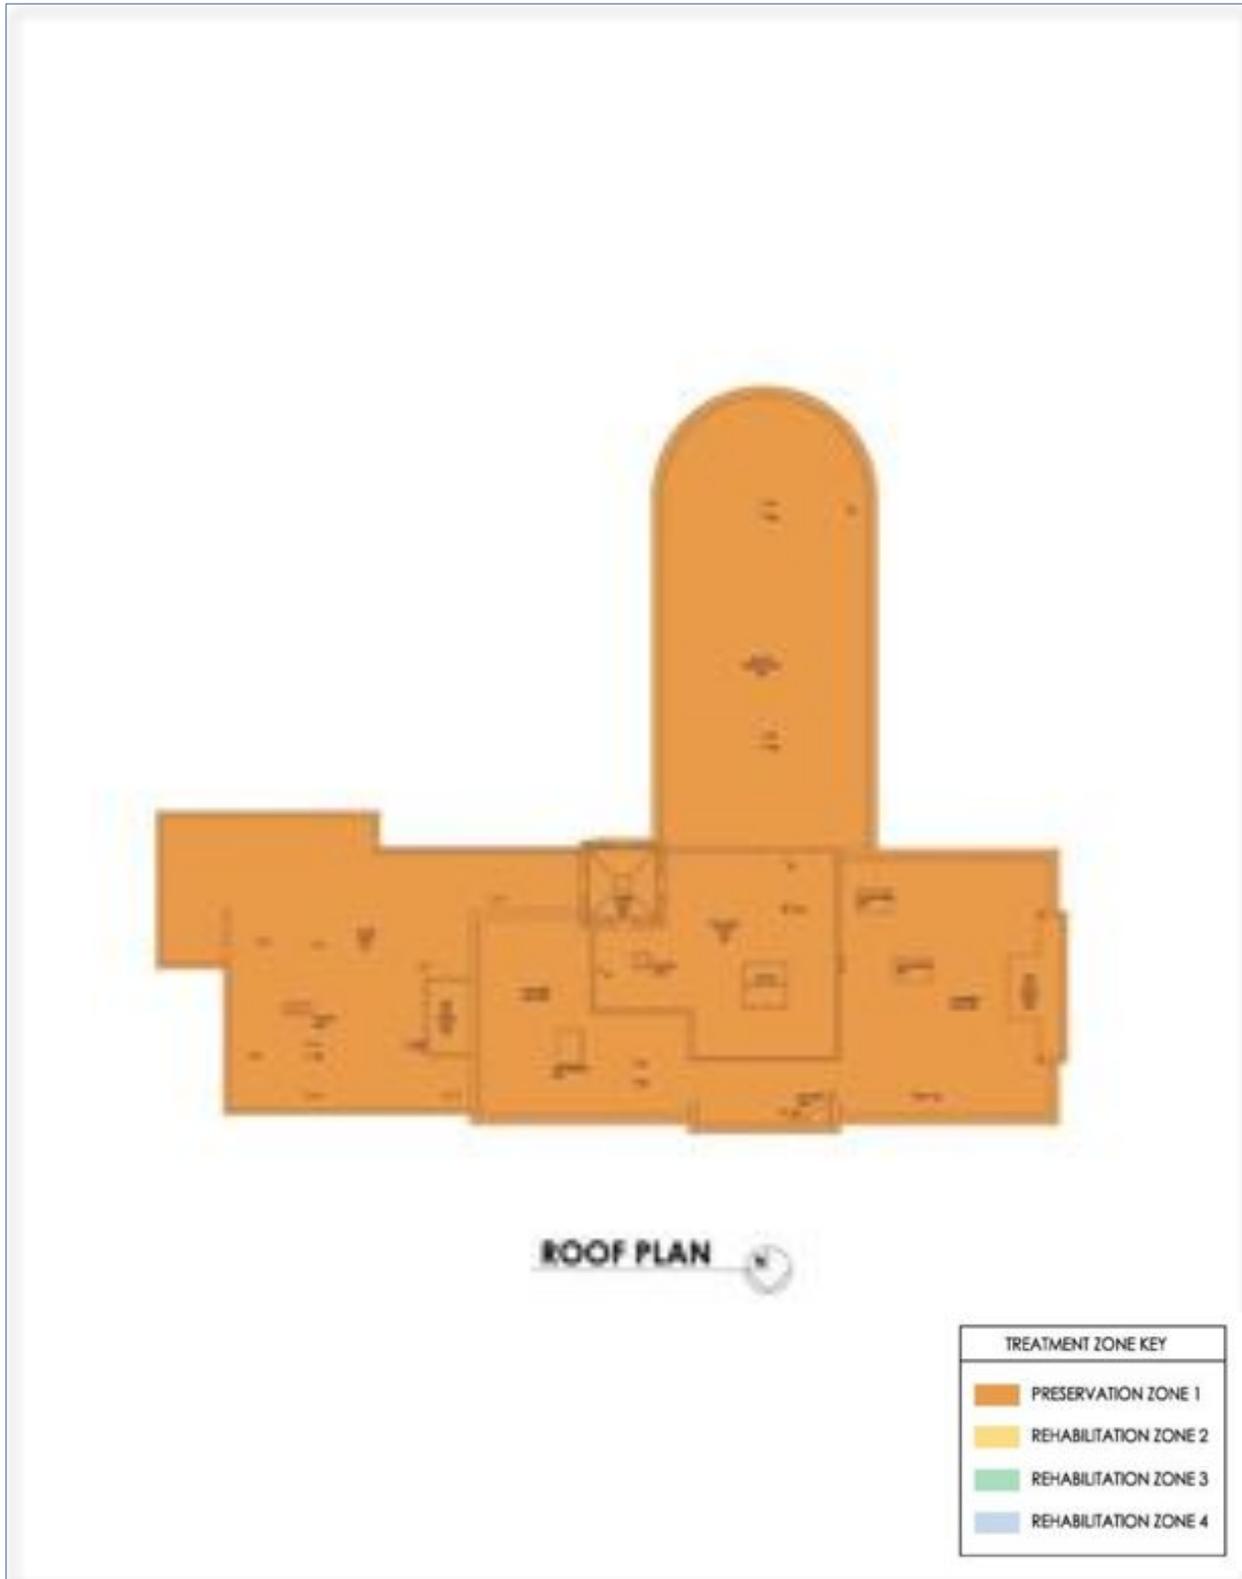
Fig. 35 Preservation Treatment Zone Diagram – Roof Plan (SRJA 2013)

The roofs are considered to be primary spaces, in that their flat designs are a component of the original Art Deco design.
