## Existing Conditions and Recommendations

### Civil and Site

Historic Hall of Waters  
 Assessment and Feasibility Study

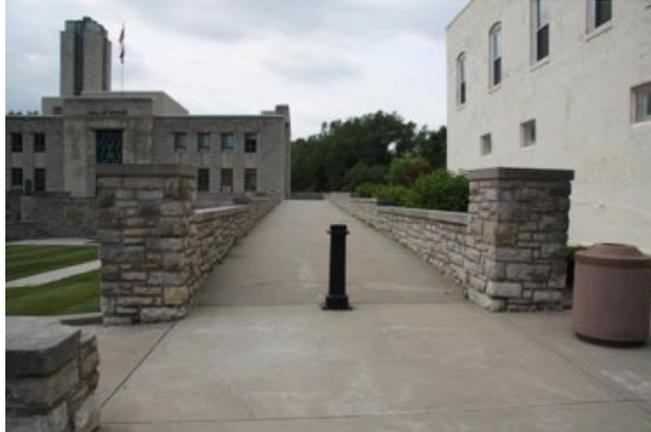
Fig. 49 North Ramp from Broadway Street

The north ramp is original to the construction of the Hall of Waters and is therefore a significant historic feature. The ramp extends from Broadway Street approximately 110 feet and lands at the intersection of the North and West Terraces. The ramp slopes gradually, though it has not been evaluated to verify it meets current ADA slope requirements, which is 1:12 grade, or 1" of rise per 12" of travel distance. The ramp is in fair condition. The side walls are constructed of pitched stone and are topped with capstones. The stone walls are very long and do not contain any expansion joints. The walls both tend to slope outwards slightly towards the tops of the wall, especially near the middle of the length of the wall. The walls also bow slightly. The walkway surface is concrete that is in fair to poor condition. The thickness of the concrete slab is unknown at this time. The upper North and West Terraces were found, during a previous

study, to have had multiple layers of concrete poured on top. These additional concrete toppers led engineers to determine that the structural system of the terraces were approximately 50% over capacity. At the top of the ramp, as it intersects the North and West Terraces, the concrete was approximately 16" thick total. It is unknown what the original top elevation of the concrete was, but it was likely at least 4"-5" below its present height. This additional concrete weight on the foundation, coupled with the fact that there is no expansion joint along the ramp edges, has likely led to the bowing and sloping walls. Further investigation is warranted in order to determine the best solution for future ramp repairs, which may include removing some of the topping concrete down to its original height, in order to reduce weight.

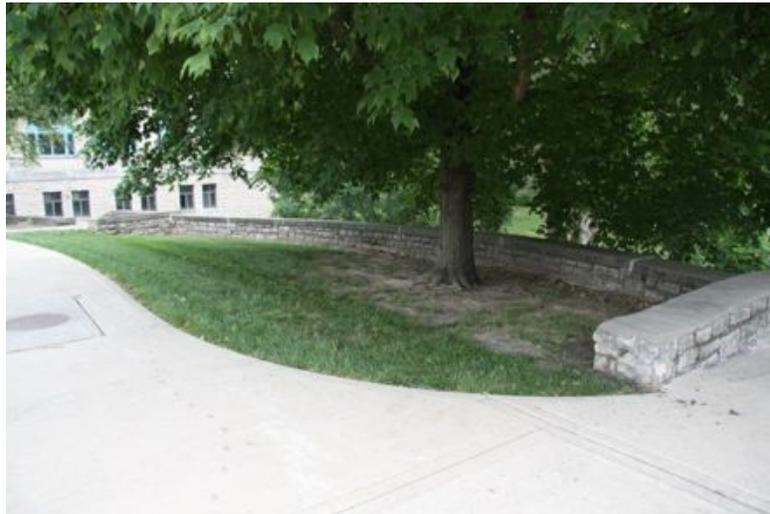
Fig. 59 Stone Retaining Wall West of Building (SKDG 2012)

Additional stone site walls, stairs and features not specifically discussed above occur throughout the site. These features are as important to the overall historic cultural landscape as some of the more major features. These include stone retaining walls and stairs to the west of the main building, paving surrounding the lower level at the Hall of Springs and the well pump house located to the east of the building.
