Building Foundation and Structure

Overview

Interior Structural Conditions

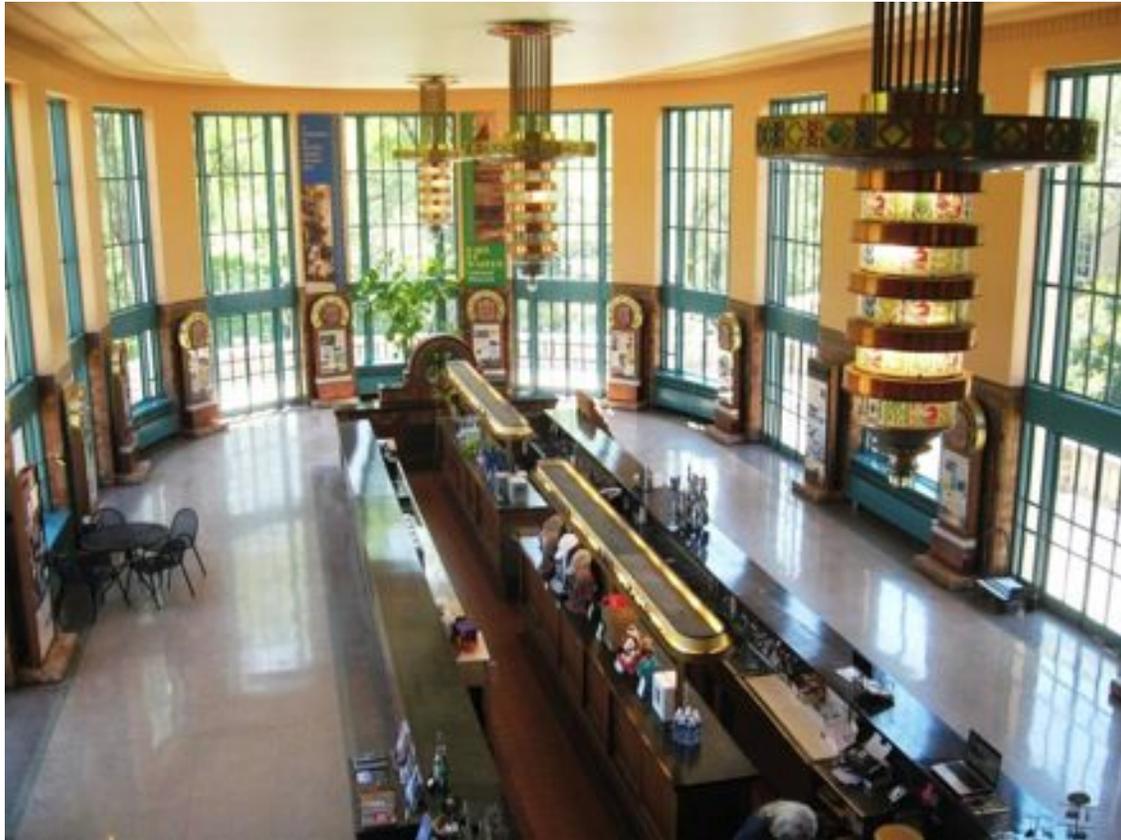
Fig. S9 View looking south in the Hall of Springs. (SEA 2012)

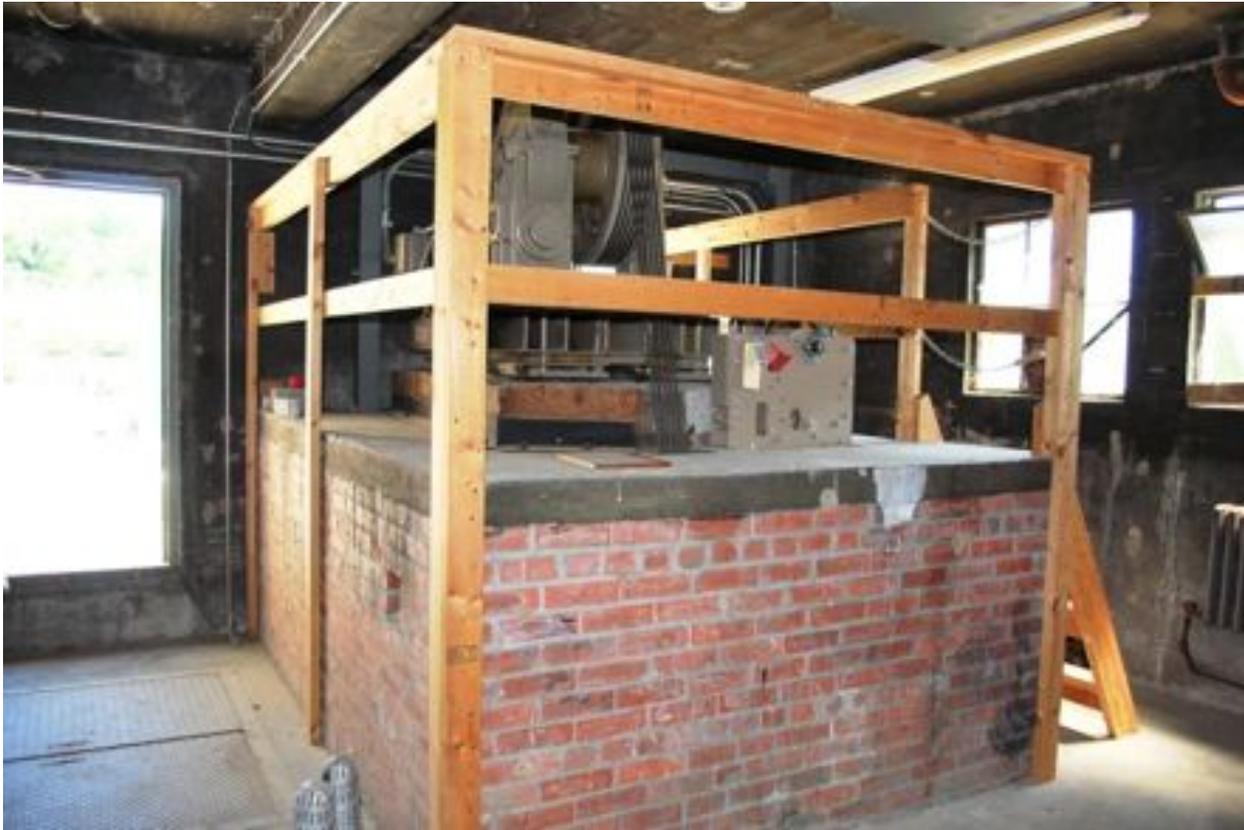
The Penthouse Floor is at Elevation 125' – 0", and houses the MEP equipment, including the existing elevator equipment (Figure S15), fire controls, air handling units, etc. Of what that is visible, there are several concrete slab repairs needed, mostly consisting of partial depth and crack injection repairs.

Fig. S15 View of elevator equipment and roof access door. (SEA 2012)

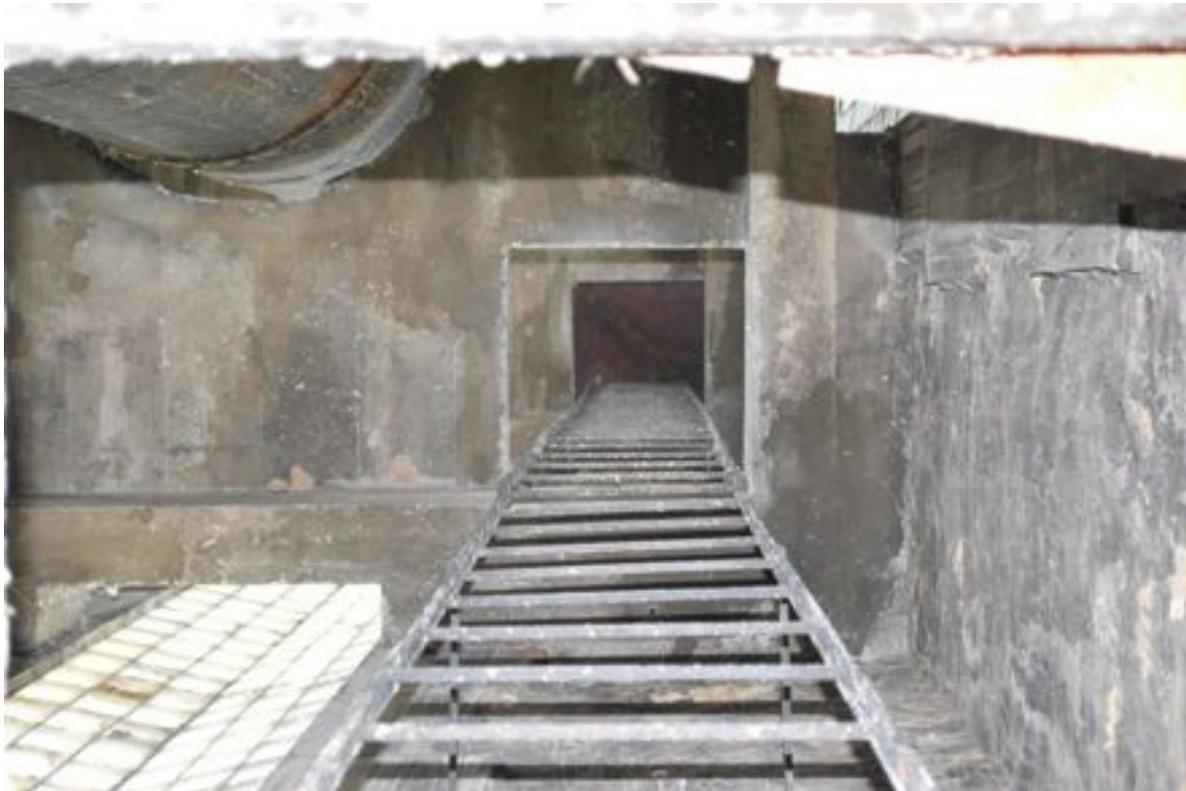
The Tower façade (refer to Exterior Assessment section) has been damaged over time by hail, vandalism, wind, and general degradation. These issues have created holes that allow pigeons to enter into the tower, and deposit their droppings throughout the interior. Pigeon droppings are odorous, as well as very caustic, as they contain high percentages of nitrogen which when combined with moisture can aggressively attack concrete and structural steel. At the time of assessment, the amount of pigeon droppings made safe access beyond the Penthouse Floor problematic and thus the Tower's interior concrete structure was only reviewed in a cursory manner.

Fig. S17 View up from bottom of the Tower access ladder. (SEA 2012)

It is recommended that a future structural assessment and possibly forensics testing be done of the Tower's structural materials. Additionally, the existing steel flue pipe should be investigated for possible leaks and degradation if it is to remain, as it could cause the concrete and mortar contamination from the carbonation process.
