## Exterior Conditions Assessment

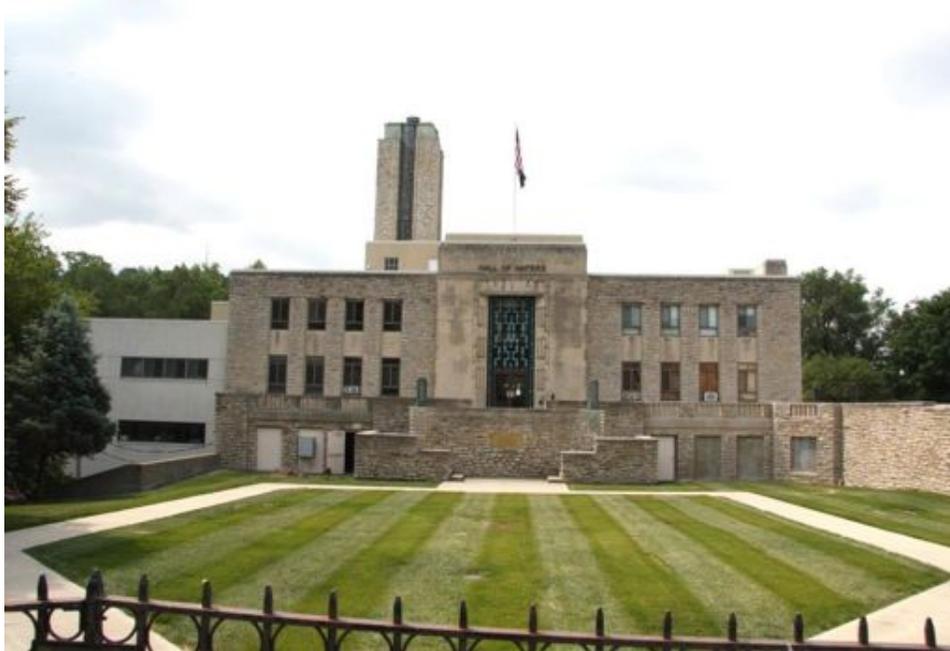
Fig. 62 North Elevation (SRJA 2012)

The North elevation of the Hall of Waters contains three different façade systems. First is the pitched face limestone, the second is cut stone, and the third is a color coated formed cast concrete with a stucco skim coat.

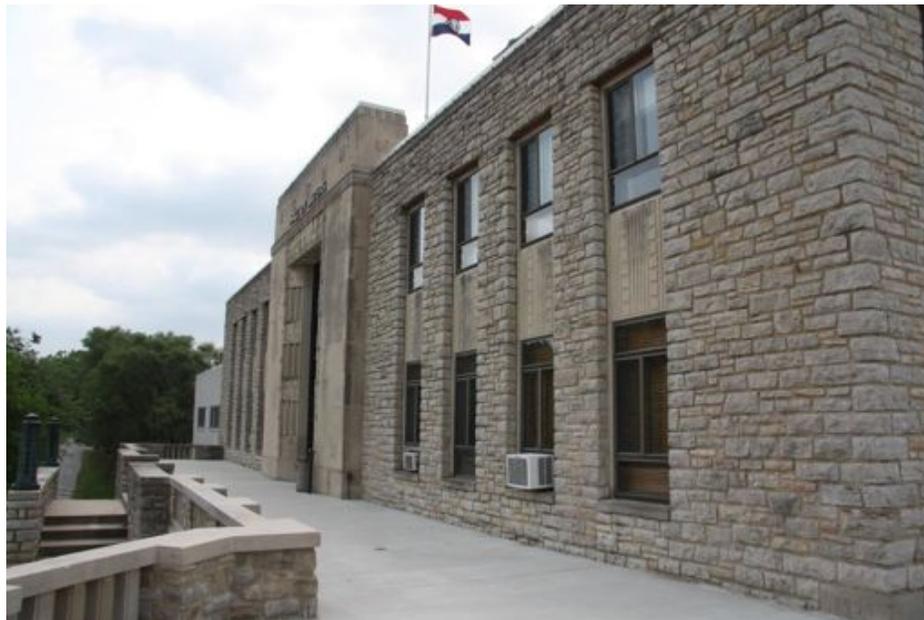
Fig. 63 North Elevation from terrace looking southeast. (SRJA 2012)

Observations made on-site revealed large portions of the limestone mortar joints have failed. The mortar has either separated from the stone or has cracked in the center portions. Additional mortar has flaked off which indicates a shallow surface-applied pointing repair during a previous project (Figure 64).

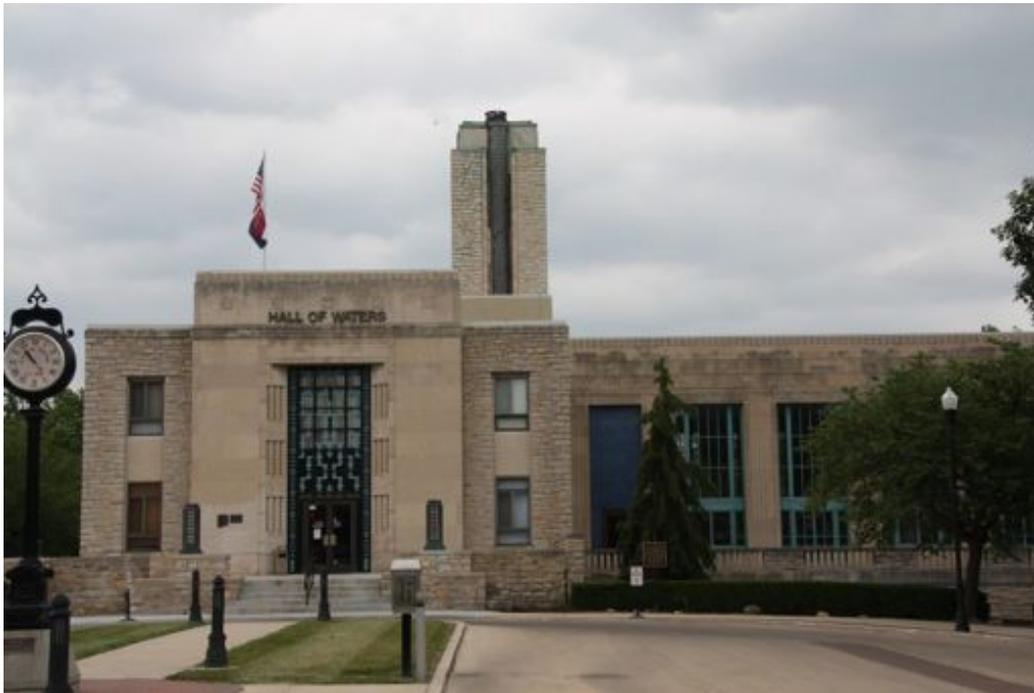
Fig. 70 West Elevation. (SRJA 2012)

The West elevation of the Hall of Waters contains two different façade systems. First being the pitched face limestone and the second being the cast stone.

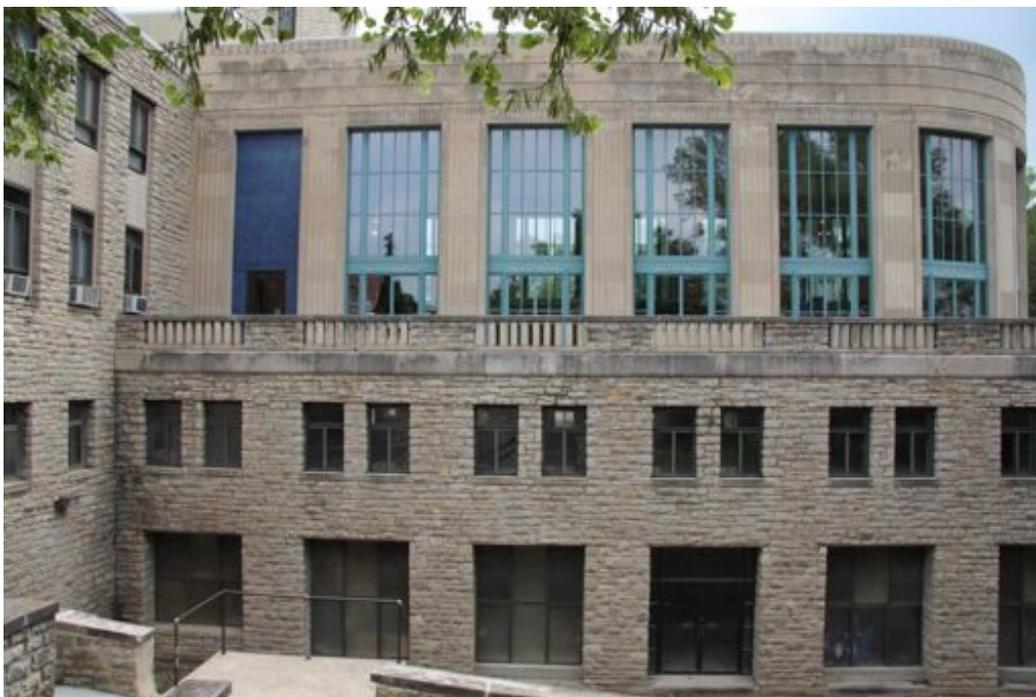
Fig. 71 West Elevation of the Hall of Springs and Ground/Ground Mezzanine Levels. (SRJA 2012)

Observations made on-site showed large portions of the limestone mortar joints have failed. The mortar has either separated from the stone or has cracked in the center portions. Additional mortar has flaked off which indicates a shallow surface mortar applied repair done during a previous project (Figure 72).

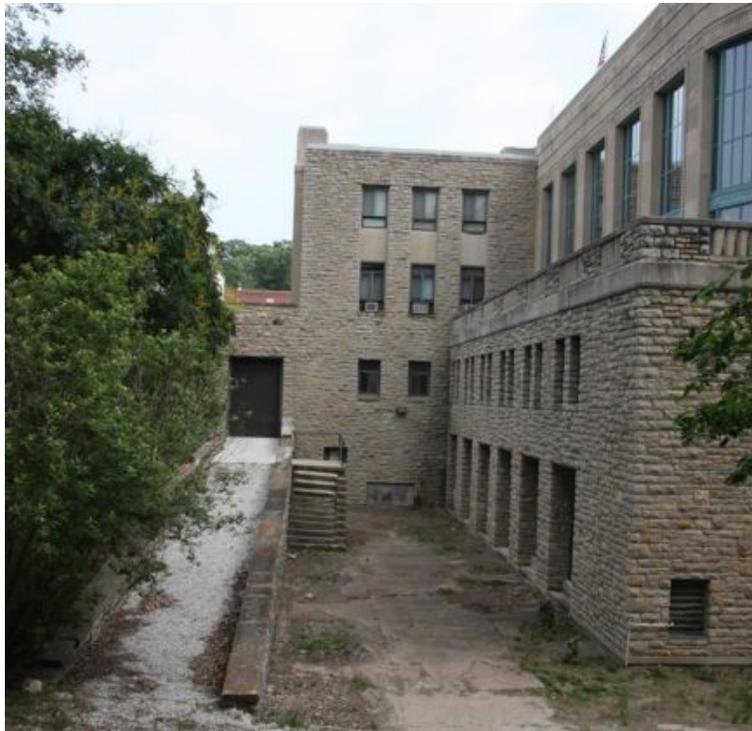
Fig. 76 South Elevation, west portion. (SRJA 2012)

The South elevation of the Hall of Waters contains three different façade systems. The first system is the pitched face limestone, the second is cast stone, and the third is a formed cast concrete with a color-coated stucco skim coat.

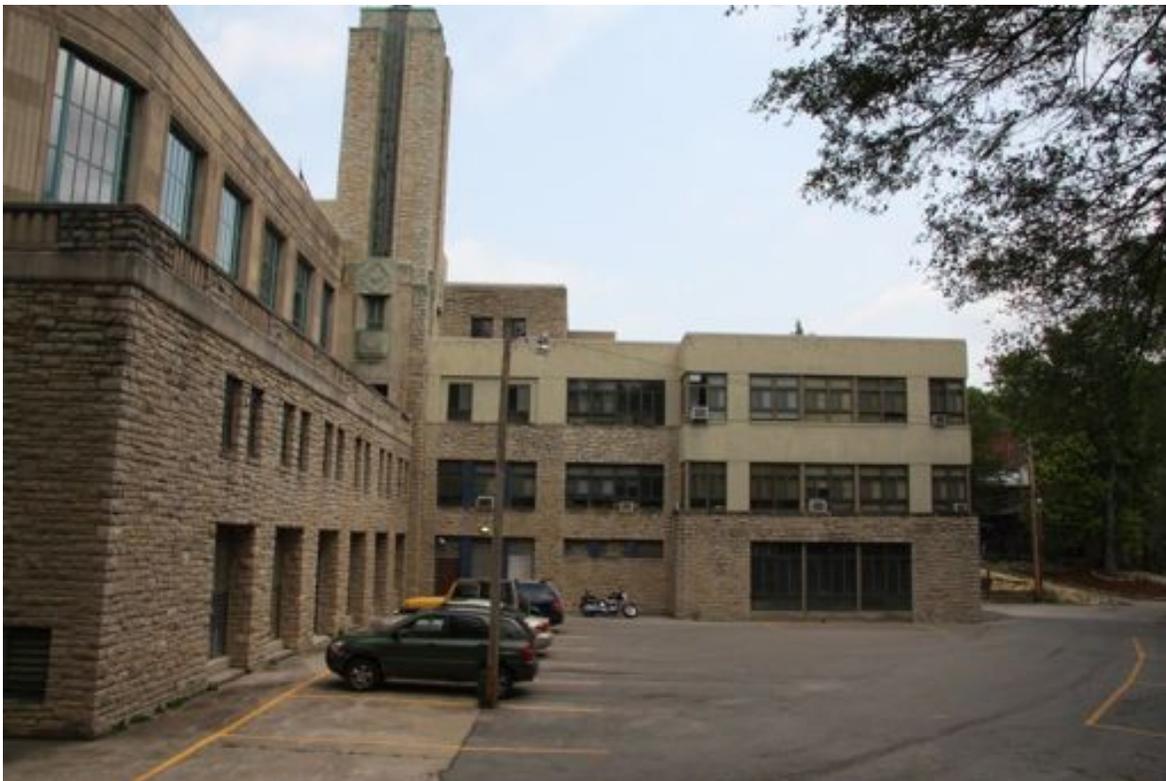
Fig. 79 South Elevation, east portion. (SRJA 2012)

Observations made on-site showed large portions of the limestone mortar joints have failed. The mortar has either separated from the stone or has cracked in the center portions. Additional mortar has flaked off which indicates a shallow surface applied repair done at a previous time.

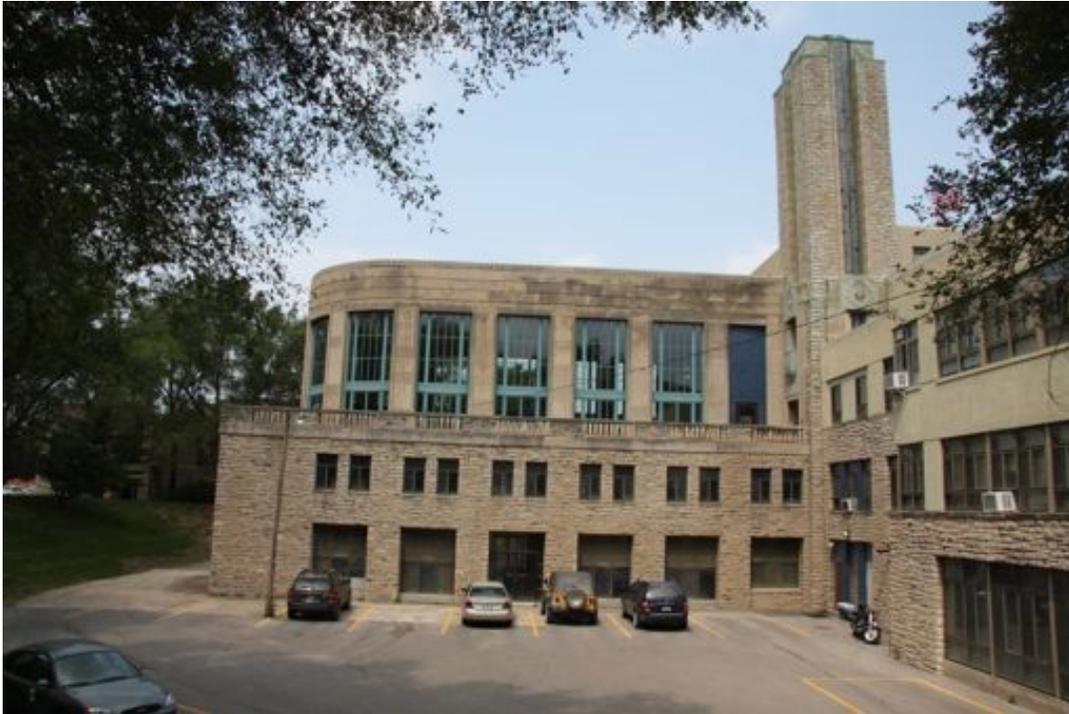
Fig. 84 East Elevation of the Hall of Springs. (SRJA 2012)

The East Elevation of the Hall of Waters contains three different façade systems. The first system is pitched face limestone, the second is cast stone, and the third is a formed cast concrete with a color-coated stucco skim coat.

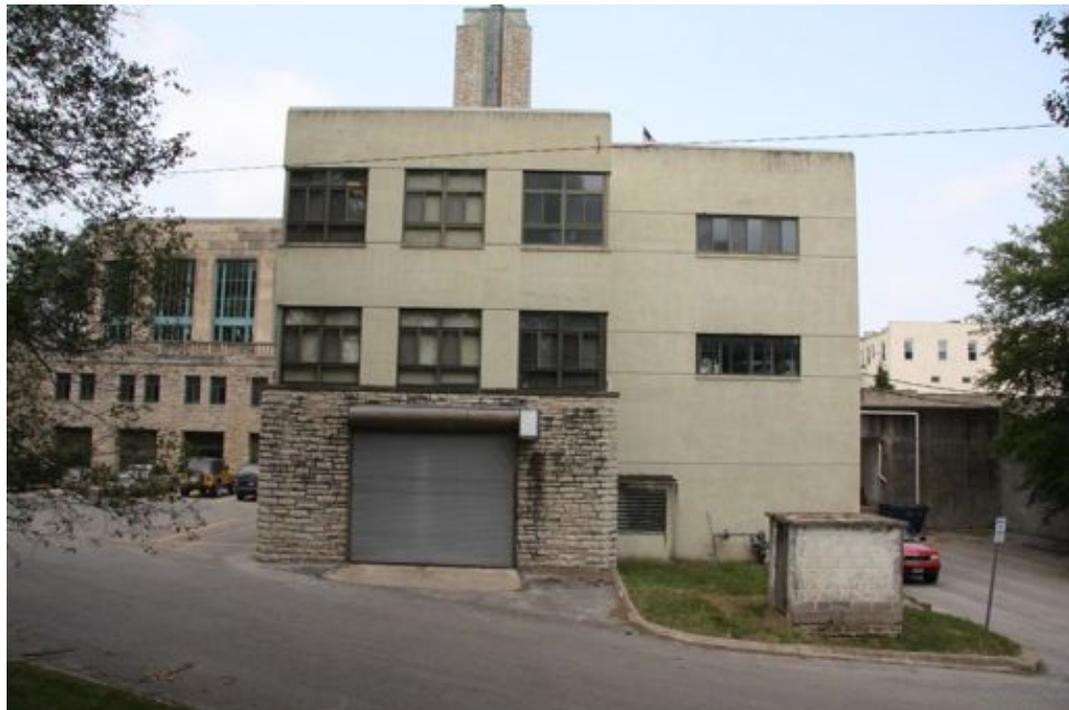
Fig. 85 East Elevation of east portion of the building. (SRJA 2012)

The rubble stone façade has multiple types of deterioration that is occurring. Observations on-site revealed that large portions of the limestone mortar joints have failed. The mortar has either separated from the stone or has cracked in the center portions. Additional mortar has flaked off which indicates a shallow surface mortar repair was applied during a previous project.

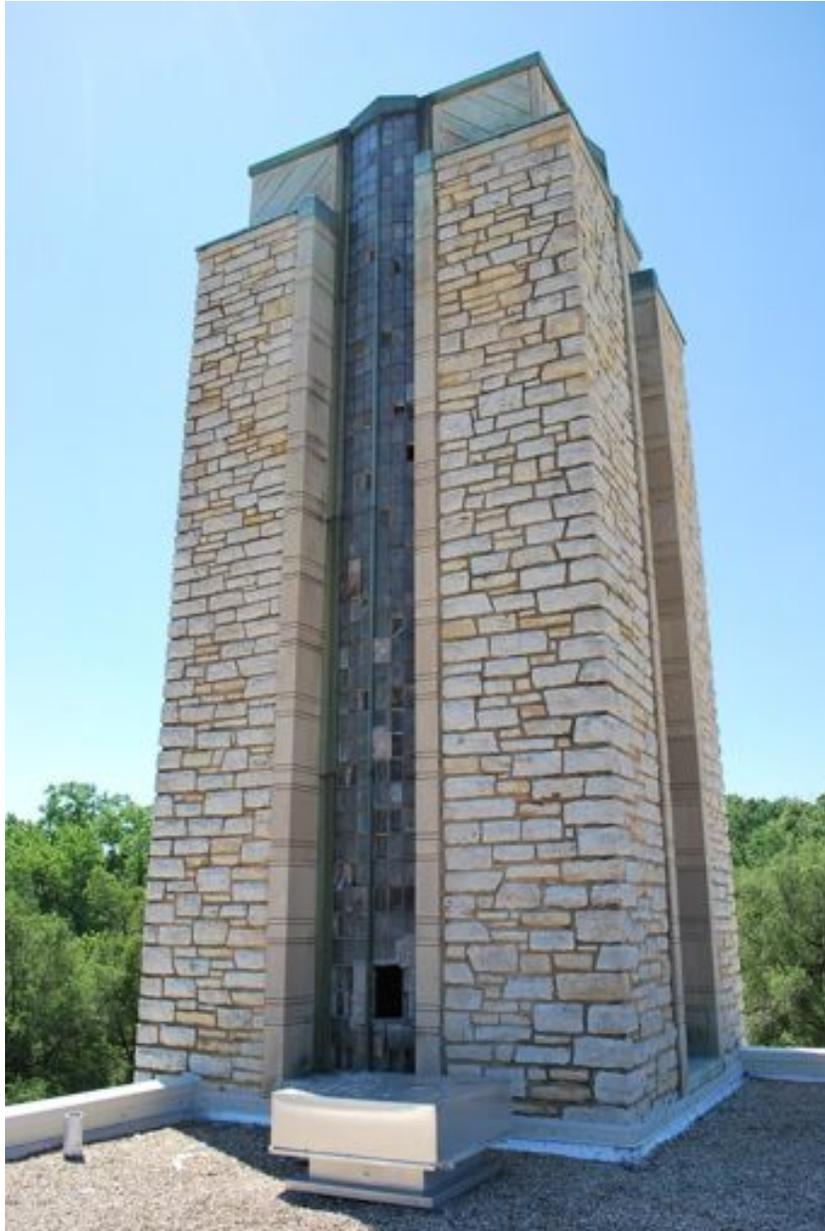
Fig. 95 Hall of Waters Tower looking southeast. (SEA 2012)

The Tower at the Hall of Waters contains three different façade systems. First is the pitched face limestone, the second is cut stone, and the third consists of glass tile blocks with wood blocking and metal cladding and fascias.
