**Subject: Asbestos-Containing Materials and Lead-Based Paint Inspection Report  
Former Wyman High School Site, Excelsior Springs, Missouri  
Missouri Environmental Assessment Services Contract, Contract No. CS210096002  
Vendor No. 48120656000**

**ASBESTOS-CONTAINING MATERIALS AND LEAD-BASED PAINT INSPECTION**

**FORMER WYMAN HIGH SCHOOL SITE  
EXCELSIOR SPRINGS, MISSOURI**

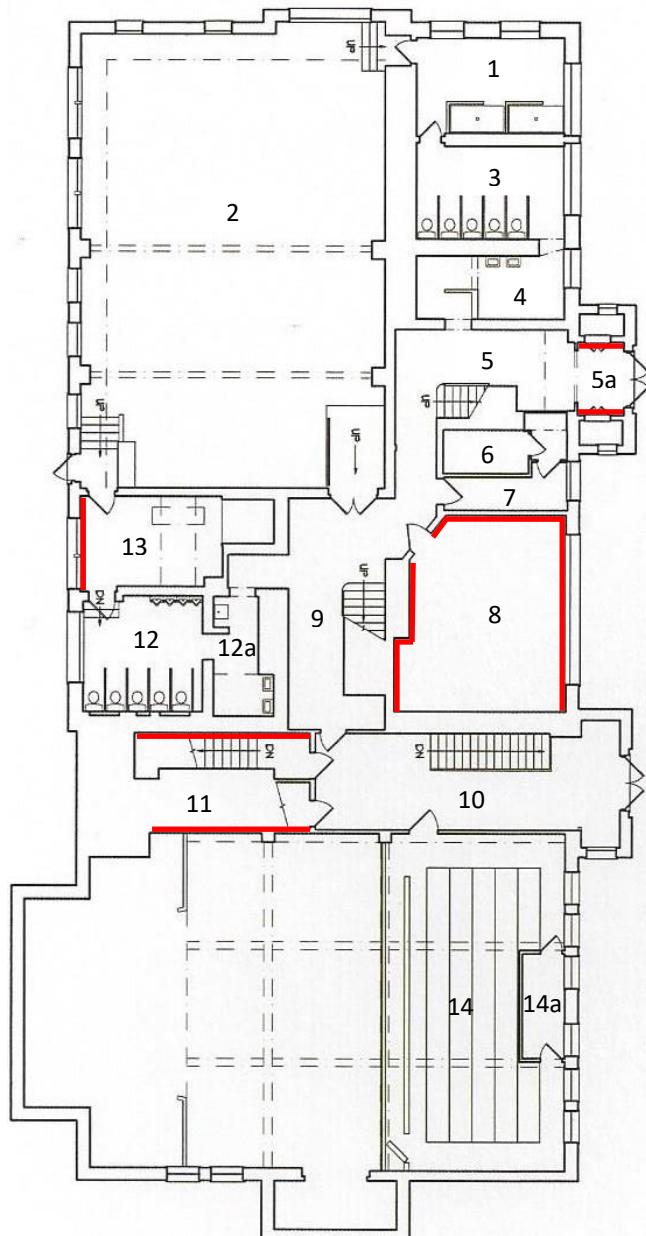
### Figure 7 LBP on First Floor

— Wall with LBP (lower portion where upper/lower sections are present)

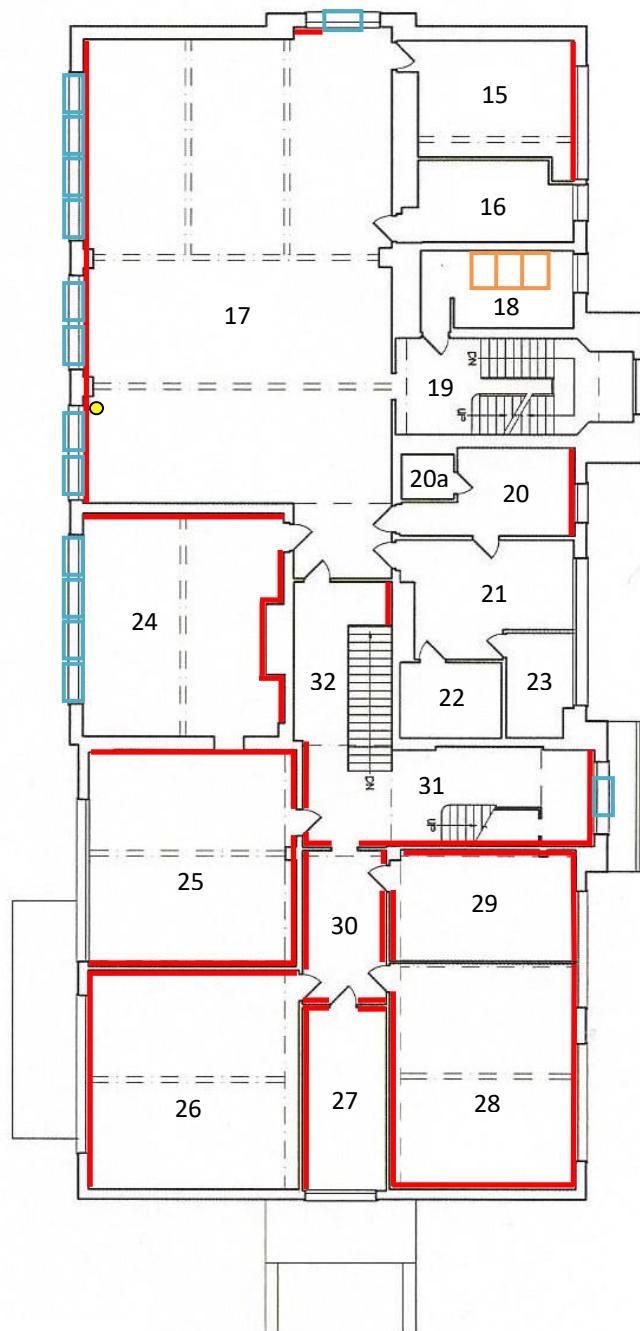
**Figure 8**  
**LBP on Second Floor**Former Wyman High School Site  
Excelsior Springs, Missouri

- LBP Lead-based paint
- Wall with LBP (lower portion)
- Window frame with LBP

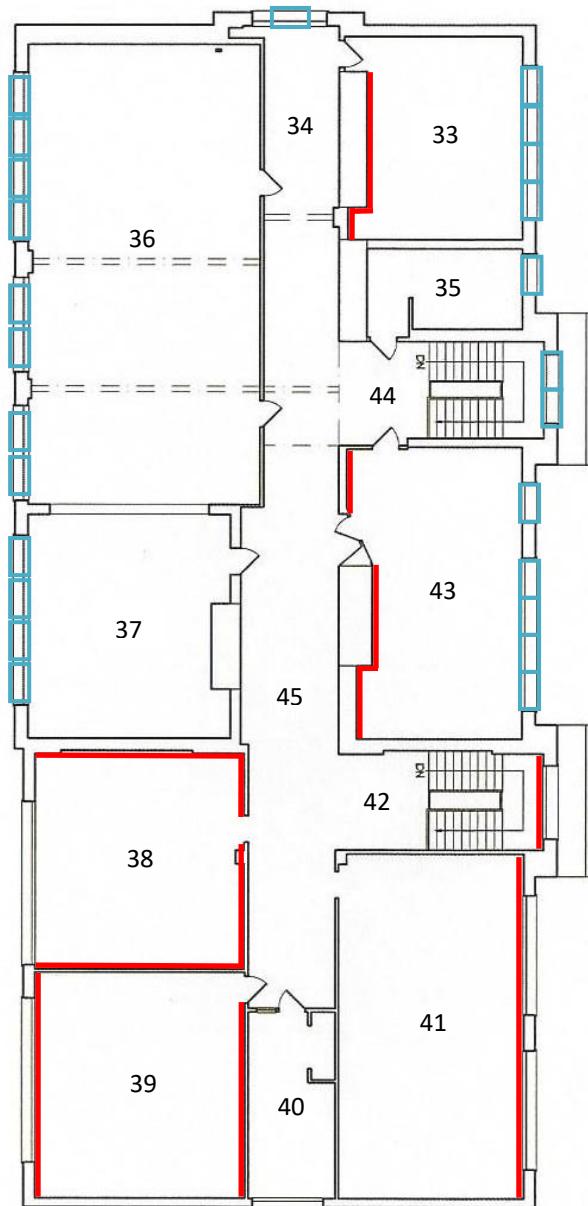
### Figure 9 LBP on Third Floor

— Wall with LBP (lower portion)

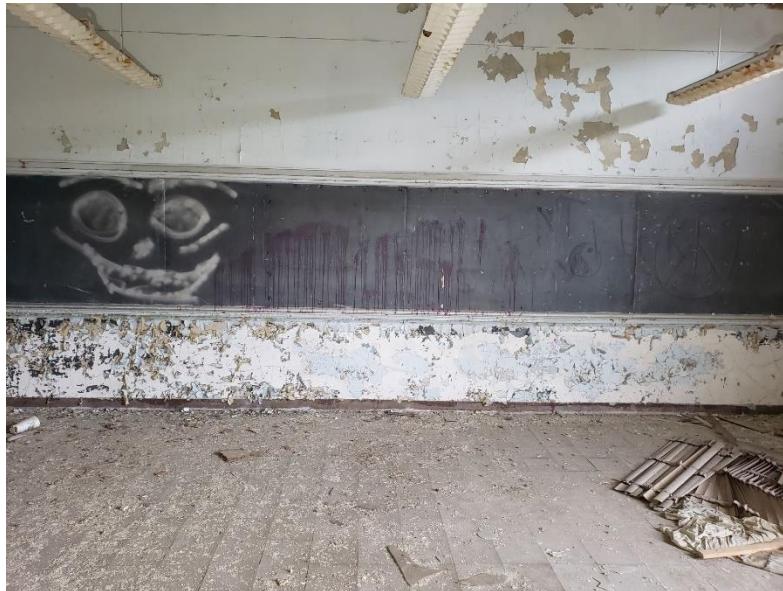
Client: Missouri Department of Natural Resources	Description: Photograph of a chalkboard in a classroom of the former school building. These chalkboards, which were located throughout the building, were represented by samples BB1-1, BB1-2, and BB1-3 for asbestos analysis.	Photograph Number: 10
Direction: NA	Photographer: Lynn Parman	Date: 10/13/2021

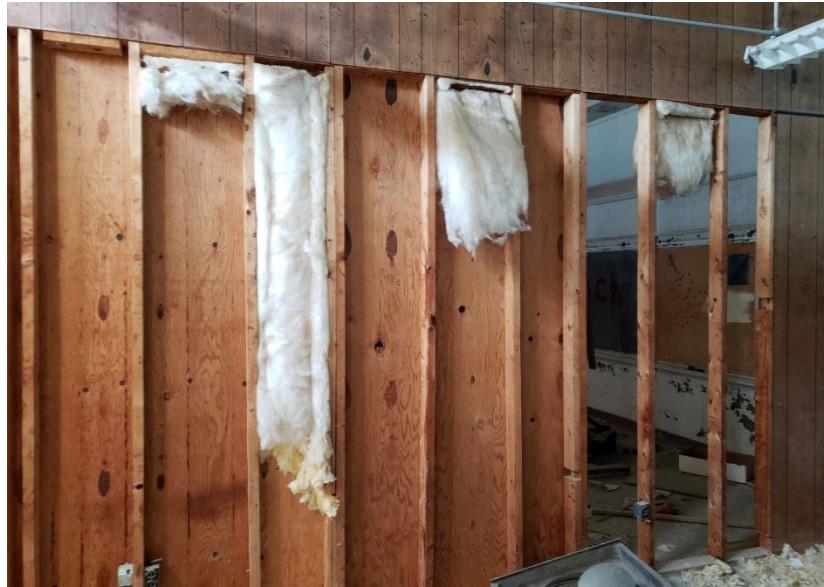
Client: Missouri Department of Natural Resources	Description: Photograph of fiberglass insulation batts in a wall of the former school building.	Photograph Number: 13
Direction: NA	Photographer: Lynn Parman	Date: 10/12/2021

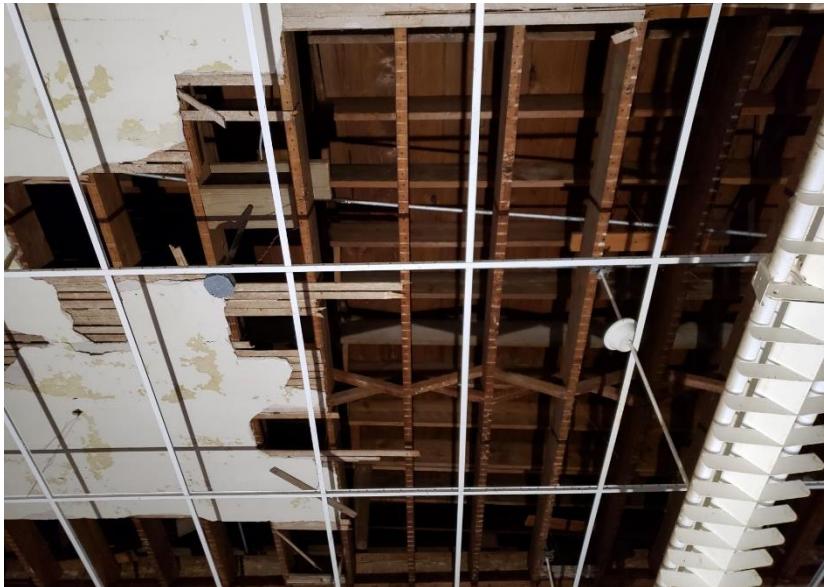
Client: Missouri Department of Natural Resources	Description: Photograph of exposed ceiling joists in the former school building.	Photograph Number: 14
Direction: NA	Photographer: Lynn Parman	Date: 10/13/2021

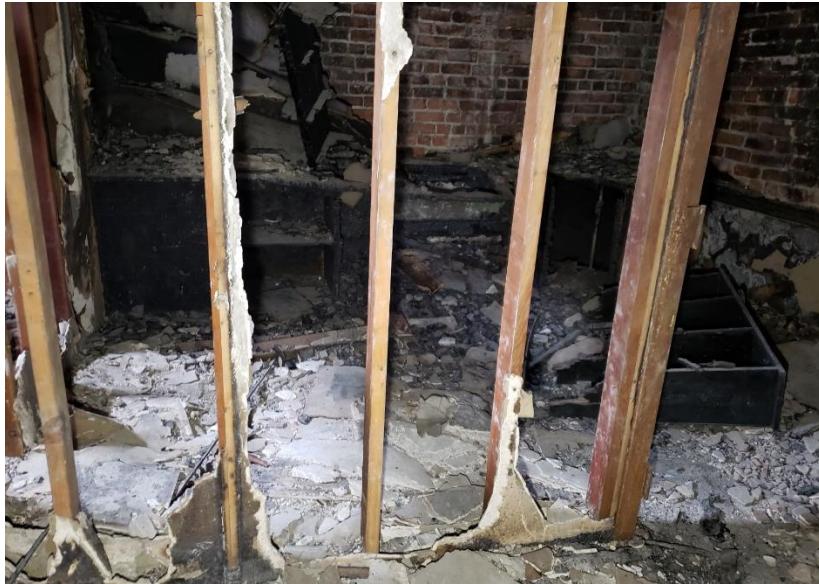
Client: Missouri Department of Natural Resources	Description: Photograph of Room 22 on the second floor of the former school building where a fire had occurred.	Photograph Number: 15
Direction: NA	Photographer: Lynn Parman	Date: 10/13/2021

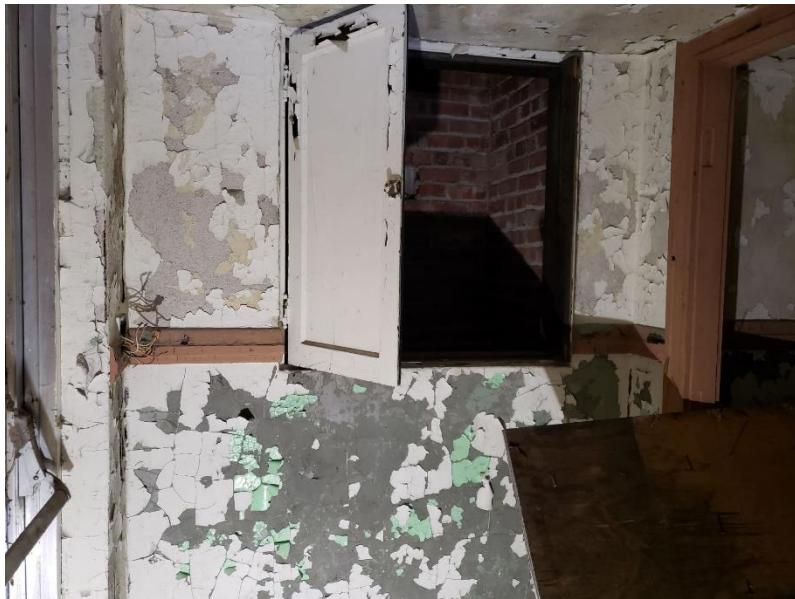
Client: Missouri Department of Natural Resources	Description: Photograph of the lower portion of the south wall in Room 5a that was positive for lead-based paint (LBP).	Photograph Number: 16
Direction: NA	Photographer: Lynn Parman	Date: 10/12/2021

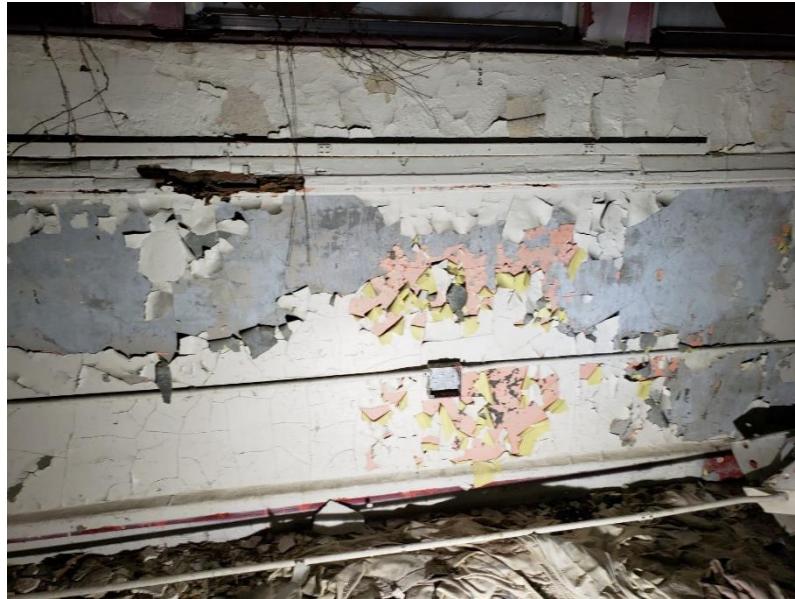
Client: Missouri Department of Natural Resources	Description: Photograph of the lower portion of the east wall in Room 8 that was positive for LBP.	Photograph Number: 18
Direction: NA	Photographer: Lynn Parman	Date: 10/12/2021

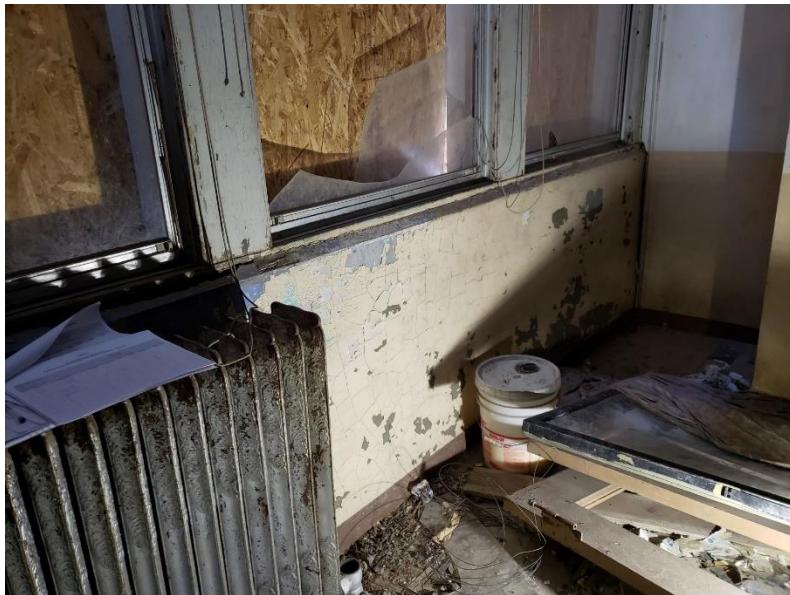
Client: Missouri Department of Natural Resources	Description: Photograph of the lower portion of the east wall in Room 15 that was positive for LBP.	Photograph Number: 24
Direction: NA	Photographer: Lynn Parman	Date: 10/12/2021

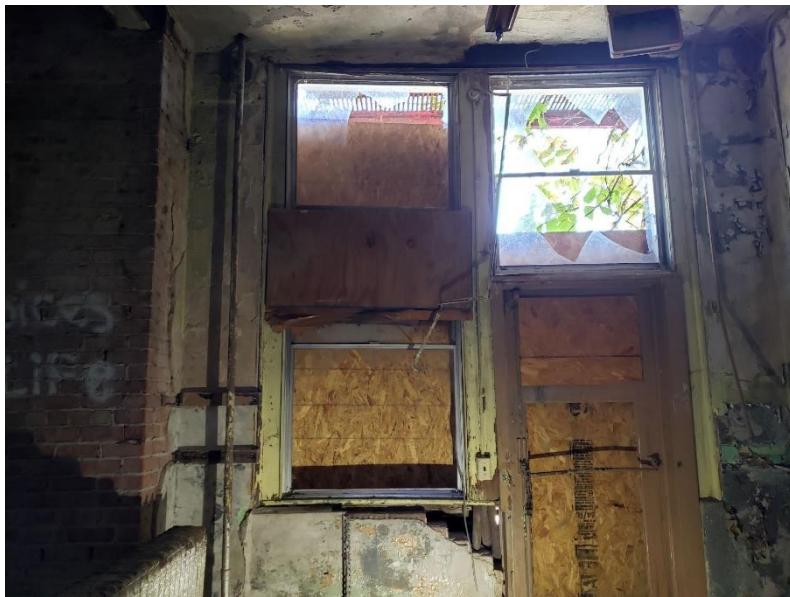
Client: Missouri Department of Natural Resources	Description: Photograph of a window frame and lower portion of the wall near an exterior door on the north wall in Room 17 that were positive for LBP.	Photograph Number: 26
Direction: NA	Photographer: Lynn Parman	Date: 10/12/2021

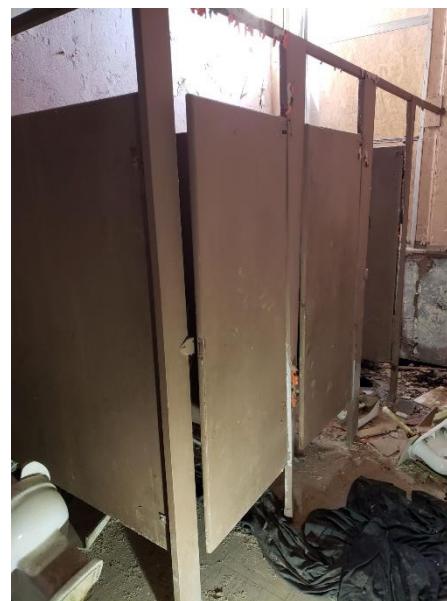
Client: Missouri Department of Natural Resources	Description: Photograph of bathroom stall doors and walls in Room 18 that were positive for LBP.	Photograph Number: 28
Direction: NA	Photographer: Lynn Parman	Date: 10/12/2021

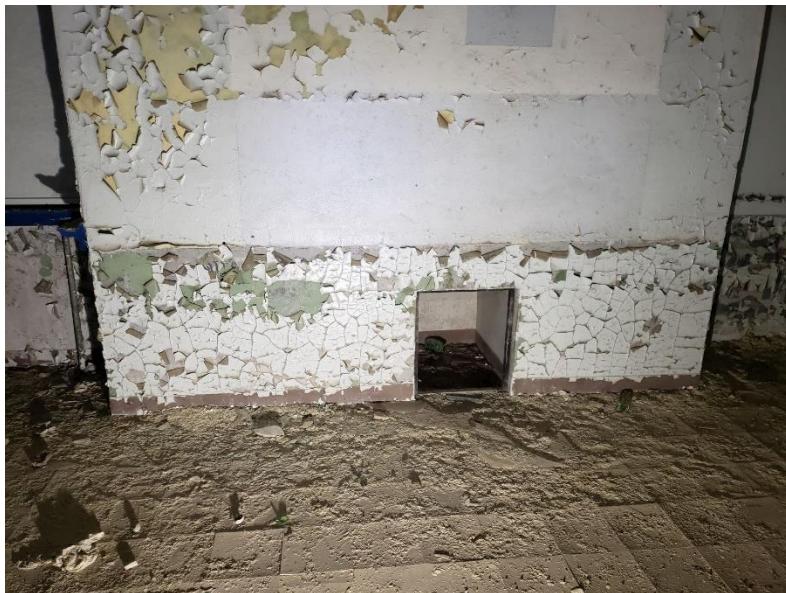
Client: Missouri Department of Natural Resources	Description: Photograph of the lower portion of the east wall in Room 24 that was positive for LBP.	Photograph Number: 30
Direction: NA	Photographer: Lynn Parman	Date: 10/12/2021

<b>PROJECT NAME</b> Former Wyman High School					<b>DATE</b> October 13, 2021			
<b>PROJECT NUMBER</b> MOESA109EA1					<b>INSPECTOR(S)</b> Lynn Parman			
<b>PROJECT LOCATION</b> Excelsior Springs, Missouri					<b>BUILDING NUMBER/NAME</b> Second Floor			
No.	Color	Room/Location	Component	Substrate	Result (mg/cm <sup>2</sup> )	Positive / Negative	Condition	Notes
52	White	Room 20a – north side	Wall	Wallboard	ND	Negative	Fair	
53	White	Room 20a – east side	Wall	Wallboard	ND	Negative	Good	
54	White	Room 20a – south side	Wall	Wallboard	ND	Negative	Good	
55	White	Room 20a – west side	Wall	Wallboard	ND	Negative	Good	
56	White	Room 24 – north side (top)	Wall	Plaster	0.063	Negative	Poor	
57	White	Room 24 – north side (bottom)	Wall	Plaster	1.27	Positive	Poor	88 ft <sup>2</sup>
58	White	Room 24 – east side (top)	Wall	Plaster	0.142	Negative	Poor	
59	White	Room 24 – east side (bottom)	Wall	Plaster	1.26	Positive	Poor	100 ft <sup>2</sup>

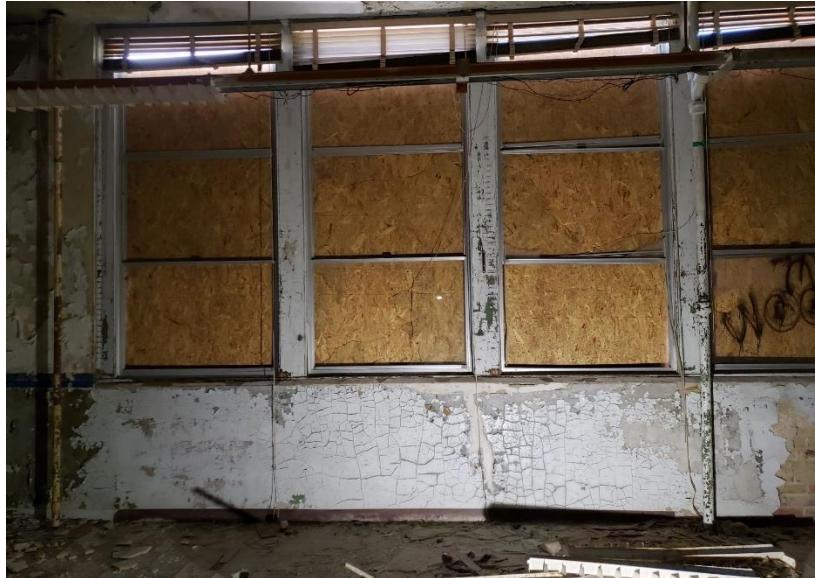
Client: Missouri Department of Natural Resources	Description: Photograph of window frames on the west wall in Room 24 that were positive for LBP.	Photograph Number: 31
Direction: NA	Photographer: Lynn Parman	Date: 10/12/2021

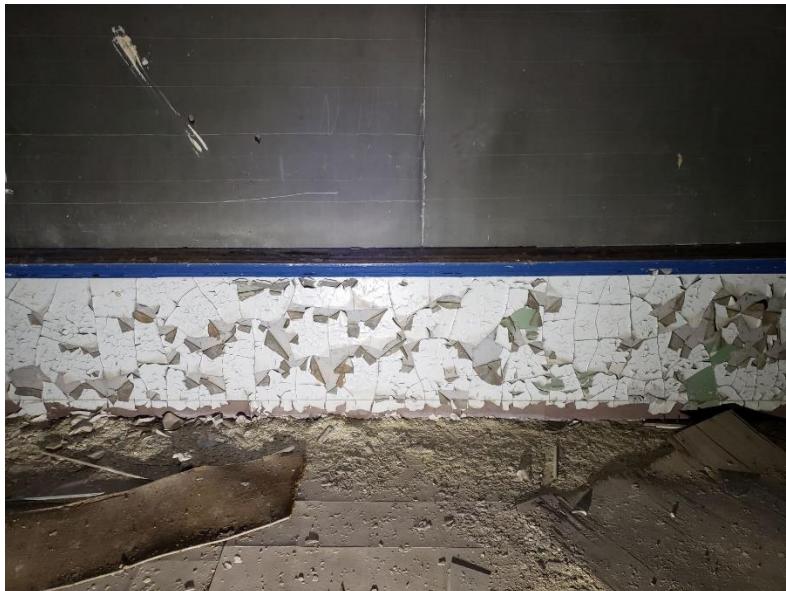
Client: Missouri Department of Natural Resources	Description: Photograph of the lower portion of the north wall in Room 24 that was positive for LBP.	Photograph Number: 32
Direction: NA	Photographer: Lynn Parman	Date: 10/12/2021

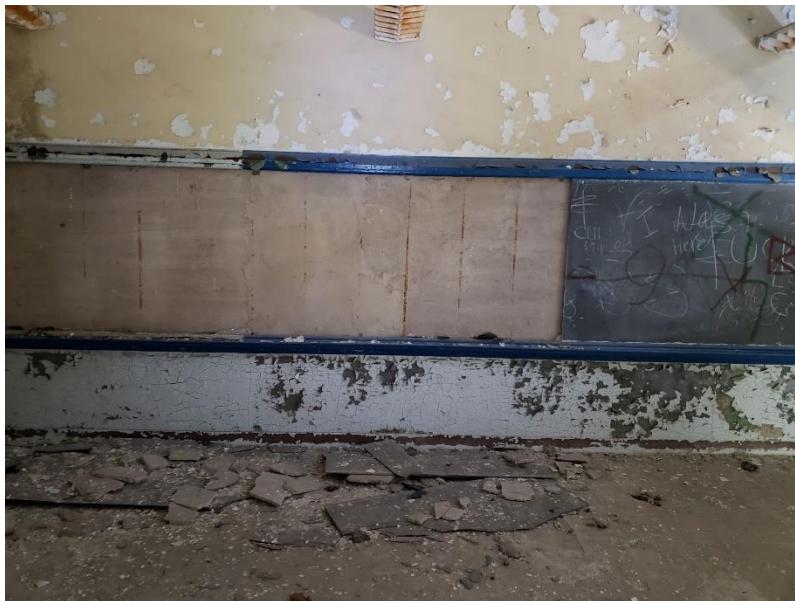
Client: Missouri Department of Natural Resources	Description: Photograph of the lower portion of the south wall in Room 25 that was positive for LBP.	Photograph Number: 34
Direction: NA	Photographer: Lynn Parman	Date: 10/12/2021

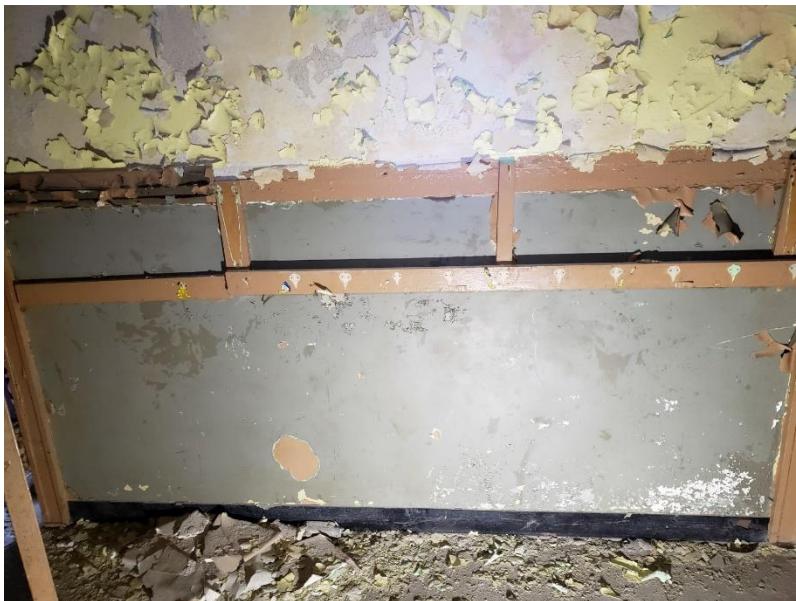
Client: Missouri Department of Natural Resources	Description: Photograph of the lower portion of the east wall in Room 30 that was positive for LBP.	Photograph Number: 46
Direction: NA	Photographer: Lynn Parman	Date: 10/12/2021

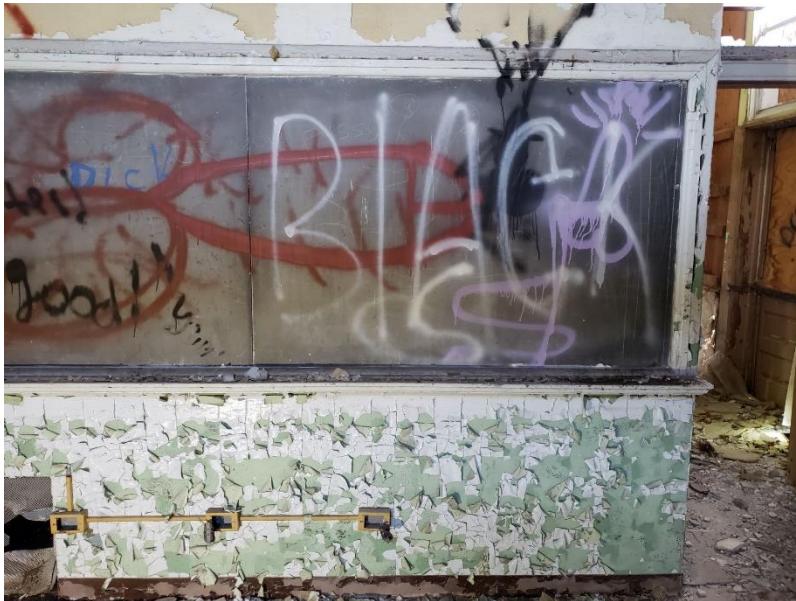
Client: Missouri Department of Natural Resources	Description: Photograph of the lower portion of the west wall in Room 33 that was positive for LBP.	Photograph Number: 54
Direction: NA	Photographer: Lynn Parman	Date: 10/12/2021

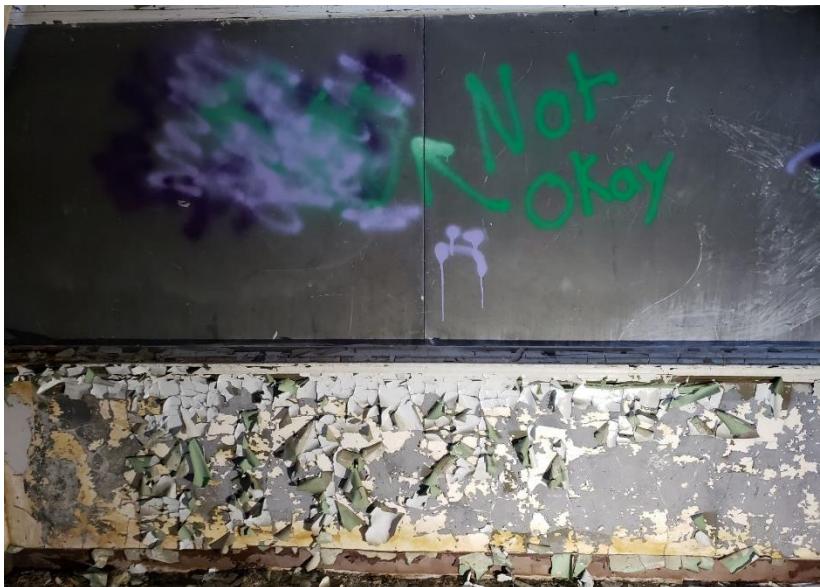
Client: Missouri Department of Natural Resources	Description: Photograph of the lower portion of the north wall in Room 38 that was positive for LBP.	Photograph Number: 61
Direction: NA	Photographer: Lynn Parman	Date: 10/12/2021

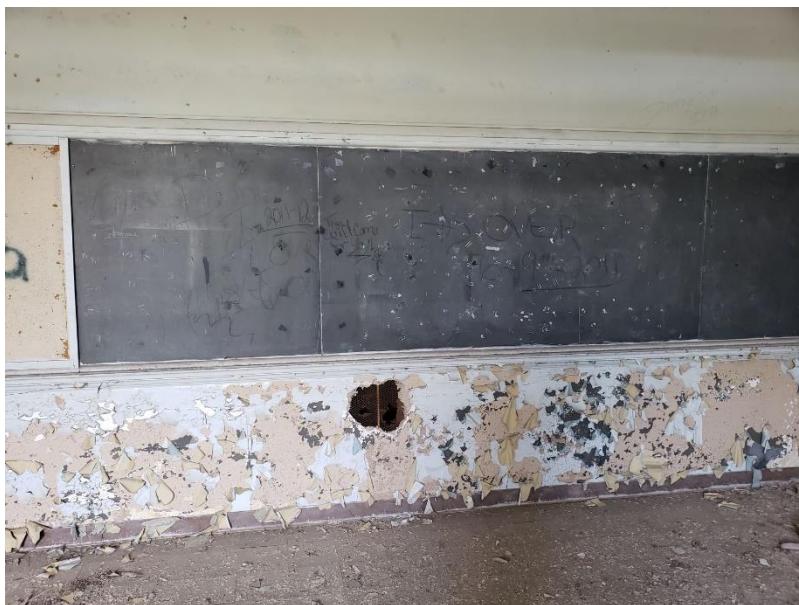
Client: Missouri Department of Natural Resources	Description: Photograph of the lower portion of the east wall in Room 39 that was positive for LBP.	Photograph Number: 62
Direction: NA	Photographer: Lynn Parman	Date: 10/12/2021

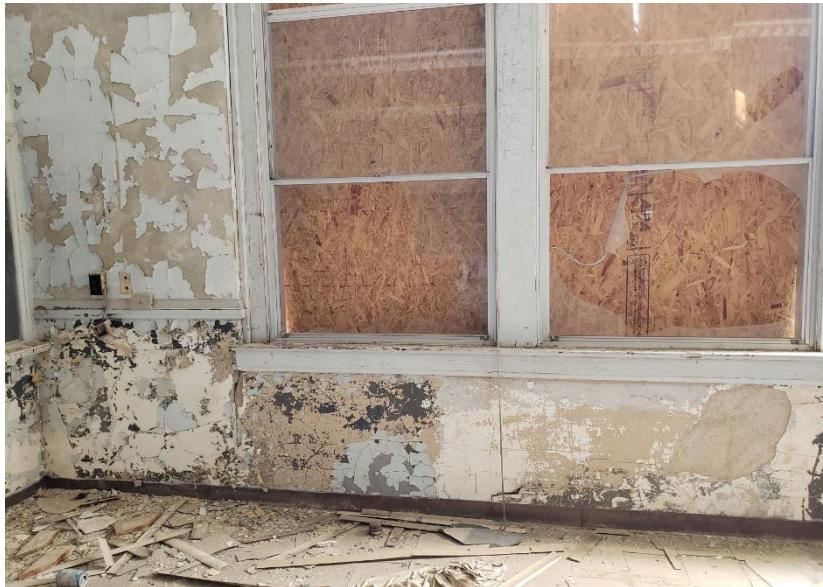
Client: Missouri Department of Natural Resources	Description: Photograph of the lower portion of the west wall in Room 39 that was positive for LBP.	Photograph Number: 63
Direction: NA	Photographer: Lynn Parman	Date: 10/12/2021

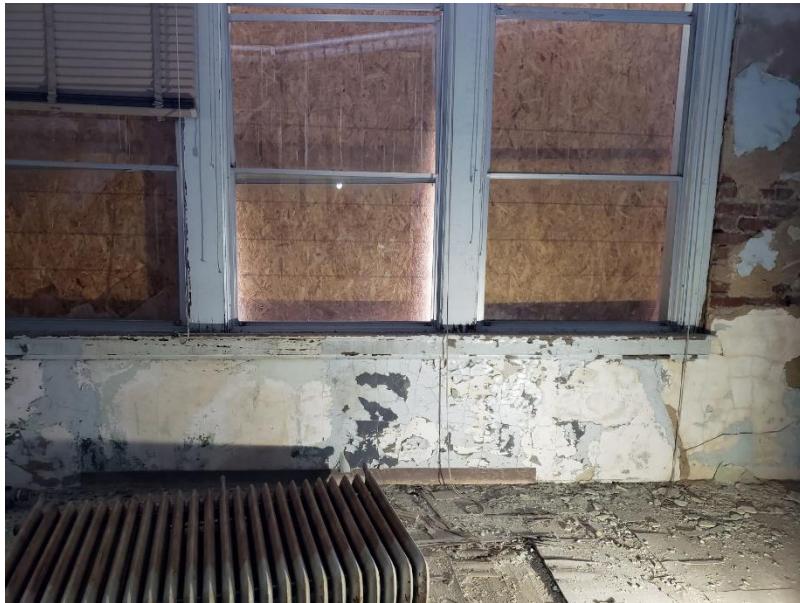
Client: Missouri Department of Natural Resources	Description: Photograph of the lower portion of the east wall in Room 41 that was positive for LBP.	Photograph Number: 64
Direction: NA	Photographer: Lynn Parman	Date: 10/12/2021

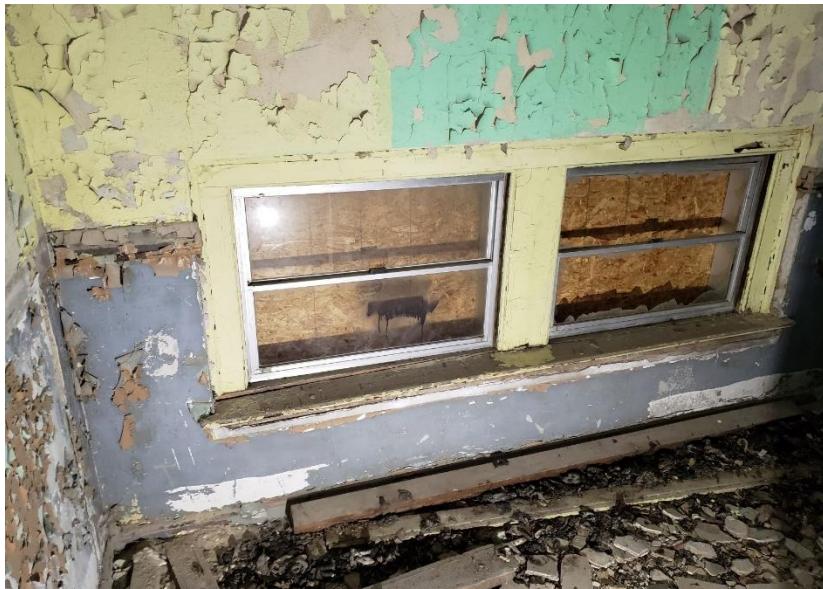
Client: Missouri Department of Natural Resources	Description: Photograph of the lower portion of the east wall in Room 42 that was positive for LBP.	Photograph Number: 65
Direction: NA	Photographer: Lynn Parman	Date: 10/12/2021

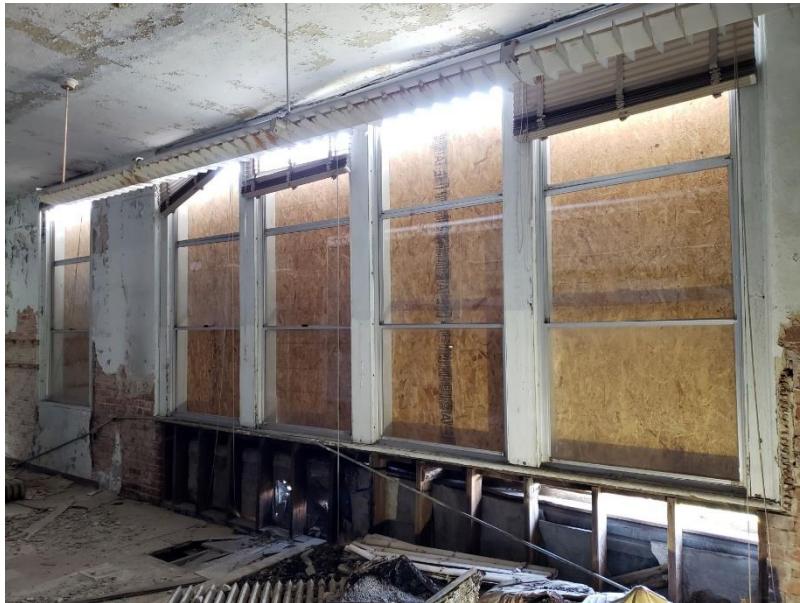
Client: Missouri Department of Natural Resources	Description: Photograph of window frames on the east wall in Room 43 that were positive for LBP.	Photograph Number: 66
Direction: NA	Photographer: Lynn Parman	Date: 10/12/2021

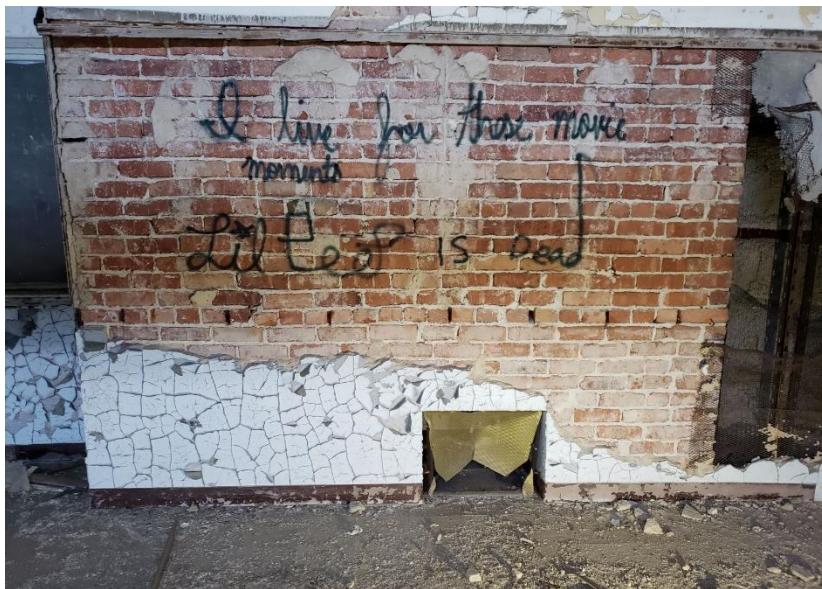
Client: Missouri Department of Natural Resources	Description: Photograph of the lower portion of the west wall in Room 43 that was positive for LBP.	Photograph Number: 67
Direction: NA	Photographer: Lynn Parman	Date: 10/12/2021

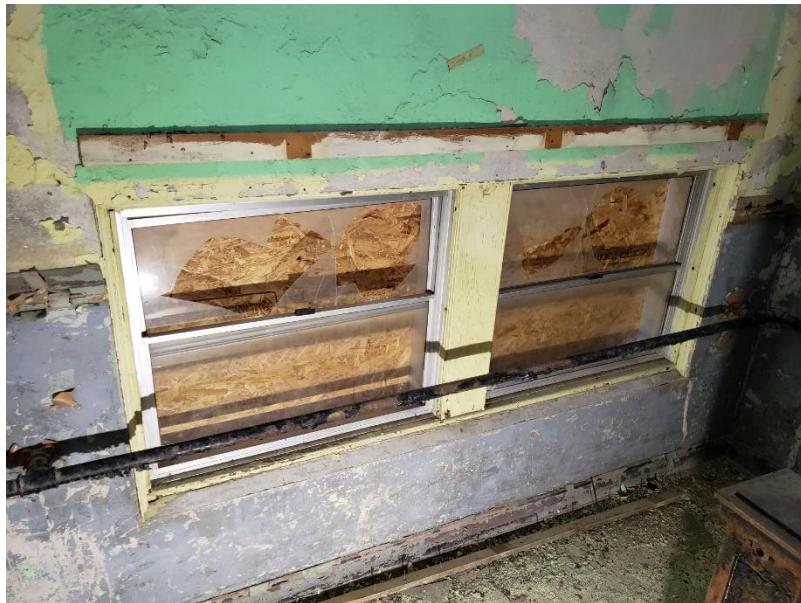
Client: Missouri Department of Natural Resources	Description: Photograph of lower window frames on the east wall in Room 44 that were positive for LBP.	Photograph Number: 68
Direction: NA	Photographer: Lynn Parman	Date: 10/12/2021

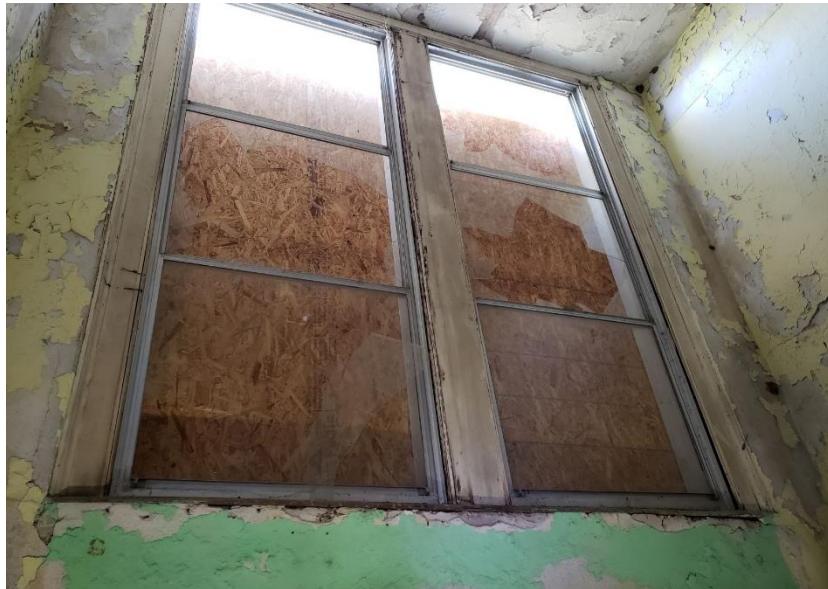
Client: Missouri Department of Natural Resources	Description: Photograph of upper window frames on the east wall in Room 44 that were positive for LBP.	Photograph Number: 69
Direction: NA	Photographer: Lynn Parman	Date: 10/12/2021

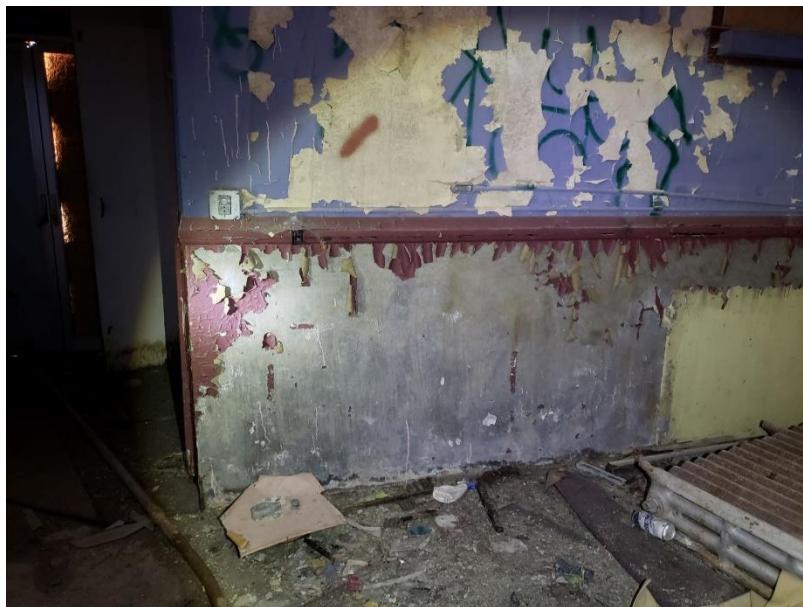
Client: Missouri Department of Natural Resources	Description: Photograph of the lower portion of the south wall in Room 46 that was positive for LBP.	Photograph Number: 70
Direction: NA	Photographer: Lynn Parman	Date: 10/12/2021

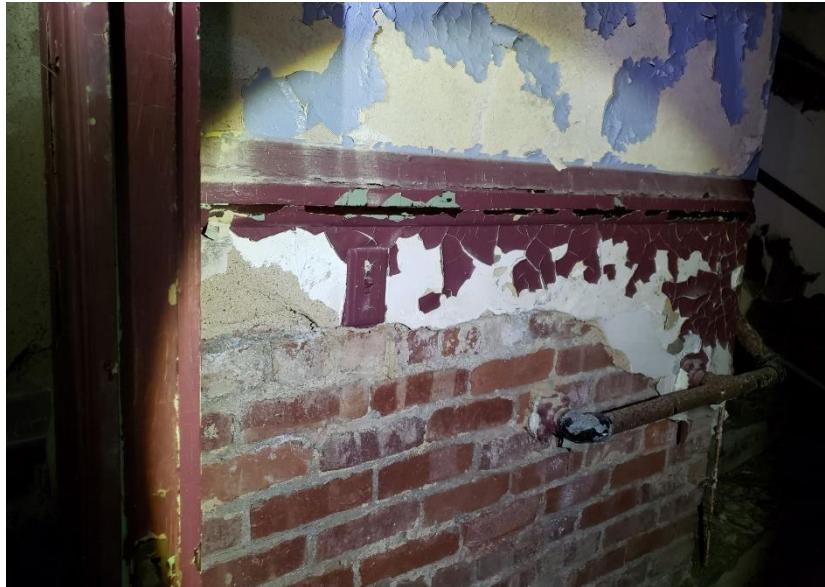
Client: Missouri Department of Natural Resources	Description: Photograph of the lower portion of the north wall in Room 47 that was positive for LBP.	Photograph Number: 71
Direction: NA	Photographer: Lynn Parman	Date: 10/12/2021

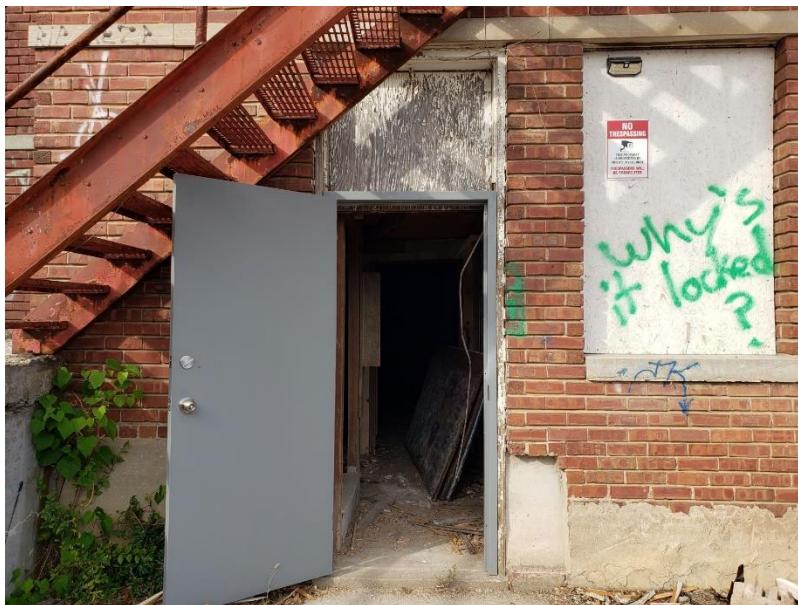
Client: Missouri Department of Natural Resources	Description: Photograph of an exterior doorframe at the southwest corner of the former school building that was positive for LBP.	Photograph Number: 72
Direction: North	Photographer: Lynn Parman	Date: 10/12/2021

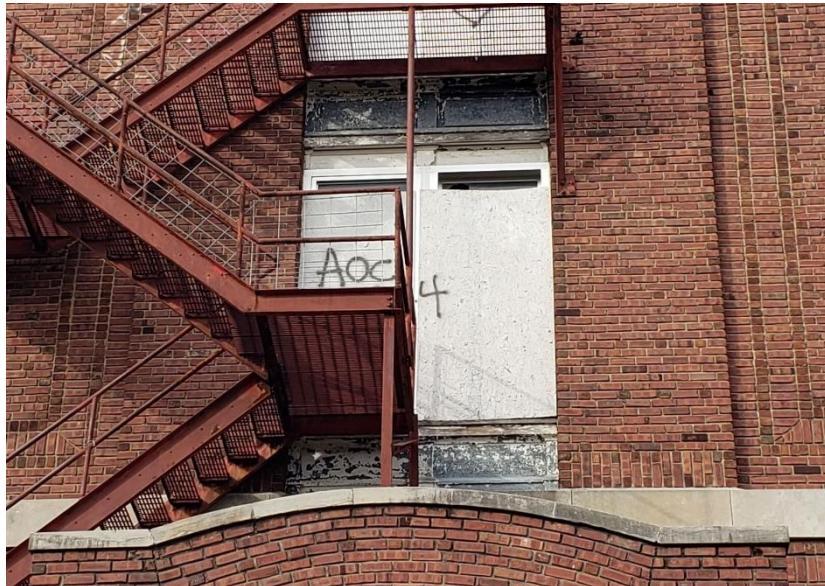
Client: Missouri Department of Natural Resources	Description: Photograph of an exterior doorframe on the south side of the second floor of the former school building that was positive for LBP.	Photograph Number: 73
Direction: North	Photographer: Lynn Parman	Date: 10/12/2021
